## MGB V8 Roadster restoration project – Report 24

**Easter Sunday 5<sup>th</sup> April 2015**

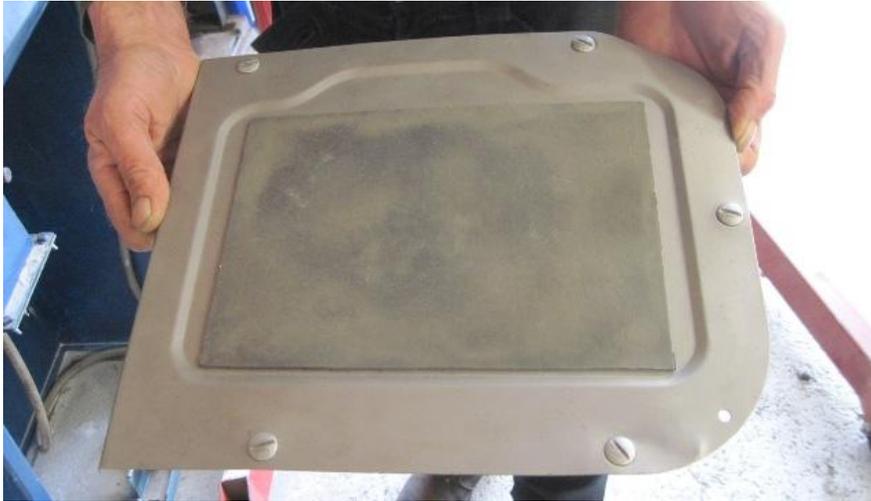
Finished repairing the 'blaster' first thing this morning. Tried it out on the battery cover opening plate. It worked better than it had since I have owned the blasting cabinet.

I must remember to etch prime this battery opening cover plate before it starts going rusty again.

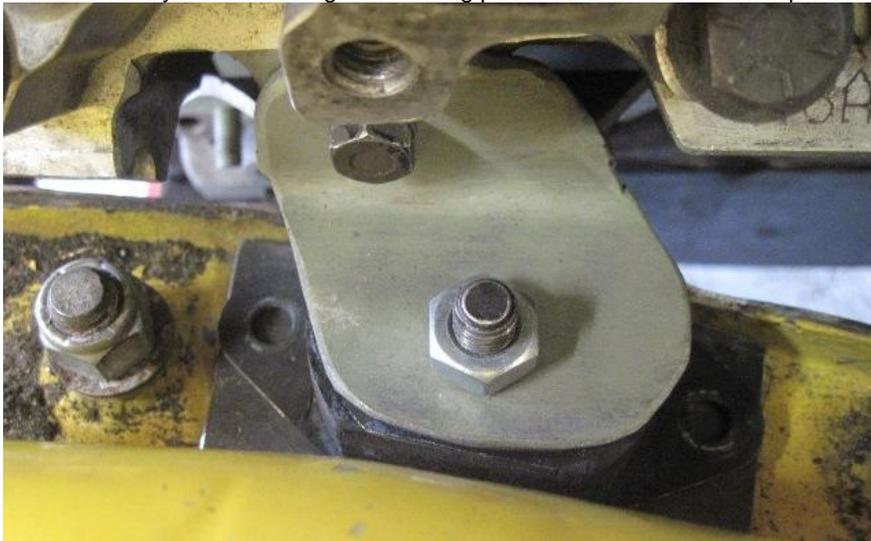
This is how they looked the engine mounting plates looked when bolted in position.

From the photo it looks as if it is only attached to the engine by one 5/16" UNC bolt. The part you can't see is the large plate underneath that has 2 x 3/8" UNC bolts that go into the engine block. Next job is to scribe the hole positions the threaded rod or high tensile bolt thread that will be threaded into, and welded to the 3/16" metal plate that will eventually be welded to the top of the chassis rail.

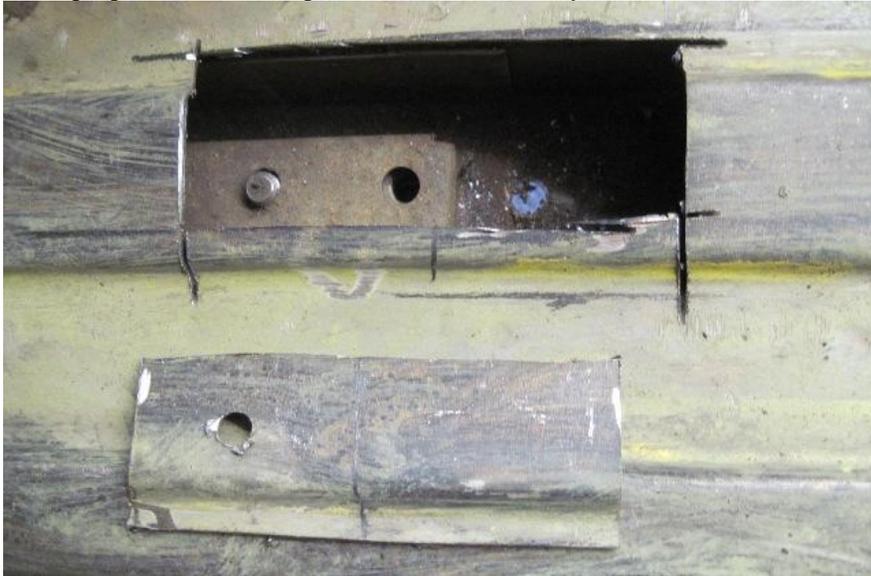
Only the front two of the four gearbox mounting bolts lined up with the threaded holes in the chassis rail for the gearbox cross member. Therefore I needed to fit a nut or bolt, with strengthening, inside the box section. To access this area I needed to open the floor above up to get to the area. Instead of measuring the position I put a drill bit in the battery drill the same size as the 3/8" bolt. Drilled lightly to get the centre of the hole and then put a smaller drill through both the lower chassis rail and the floor pan above it. I got John to check that I was holding the drill straight from both the side of the car and the front of the car. It is very difficult with varifocal glasses to see if the drill is being held straight. Next was to open up the floor above the chassis rail so that I could access the inside of the chassis rail to fit a captured nut. I should have used the Dremel to do this but as the angle grinder, with cutting disc attached was handy I used this.

What a mess! Anyway, welding can hide a multitude of sins. The trouble was I was so excited that we were actually getting somewhere at last. It has seemed to take forever to get the engine in place and fitted. I was pleased to see that the inside of the chassis rail had a good coating of wax protection. I will probably leave the 1/4" hole in the top of the floor panel and blank it off with a rust proofing plug. This can then be removed when the time comes to reinject more rust proofing material.

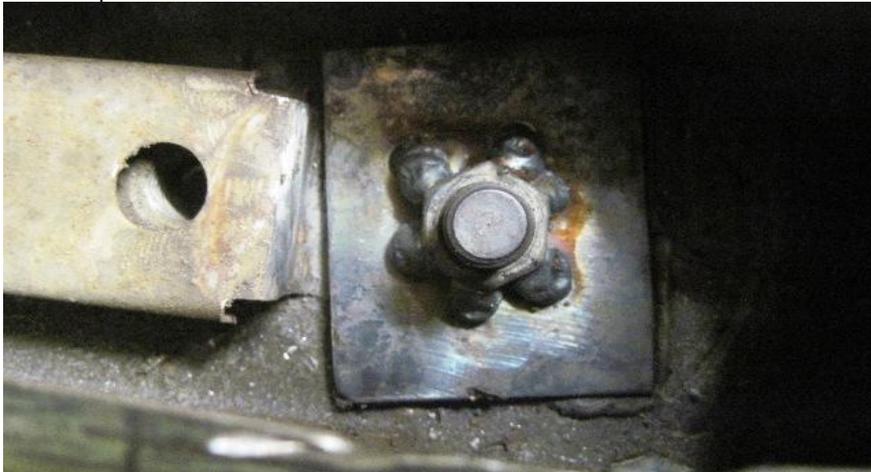
Made a plate for the locking plate to fit into the chassis rail. Used a 2" x 1-1/2" x 1/8" plate drilled a good clearance hole where the nut was going to be. Cleaned

the plating off the nut, so it was easy to weld. Fitted the 5/16" UNF bolt to the plate and welded the nut in position. Unbolted the bolt once it was cool enough and then bolted the LH side gearbox crossmember into position. The next job was to weld the plate with the nut to the inside of the chassis rail.

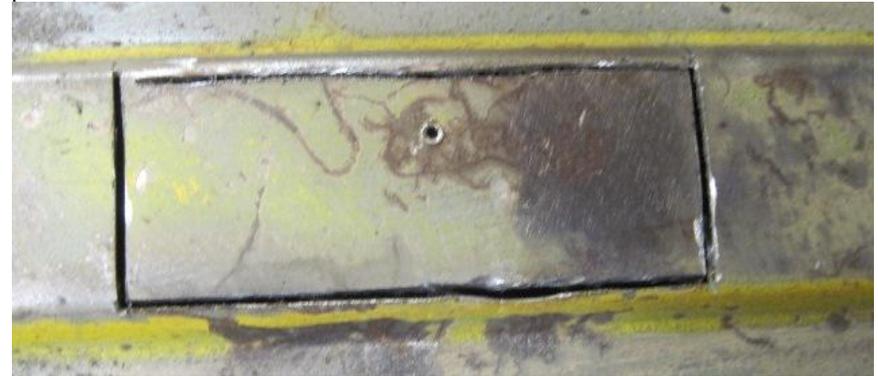
On the RH side gearbox mounting, I thought about it more, before rushing in. I used the small Dremel cutting disc and left a couple of bits of plate still attached so I could just fold the metal back. This should make it easier to weld back in position.

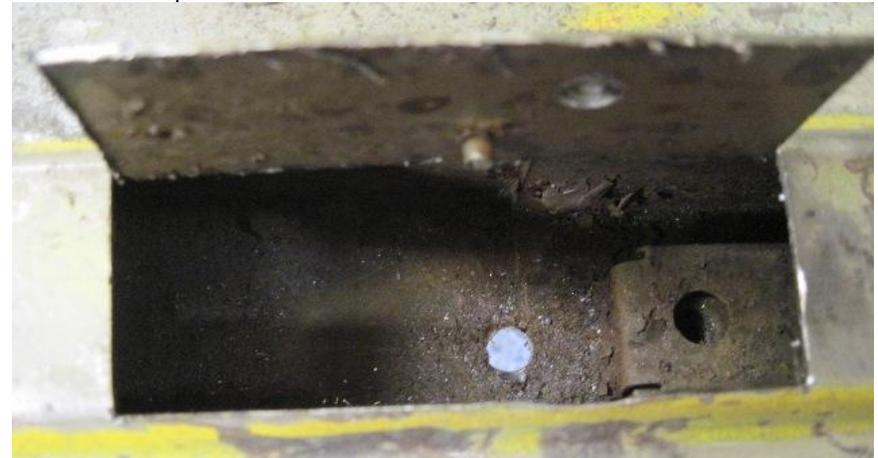
On the drivers side of the car when I lifted the plate I had cut out I found no rustproofing in this area. I will have to clean the area up as best I can and treat with Kurust or Jenolite. It may be possible to spray some down each side of the opening. I will have to make sure that this area gets injected with Waxoyl or similar after the MG is painted.
