## MGB V8 Roadster restoration project – Report 37

Thursday 11<sup>th</sup> June 2015

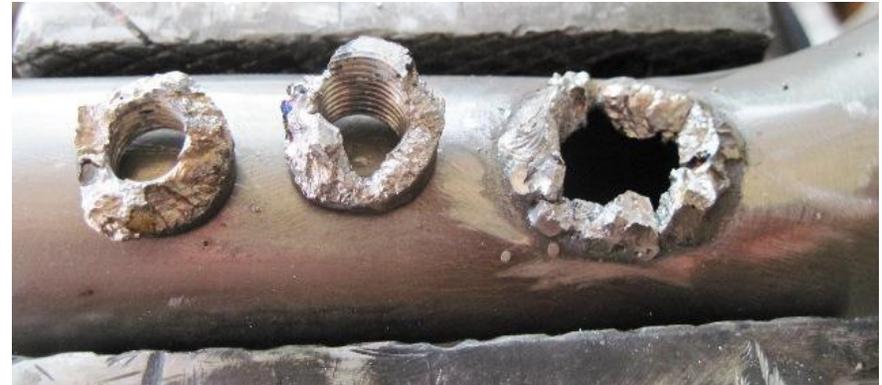
The TIG welds looked a bit cracked. When Pedro welded the collars in he said the two metals did not seem very compatible. I gave the welded in lugs a bang with a hammer to check that the weld were OK and this happened! Back to square one.

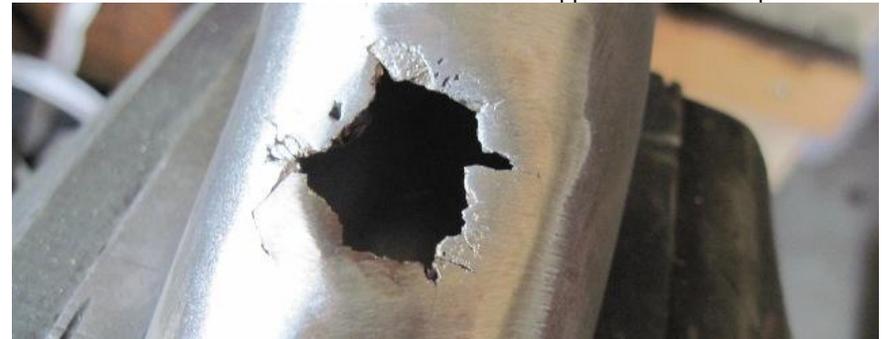
After cleaning up the mess I was left with this rather horrible hole in the exhaust down pipe. Nothing for it but to try and make the best of a bad job.

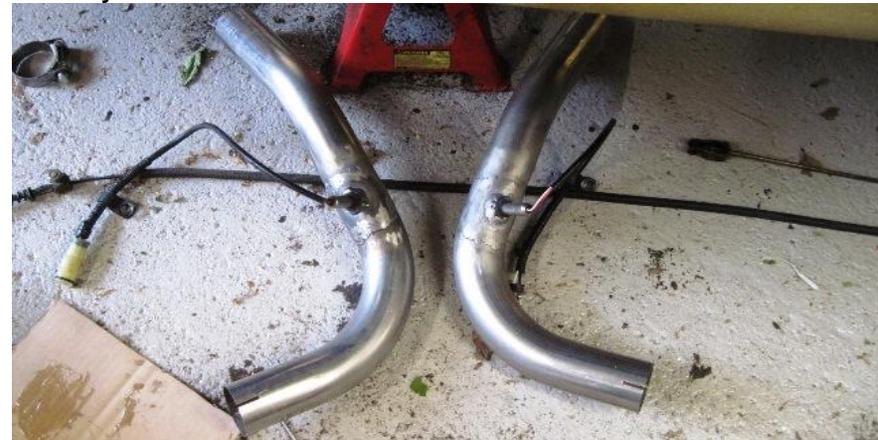
My MIG welding doesn't look as neat as it used to 20 plus years ago!.

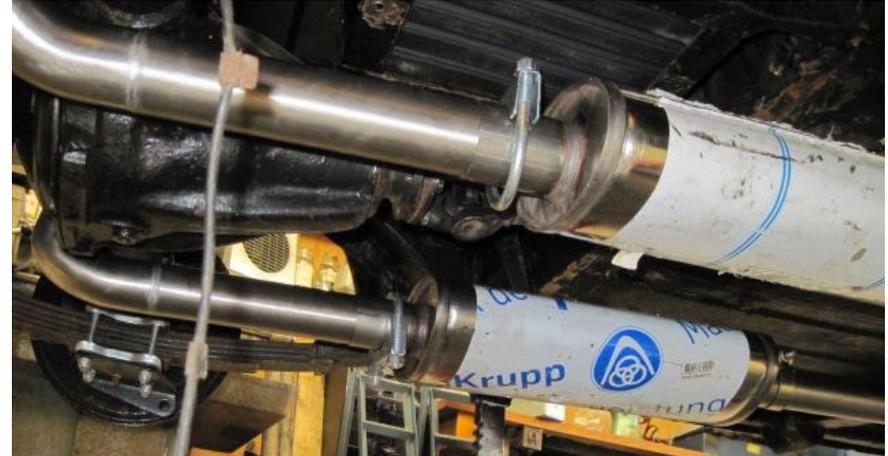
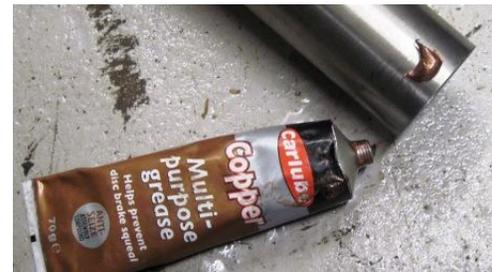
Yes, I did manage to get most of what I wanted to get done this morning. There I was having great problems trying to fit the exhaust tail pipe into the silencer on the left hand side of the MG. Jane had just gone out for a walk with the dog so she was going to be of no help! It just would not fit into the end of the silencer; I then

tried a drop of copper slip, still no joy. I was getting very out of breath and frustrated – then along came John! Although he was in his Sunday best, he held the tailpipe up at the rear while I tried to wriggle the pipe into the silencer; still no joy. Then a voice came from the rear of the MG "Why has this tailpipe got R/H written on it when you are trying

to fit the L/H tailpipe?" I changed the pipe for the L/H one and it fitted easily. I do sometimes hate these clever clogs! John then helped me with the other tailpipe and then left. When later I got down to the Black Boys with Robert, and walked in the bar, all the people in there turned around and held their left hands up and said – "What hand is this?". Bastards!
