Check your antiroll bar drop links

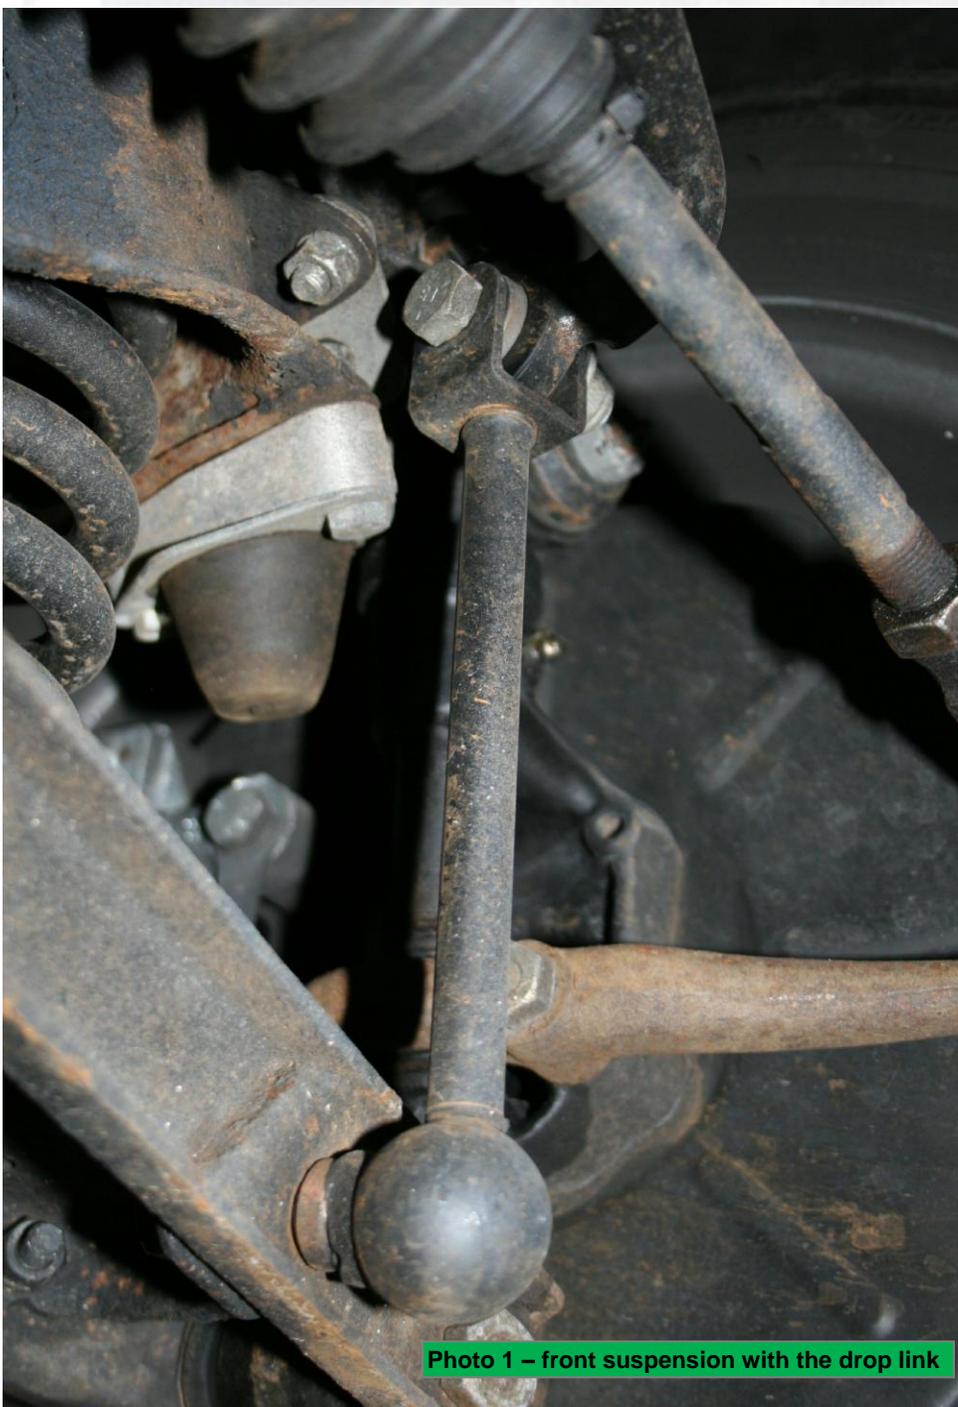
Photo 1 – front suspension with the drop link

The general arrangement of the suspension is shown in Photo 1 taken of my MGBGT, but the V8 is similar, as is the RV8.

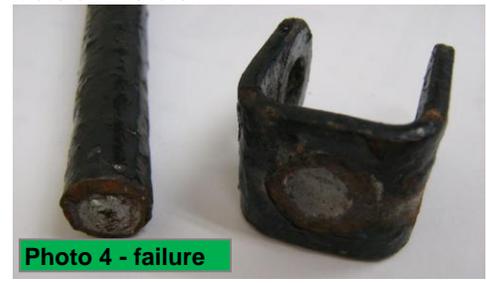
The drop link failures seen recently (Photo 4) have occurred where the steel tube is welded to the forked end. Photo 3. Rust or corrosion in this area should be scraped or wire brushed away, if there is any sign of a crack or gap, the link is suspect and is best replaced, as they are not expensive. It is important to source good quality replacements. Buying replacements from a reputable source is a good idea, although there are some which seem to have a rather spotty weld quality where the steel tube is welded to the forked end. In Photo 5 you can see the forked end of two new drop links, obtained from B&G, the one on the left is for an RV8, Part Number ZKC5754, DROP LINK LH, (RH is ZKC 5755) while the one on the right is for an MGB, Part Number AHH6544A, DROP LINK LH ANTI-ROLL BAR (RH is AAH6543A).

Photo 4 - failure

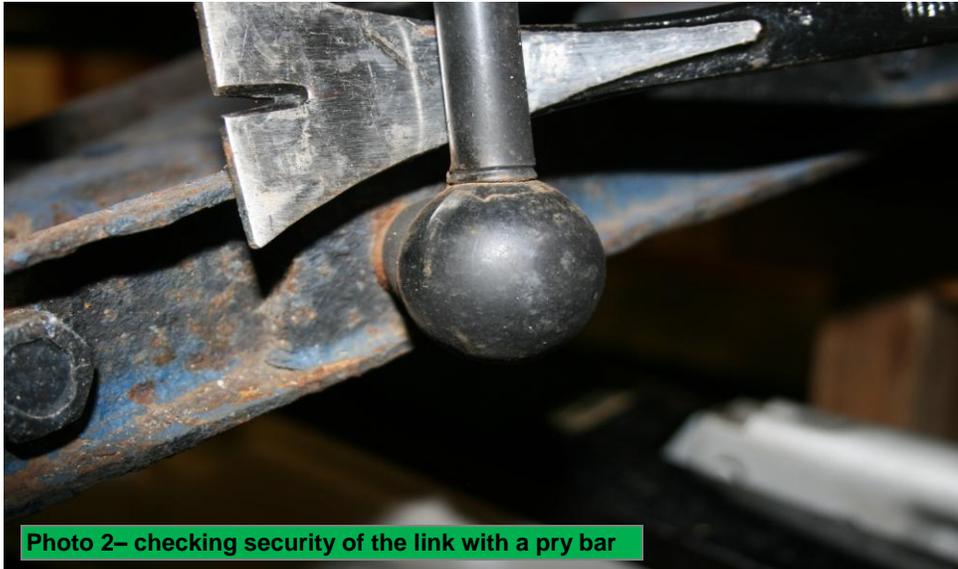
The drop links are items that are inspected by the MOT Tester, usually a visual inspection for the condition of the rubber bonded parts and by using a pry bar to check its security and integrity. See Photo 2. They will apply significant force to do this. If you do this, take care not to rock that car off the axle stands. Do not do this check with the car on a jack, neither the one that came with the car nor any other.

Photo 2– checking security of the link with a pry bar

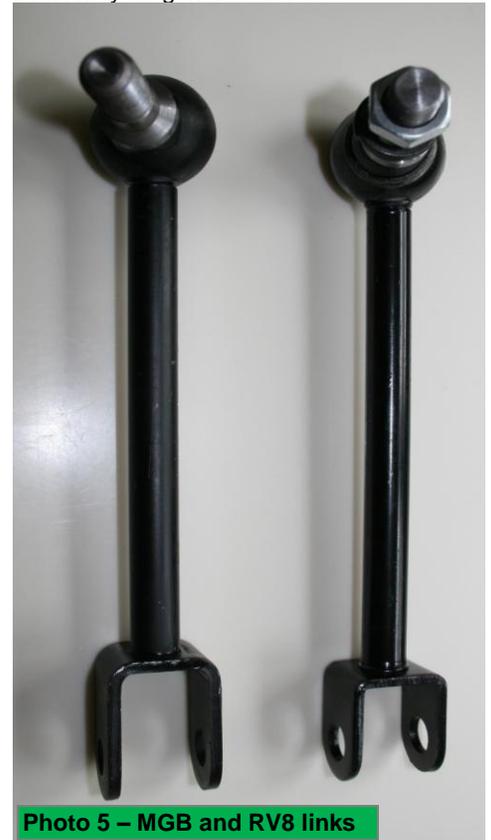
Close inspection of these parts reveals some differences, not the least of which is the thickness of the material used for the fork and the depth of same, Photo 5. In other respects the parts are the same dimensionally except the diameter of the holes in the RV8 fork, which are 11mm dia. More on this later.

Photo 5 – MGB and RV8 links

RV8 part, but not vice versa, so to prove this I fitted an RV8 part to the left side of my MGB. The diameter of the hole in the fork needs slight modification to allow the bolt pass through, on the B the hole is 7/16" (0.4375") while the RV8 Part is drilled 11mm (0.43307").

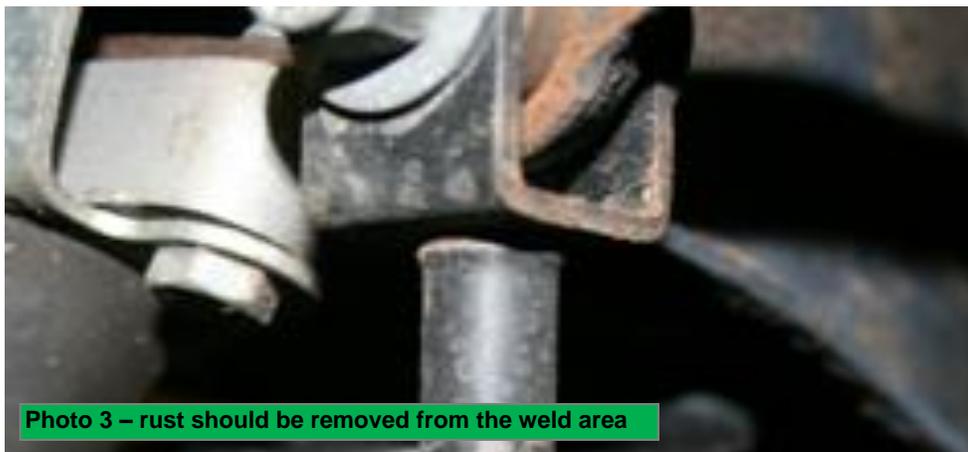
Photo 3 – rust should be removed from the weld area

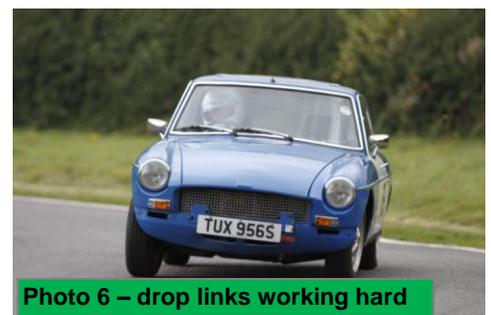
To prove this modification works I have run the car for an extended period under hard cornering, in Photo 6 you can see me placing the LH link under extreme compression load and the RH link under tension; the opposite occurs when taking left hand corners. Note: this MGB is fitted with a thicker than normal antiroll bar so the test will be arduous.

Photo 6 – drop links working hard
