Report on tyre damage from speed humps

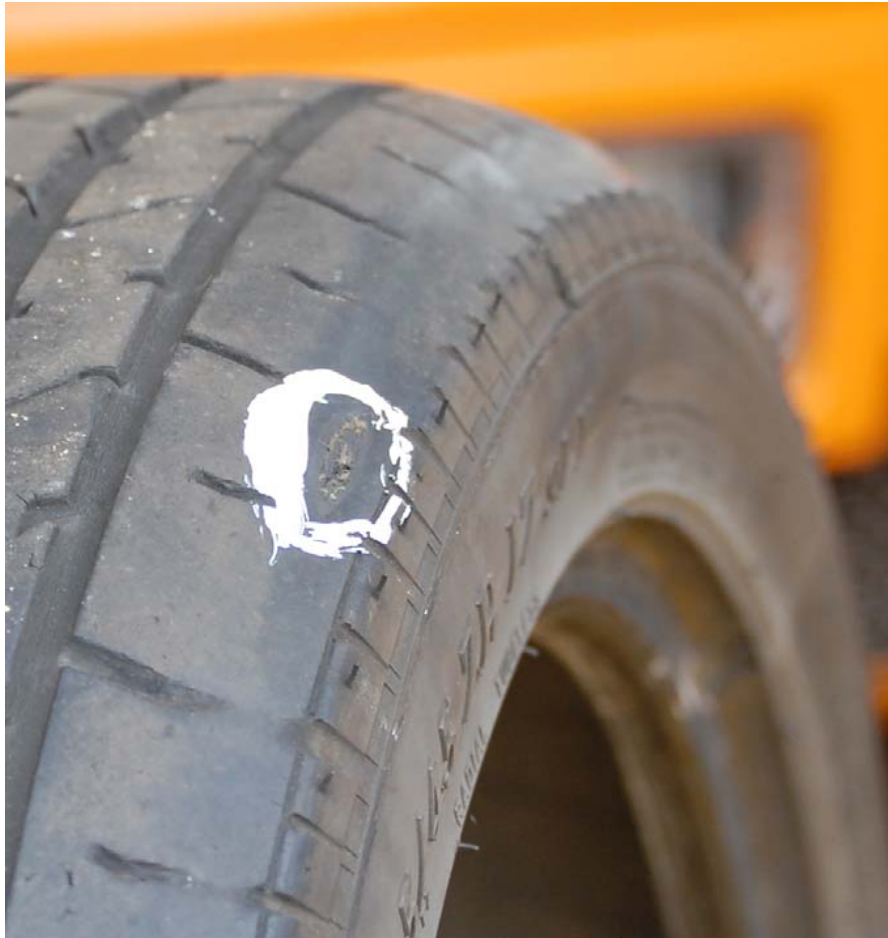
following day the vibration was really bad so I called into my usual workshop. A check with the car jacked up and the wheels still on showed no excessive play in the wheel bearings but removing the two front wheels revealed the shocking truth. Both tyres had worn significantly on their inner shoulders, one so much so that it had worn through the casing to the steel inside - see the area circled with white in the photo alongside.

I am very lucky that I did not have a tyre blow out. I thought about where I had been in the car other than to and from work and I remembered I had parked in a multi storey car park in the centre of Cambridge on the previous Thursday. This car park has, in my view, excessively high speed ramps at the bottom of each of the downward slopes from level to level and I think that even at a dead slow speed that this was where the damage was caused.

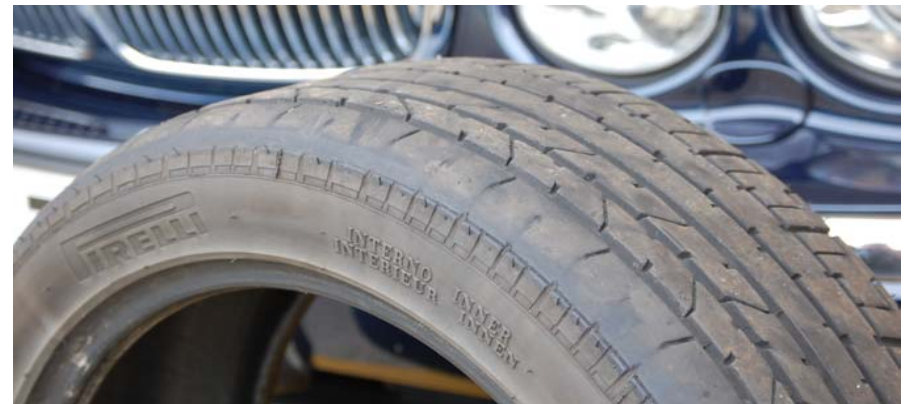
The wear on the inside edge of the tread of the front wheels is clear.
