### MGBGT V8 – renewing the fuel hose between the carburetors (and care points)

Leakage from the fuel hose linking the carburetors on a V8 (see **Figure 1**) is a relatively common theme in the V8NOTES and the procedure for its replacement has been described several times and most succinctly in V8NOTE90 written by John Dupont. Here in V8NOTE685 Jim Livingstone describes a couple of issues from his recent work on his carburetors and linkages.

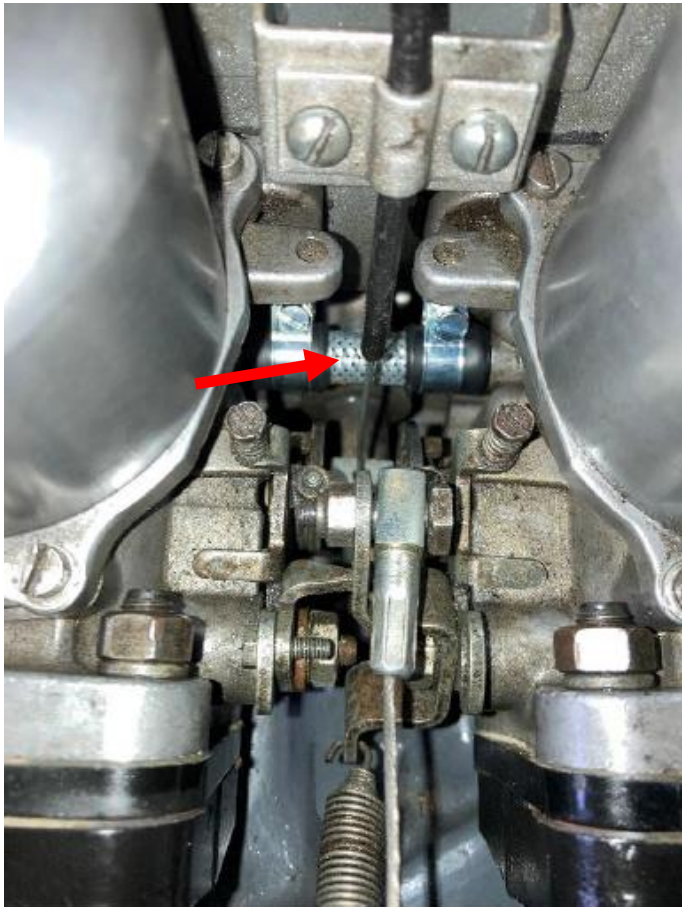
Figure 1 – hose between the carburetors

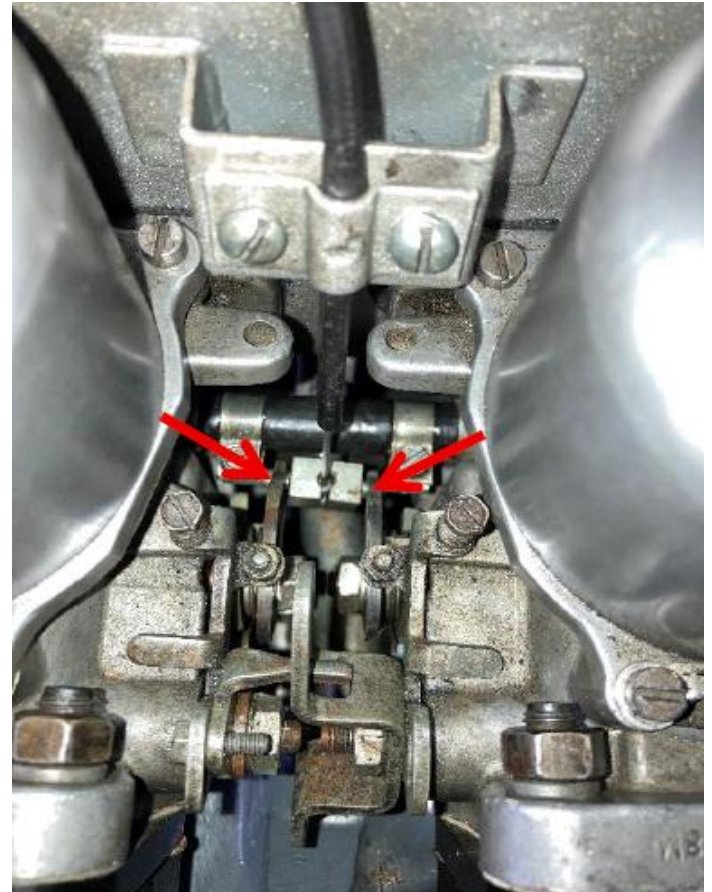
Figure 2 - ears of the hose clip must be oriented away from the choke trunnion

Accessibility for maintenance has been a personal obsession and I try wherever possible to arrange for tool access in the assembled condition. Orientation of hose clips is a case in point. In most circumstances there is no "wrong way" and it is up to the discretion of the assembler. In the case of the clips on the interconnecting fuel hose there is a definite "wrong way" as I was unfortunate enough to discover. As illustrated in **Figures 2 & 3** the ears of the hose clip must be oriented away from the choke trunnion, otherwise they will foul causing it to jam when raised and the choke cable to disengage when lowered. In manufacturing this would be addressed by a foolproof feature in the design or at the very least visible guides and operator training – see Footnote. As the error is not discovered until the assembly is complete, the consequences are a full disassembly.

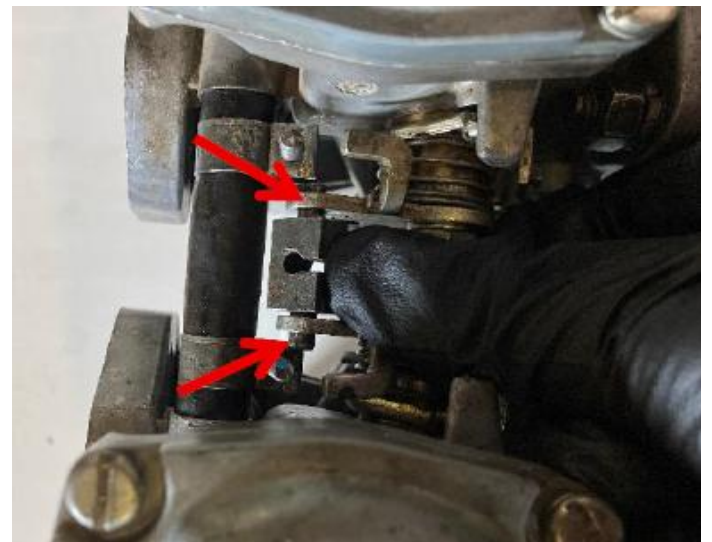
Figure 3 - ears of the hose clip must be oriented away from the choke trunnion

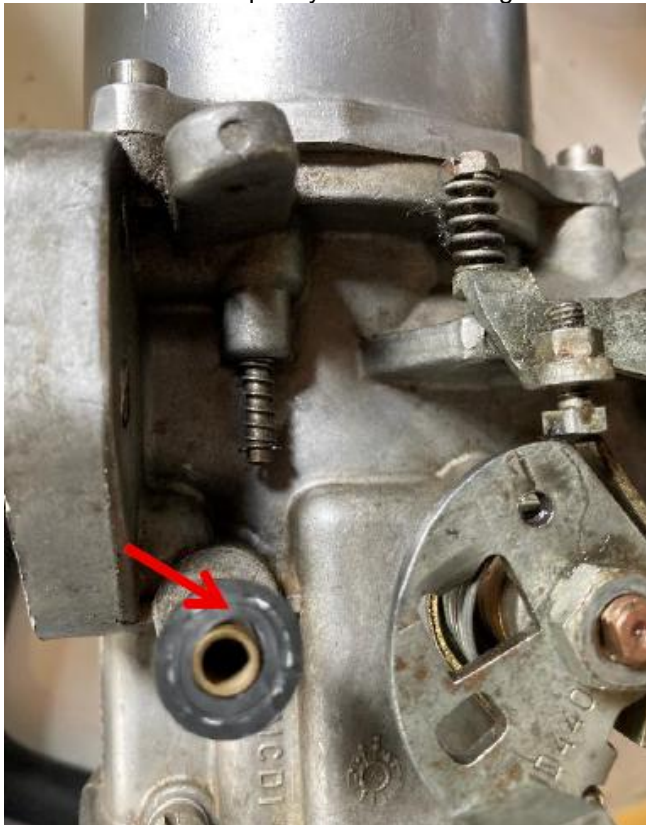
The initial leak in the interconnecting pipe between the carburettors was detected by the higher than usual frequency of pulsing of the fuel pump when the ignition was switched on. Tightening the hose clips only made matters worse and the leakage went from a drip to a stream of fuel and I quickly turned off the ignition.

**Figure 4** - ovality remained with a clear gap between hose and pipe

I had purchased two metres of Gates Barricade ¼" fuel hose (GFH1025X) in anticipation of future requirements to replace perished hose. Having recently used a section of this to replace the hose in question I was surprised that it was already leaking. On examination the existing hose appeared in good condition without signs of hardening or perishing from exposure to E10 fuel. However, the **bore was noticeably oval** on both the removed part and the coil of 'new' hose. I cut off a narrow section of this and slid it over the fuel feed pipe of the left carburettor in expectation that the ovality would disappear when assembled. However, as illustrated in **Figure 4** the **ovality remained** with a clear gap between hose and pipe evident.

I next measured the outside diameter of the pipe which came to 0.235" which probably explains its inability to remove ovality from a nominal ¼" (0.250") bore hose. Anxious to return the car to a roadworthy condition and unwilling to risk more oval hose I turned to a short section of braided hose (GGT101) I had purchased last Autumn. At 2½" this was over long for this application but was easily shortened with the aid of a rotary hand tool and cutting disc.

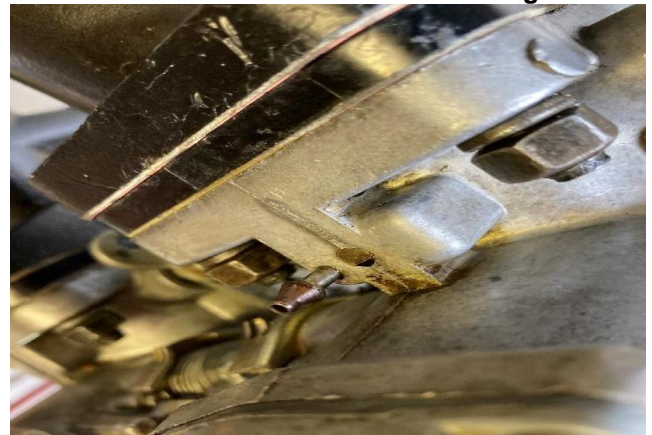
As mentioned in V8NOTE90 there are other opportunities for errors when reassembling. The first is failing to ensure that the choke trunnion is engaged in the choke operating levers (fast idle cams) of both carburettors. The second is the vacuum advance tube which should be fitted to the connection on the underside of the left carburettor before the **Adaptor is lowered on to the Induction Manifold** - **Figure 5**

**Figure 5** - Adaptor is lowered on to the Induction Manifold

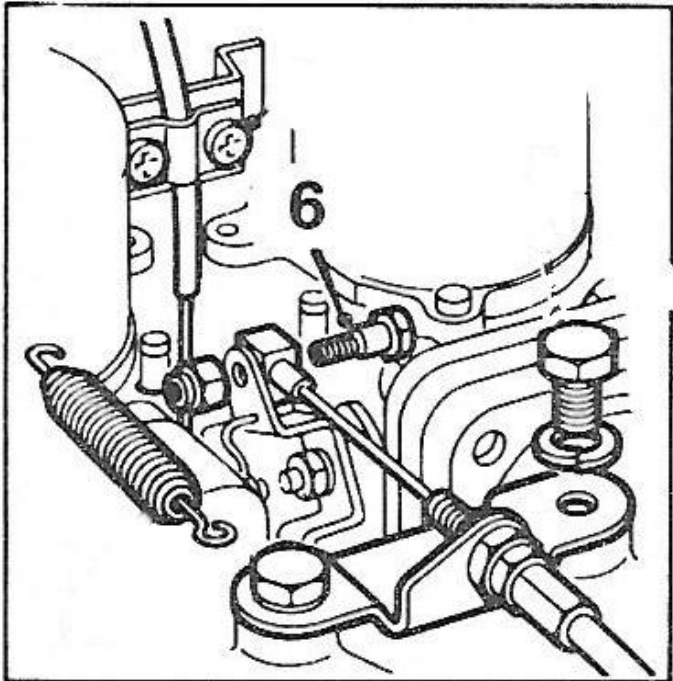
6 – bolt and nut connecting the accelerator inner cable to the carburettor linkage
