Check your antiroll bar drop links

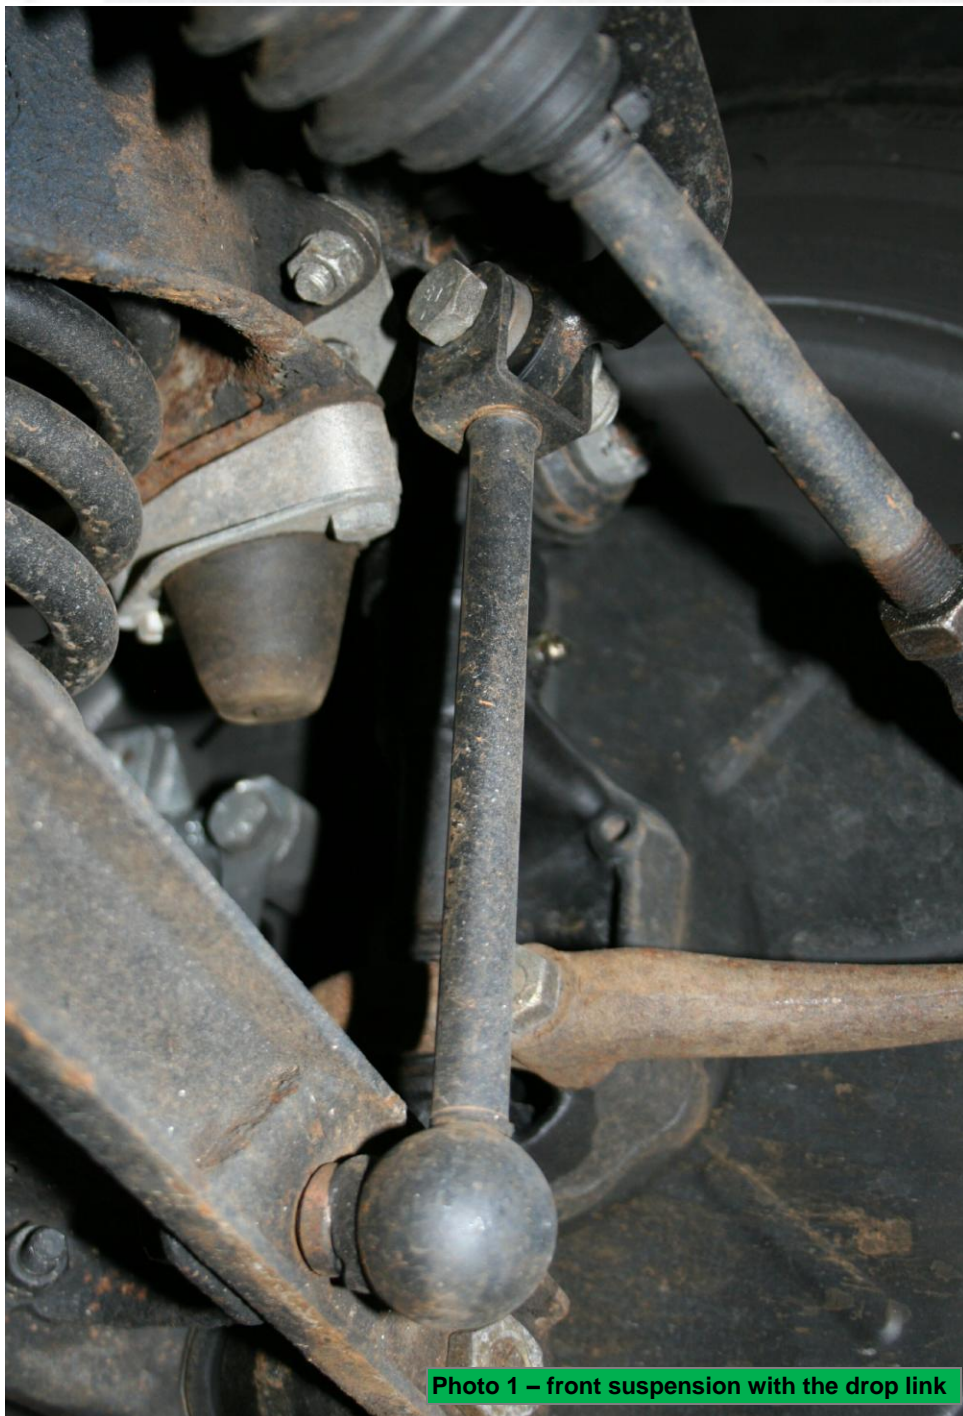
Photo 1 – front suspension with the drop link

The general arrangement of the suspension is shown in Photo 1 taken of my MGBGT, but the V8 is similar, as is the RV8.

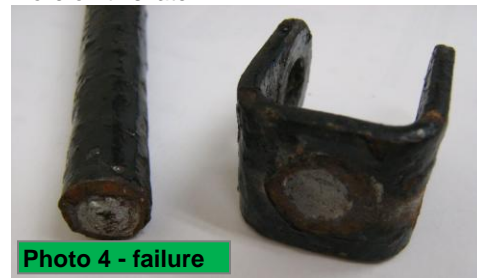
The drop link failures seen recently (Photo 4) have occurred where the steel tube is welded to the forked end. Photo 3. Rust or corrosion in this area should be scraped or wire brushed away, if there is any sign of a crack or gap, the link is suspect and is best replaced, as they are not expensive. It is important to source good quality replacements. Buying replacements from a reputable source is a good idea, although there are some which seem to have a rather spotty weld quality where the steel tube is welded to the forked end. In Photo 5 you can see the forked end of two new drop links, obtained from B&G, the one on the left is for an RV8, Part Number ZKC5754, DROP LINK LH, (RH is ZKC 5755) while the one on the right is for an MGB, Part Number AHH6544A, DROP LINK LH ANTI-ROLL BAR (RH is AAH6543A).

Photo 4 - failure

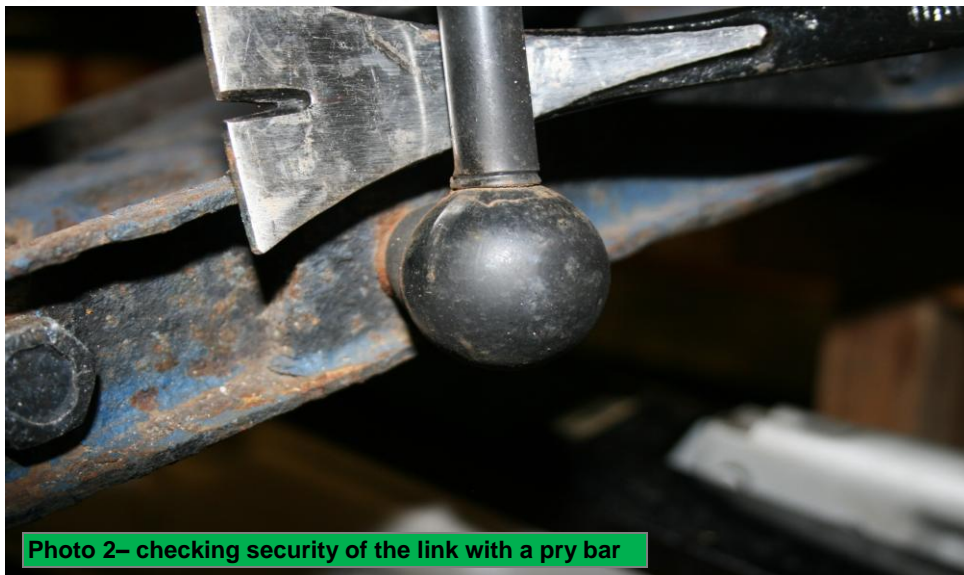
The drop links are items that are inspected by the MOT Tester, usually a visual inspection for the condition of the rubber bonded parts and by using a pry bar to check its security and integrity. See Photo 2. They will apply significant force to do this. If you do this, take care not to rock that car off the axle stands. Do not do this check with the car on a jack, neither the one that came with the car nor any other.

Photo 2– checking security of the link with a pry bar

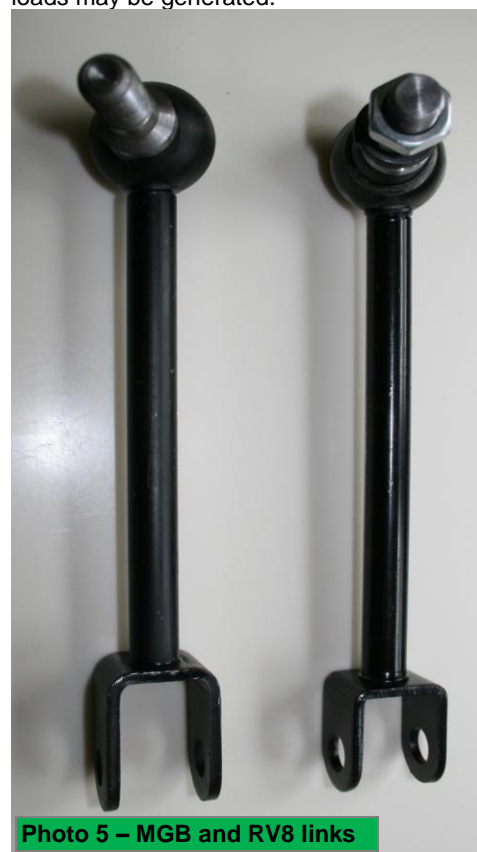
Close inspection of these parts reveals some differences, not the least of which is the thickness of the material used for the fork and the depth of same, Photo 5. In other respects the parts are the same dimensionally except the diameter of the holes in the RV8 fork, which are 11mm dia. More on this later.

Photo 5 – MGB and RV8 links

It appears to be possible to **replace an MGB drop link with a later and stronger**

RV8 part, but not vice versa, so to prove this I fitted an RV8 part to the left side of my MGB. The diameter of the hole in the fork needs slight modification to allow the bolt pass through, on the B the hole is 7/16" (0.4375") while the RV8 Part is drilled 11mm (0.43307").

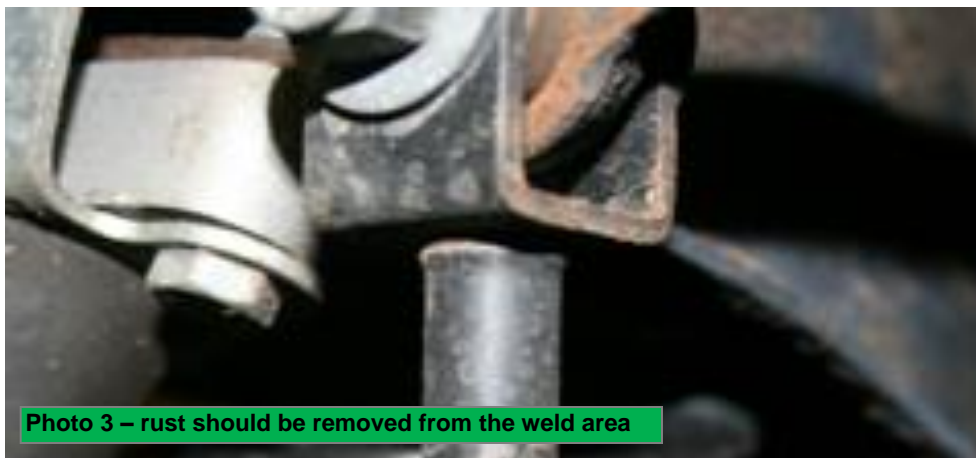
Photo 3 – rust should be removed from the weld area

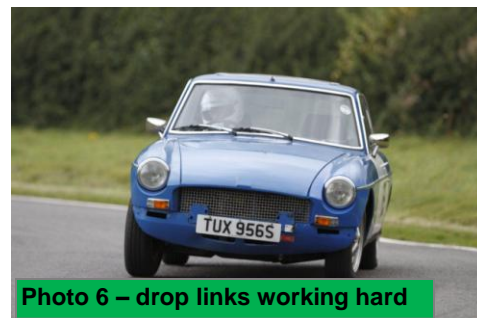
To prove this modification works I have run the car for an extended period under hard cornering, in Photo 6 you can see me placing the LH link under extreme compression load and the RH link under tension; the opposite occurs when taking left hand corners. Note: this MGB is fitted with a thicker than normal antiroll bar so the test will be arduous.

Photo 6 – drop links working hard
