MGBGTV8 (Tundra 2130) seen at the Barons auction on Tuesday 4th June 2019

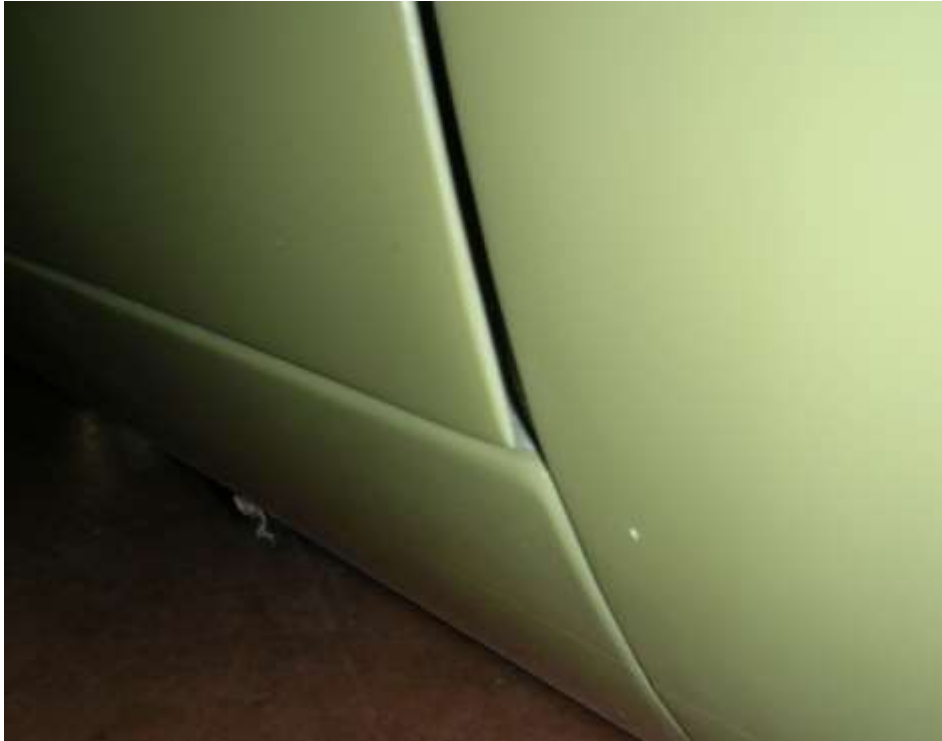
Front edge of the offside door slightly out. The cills looked good.

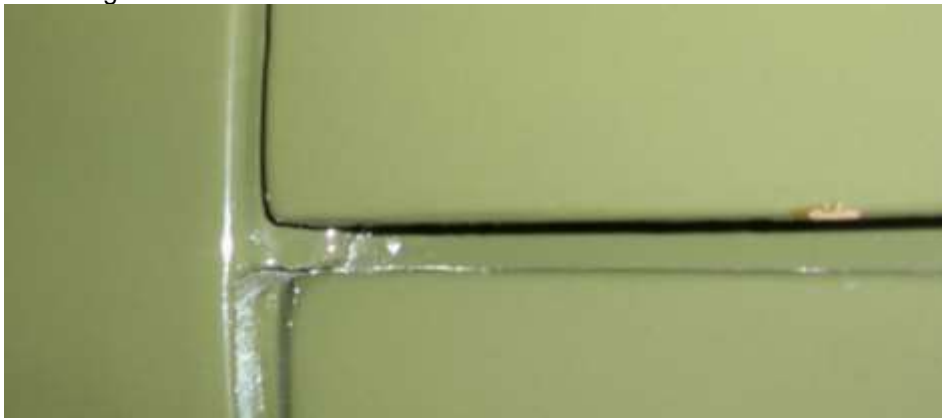
Front edge of the nearside door looked reasonable.

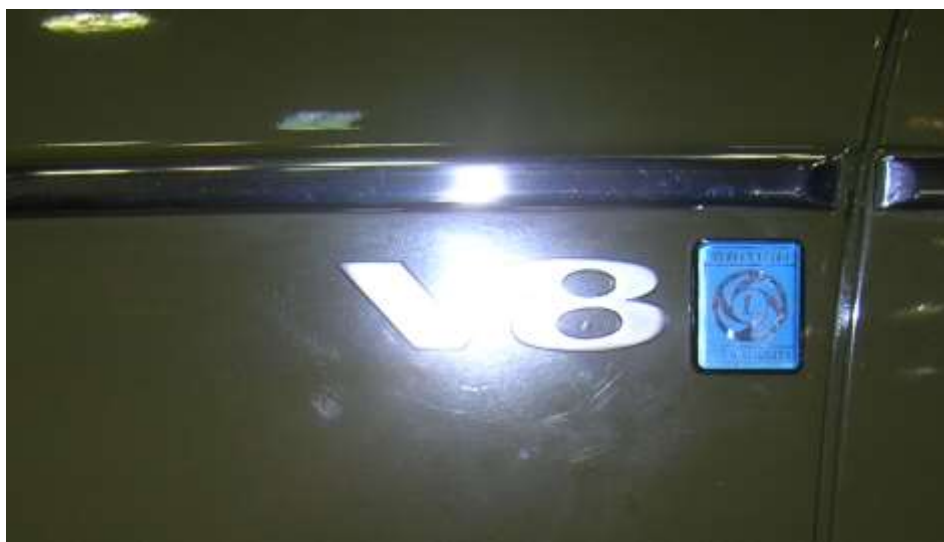
Nearside wing badging is a mess

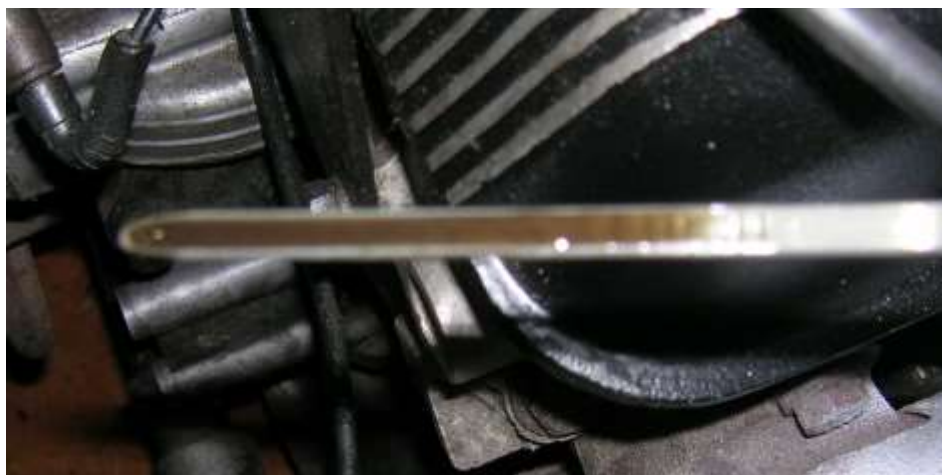
Checking the colour of the engine oil – it was slightly black but reasonably clean. On checking the dampers on the twin HIF SU carburettors, they were very nearly out of oil.

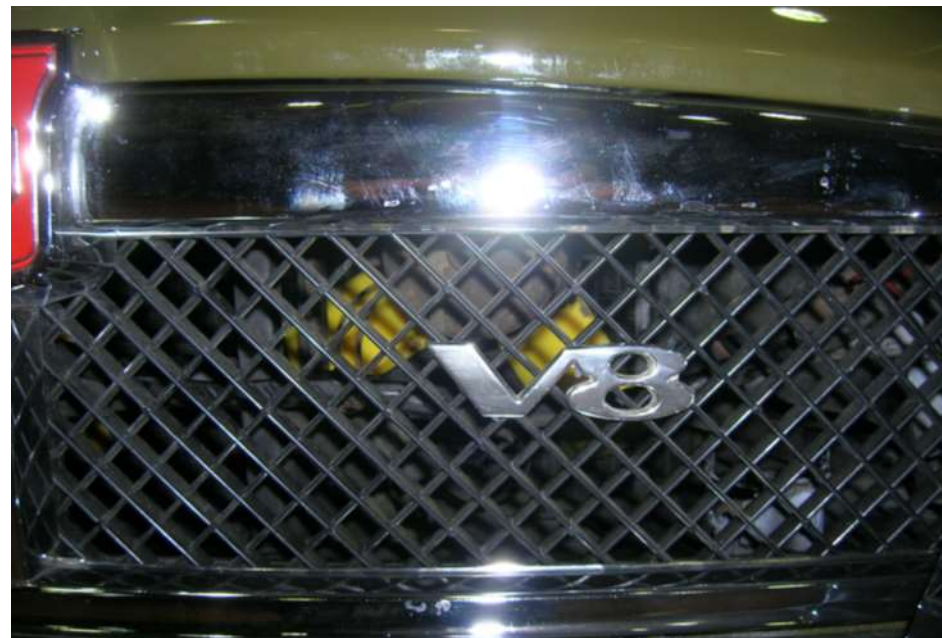
"V8" badge has been fitted to the nearside of the grille but as part of the chrome bumper conversion the restorer has used the wrong grille mesh. The correct mesh has a dominant mesh member going lower left to upper right – see below.

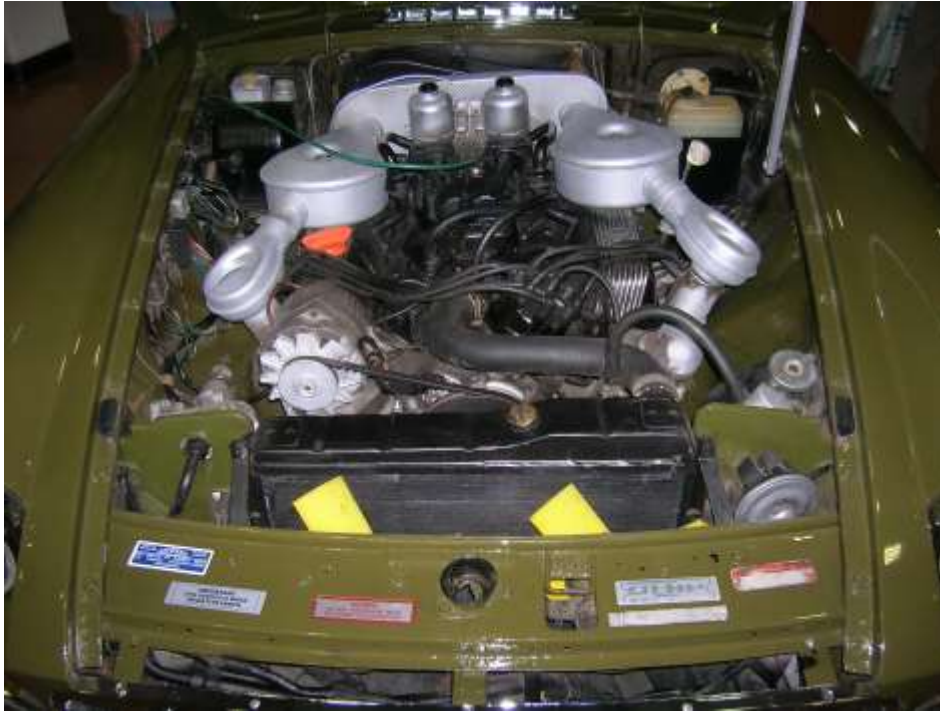
Although the paint finish from a recent restoration of the bodywork was good, the engine bay had not been similarly restored and there was some corrosion evident there. The horn is in an unusual position on the nearside in front of the coil.

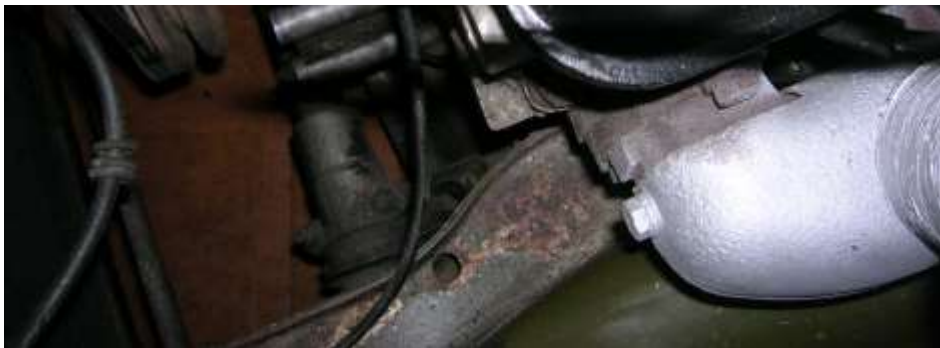
Corrosion on the chassis legs below the cast iron exhaust manifold.

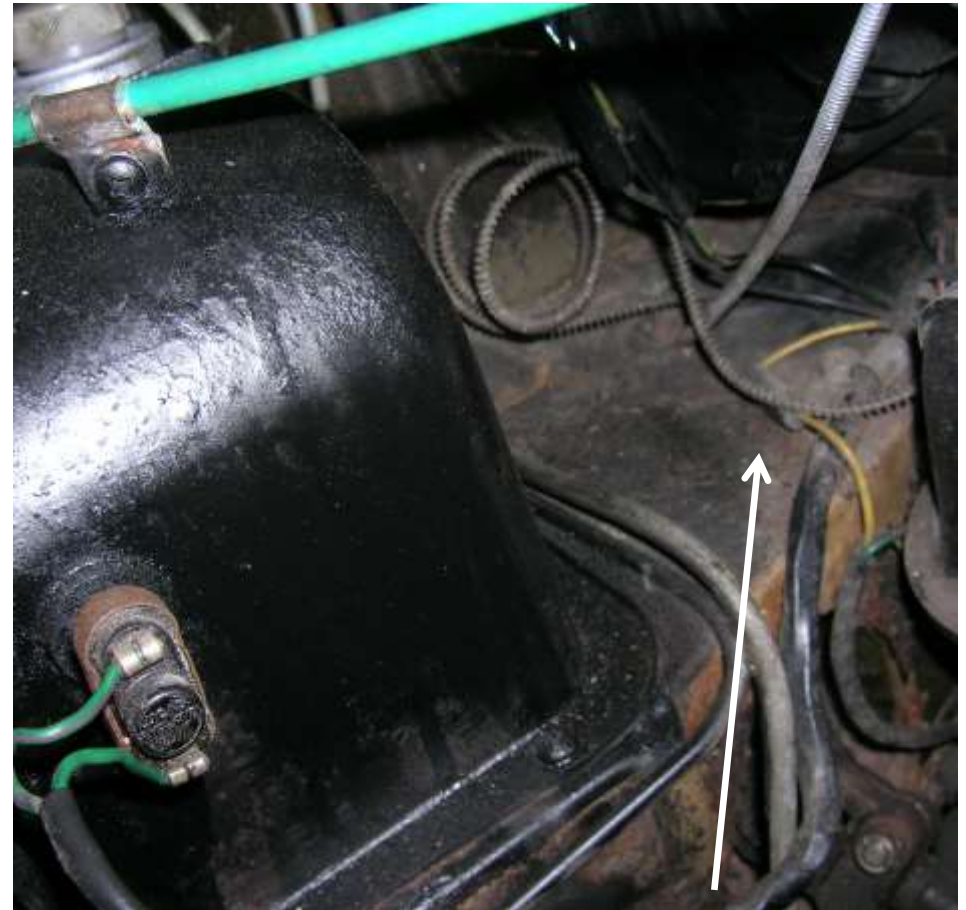
The flat panel alongside the brake and clutch reservoirs and master cylinders is an area which often shows signs of corrosion, not least from its proximity to the brake fluid. With his Tundra MGBGTV8 the area had been cleaned up but no restoration to the standards seen on the external bodywork. There were signs of earlier anti-rust treatment, possibly the Zeibart treatment mentioned in the auction listing description of the car.
