## Maintenance seen on some Dunlop composite wheels fitted to an MGBGTV8

### **Dunlop composite wheels have been given an interesting "spruce up"**

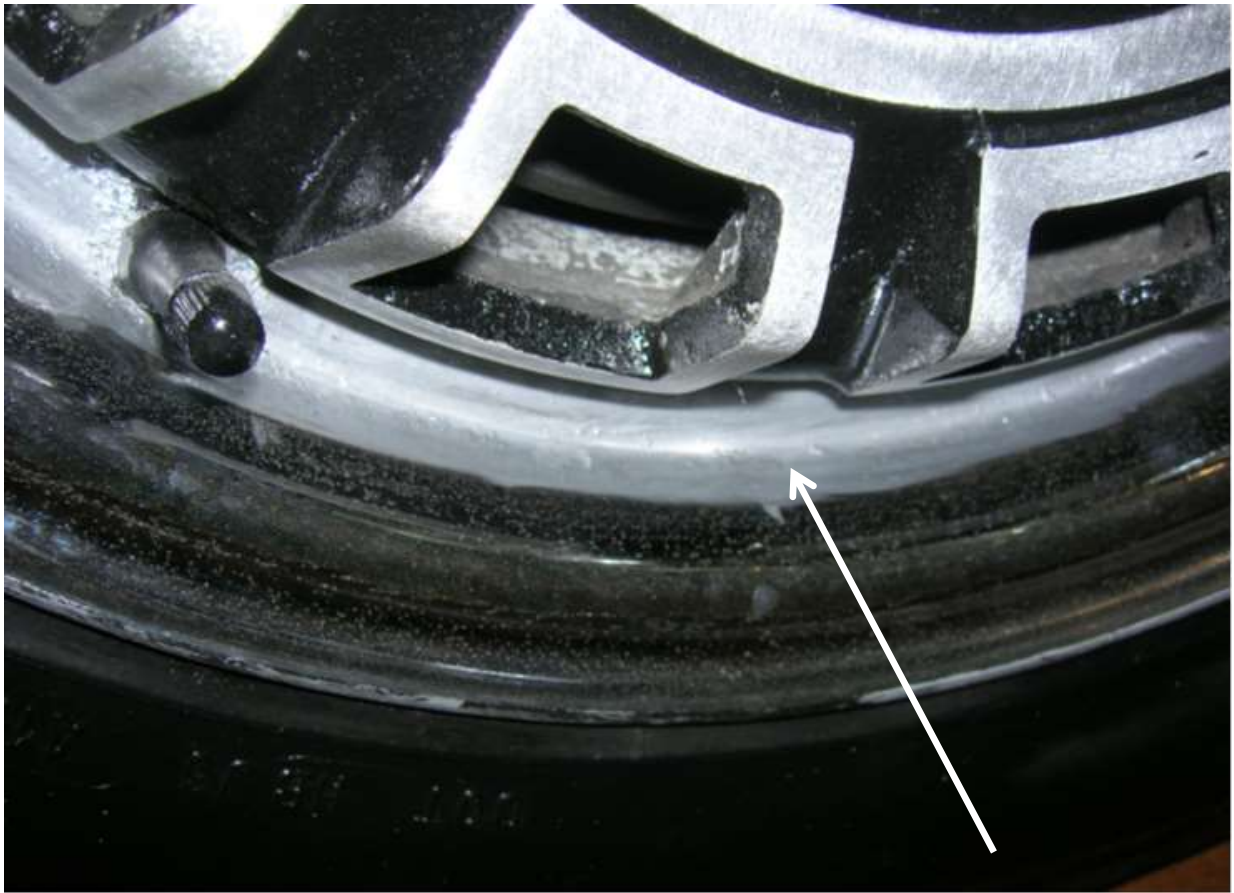
It appears any corrosion on the steel rims, which forms near the join between the chromed steel rim and the alloy centre, has been removed and then the metal painted with a narrow strip of silver paint. Unless you make a very close inspection, spotting that remedial work would be easily missed. The removal of corrosion on the chromed steel rim appears to have left a slight dip in the surface on the chrome rim as you run your finger over it, so presumably the removal of corrosion on the rim has resulted in the thickness of the steel rim being reduced slightly near the join with the alloy centre.
