Cooling fans relay burn out

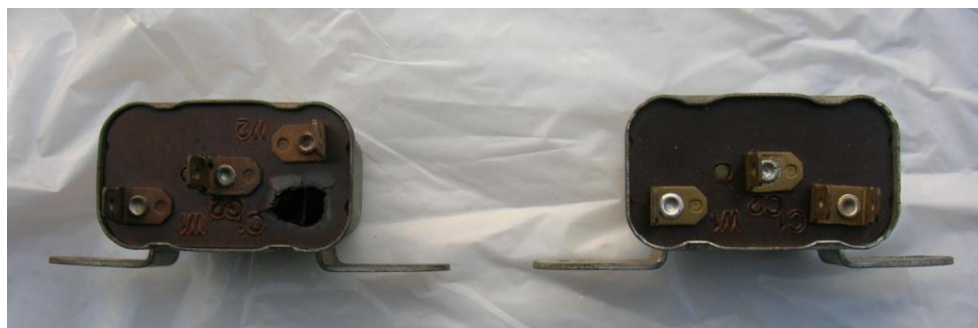
Leaning over the offside wing my search worked from the fuse box along the brown wire carrying the power supply to the fans relay and there, on the other end of that wire, I saw the spade connector to the terminal on the underside of the 6RA relay

was burnt nearly to a cinder. I removed the relay and could then see the underside and the terminal was almost hanging from a hole burnt in the base. On inspection the "C1" terminal showed signs of some corrosion, so the likely cause was an increased resistance through that connection which, with the relatively high current drawn to run the twin fans, must have generated a great deal of heat. The relay is rated 12V 20A.

I then went off to my spares bag and found I had a new "6RA" relay so began fitting it until it dawned on me it was a three terminal 6RA and not a four terminal 6RA which I needed to make the replacement. Both relays have "6RA" on the side of the unit, so if you need to buy one do check you get the right one! Fortunately Brown & Gammons had a four terminal 6RA in stock (part number 142169A replacing 589665).

Once the relay and a new section of brown wire (7.5 cm long BTW) with insulated spade connectors crimped to each end was replaced it was found the Otter switch (part number BHA5252) also needed

So a worthwhile preventative maintenance item is checking the spade connectors at either end of this brown wire. After 35 years preventative replacement is worth considering together with a replacement Otter switch because reliable cooling is essential with a V8 engine in an MGBGT V8 engine bay.
