RV8 rear light repair

After a recent accident, RV8 owner Aidan Pavey in Australia had a broken tail light. Luckily a replacement was found and the car was repaired under an insurance claim. He still had the damaged light and as they are in short supply he thought that he might try and repair it. This is what he discovered on his repair journey.

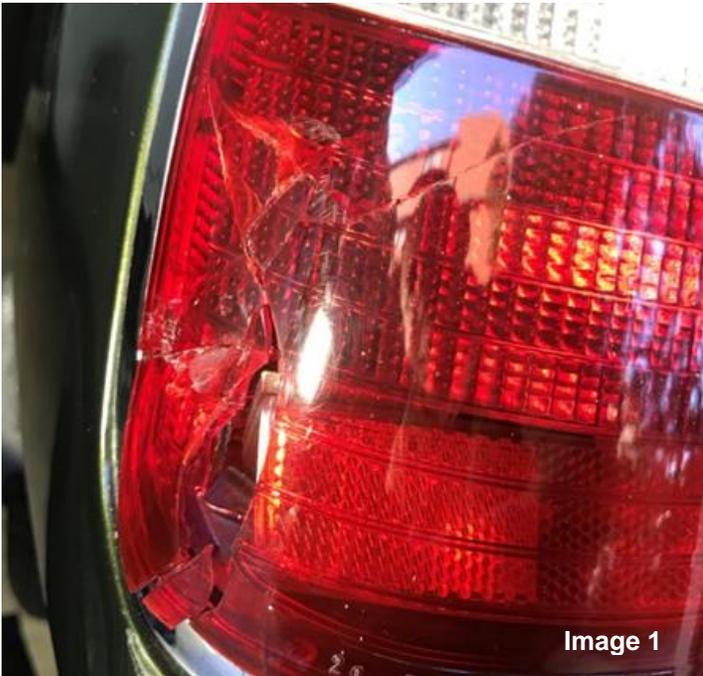
Image 1

The photo alongside (Image 1) shows the damage to the tail light. Some parts were dislodged however I was able to collect all of them. On inspection I found that some of the parts needed to be fitted from inside the light. There was also a reflector inside the light that had become dislodged, therefore I needed to take the light apart.

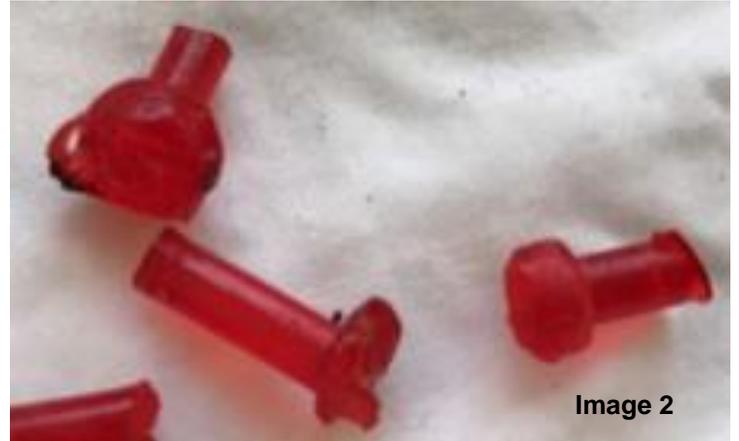
Image 2

The lens of the light is held in place by 16 pins around the outer edge. During the assembly process the pins are heated and mushroomed over to secure in place. The photo below (Image 2) shows the bottom back of the light with some of the pins. In this

case many of the pins were broken during the impact.

You can see here how the ends of the pins are mushroomed over.

To get the lens off the main body of the light, I needed to remove the mushroom ends while trying to retain as much of the pin as possible. I used a Dremel with a bur tip. Not all the pins survived but I was able to disassemble the light. The photo on the following page (Image 4) shows the individual parts of the light.

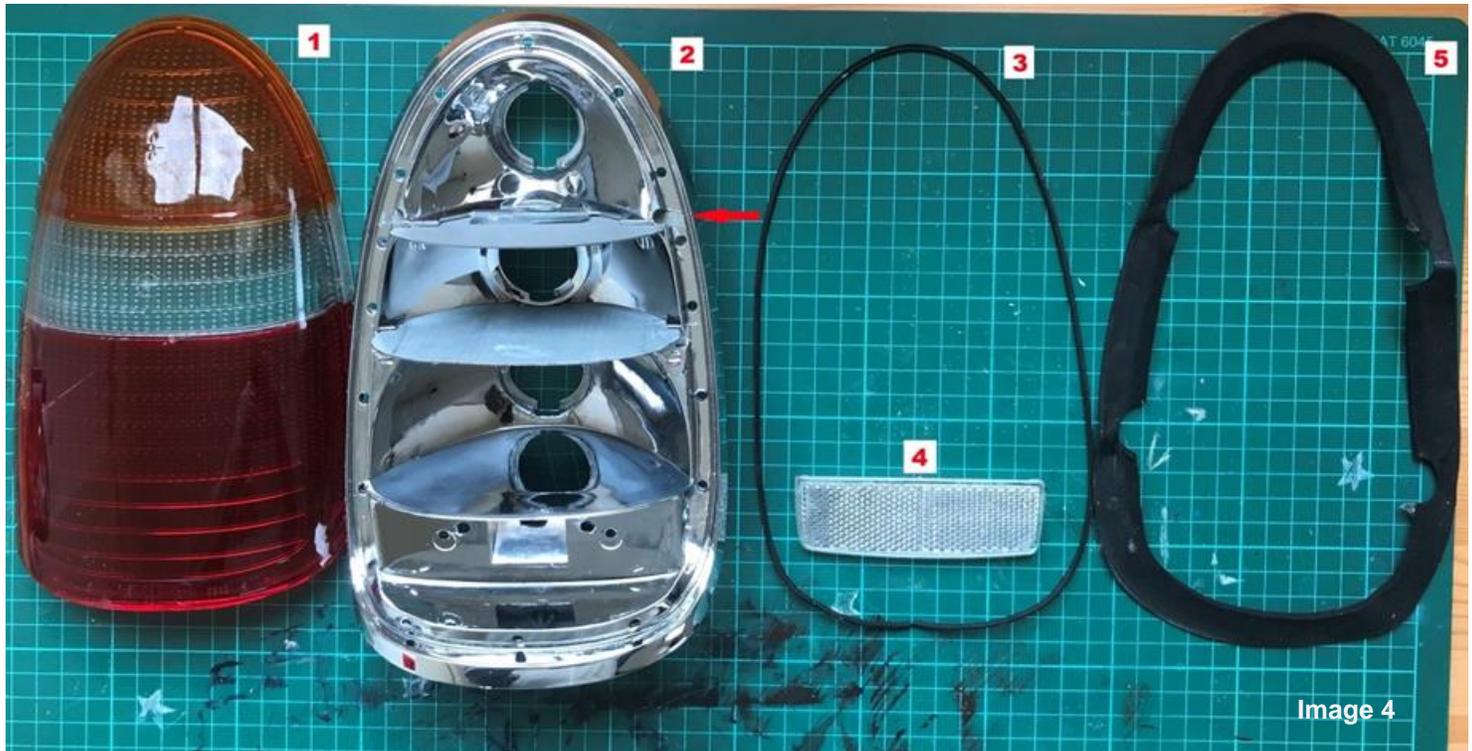
Image 4

Looking at the individual parts of the lamp unit

1. The lens, moulded in one part.
2. The base or backing has a reflective surface. There are two metal separating plates at the top and a plastic one at the bottom.
3. The lens seal. This goes in the groove at the base (see arrow).
4. The reflector that goes in the bottom section of the light.
5. The seal that goes on the back of the base (this is held in place with double sided tape) and mates with the car.

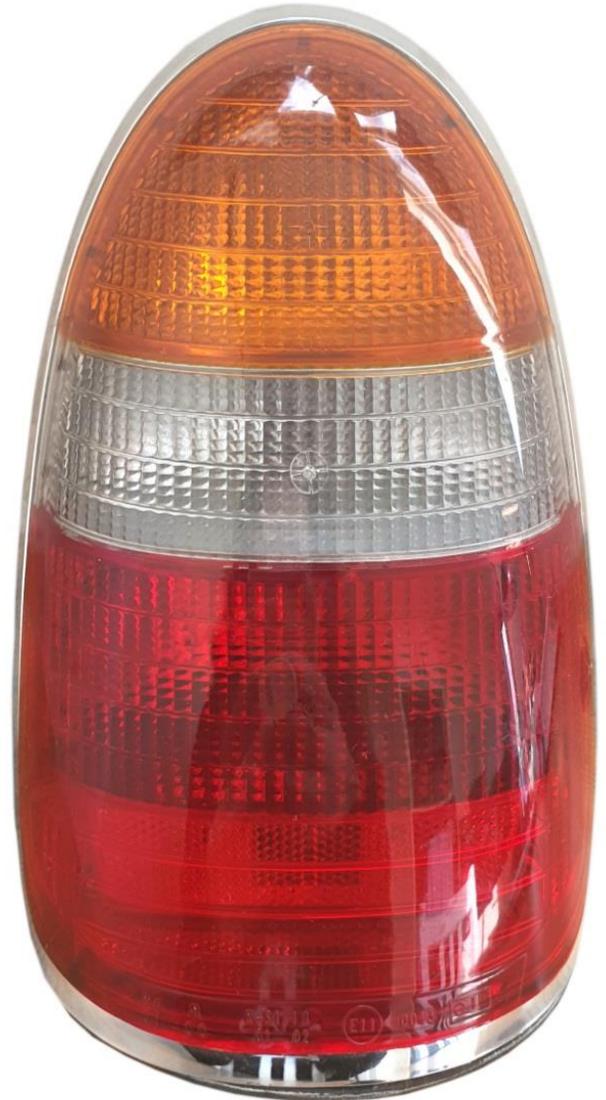
Image 11

Here is the finished product. The photo is slightly deceptive as you can still see the cracks when you are up close. It is not a concours lamp unit, however a very serviceable one.
