RV8 rear bumper alignment – RV8NOTE325

Peter Garton in Germany posted a note on the V8 Bulletin Board and later sent in a set of photos which help explain how he got his nearside rear bumper correctly aligned. (April 2010)

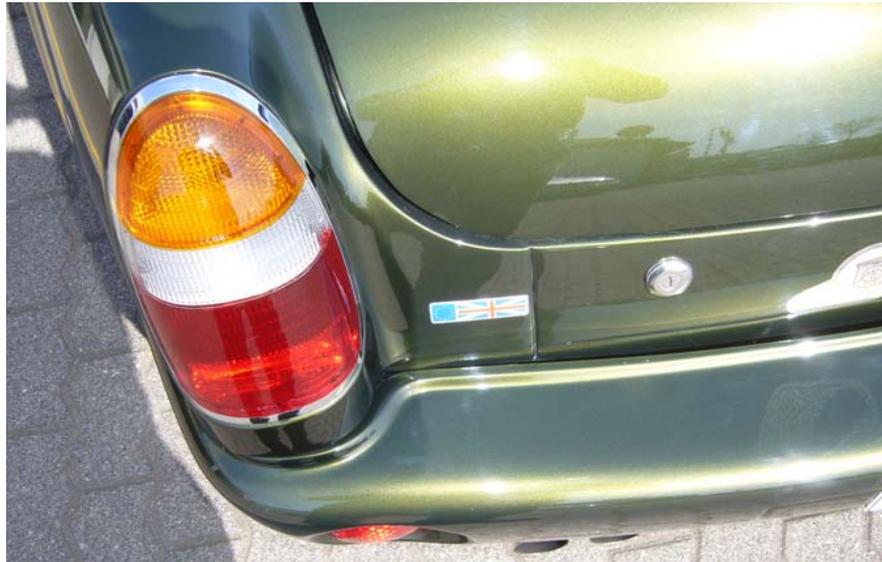
Bumper distance to valance prior to adjustment

I suspect that many RV8 rear bumpers are fractionally misaligned with the rear valance and also with the rear wing itself. My bumper was about 2mm out on the left side (nearer to the valance than the other side) and the arm of the actual bumper was not parallel with the wing itself.

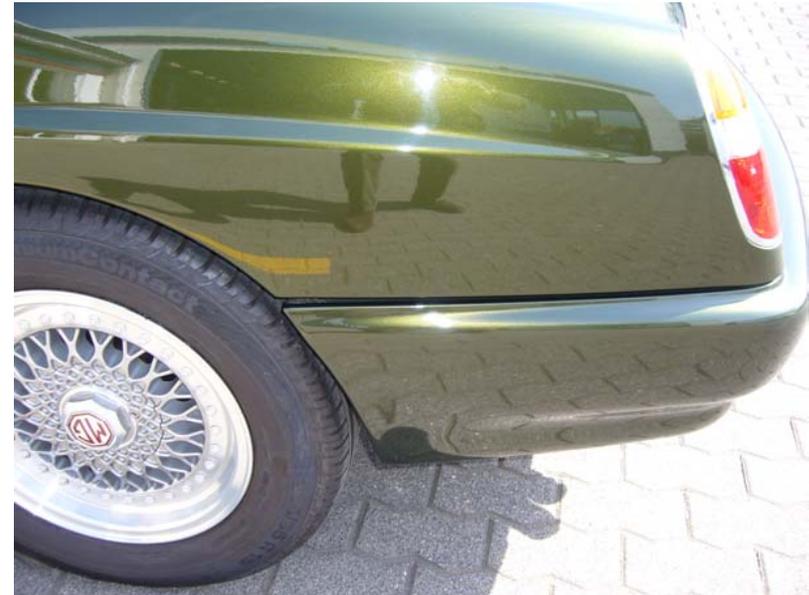
Left hand bumper arm showing metal lip at the top edge which is not located in the bumper

To do the job we needed a ramp and a minimum of 2 to 3 pairs of hands! When the car is up on the ramp one can clearly see the attaching brackets and also a nut which holds the bumper arm to the wing. This nut can be removed as can the mounting two nuts which are vertical when one looks upwards. One person gets to the end of the bumper on the wing and pushes upwards and backwards towards the rear of the car. Another person then gets a sturdy plastic wedge and inserts this between the valance and the bumper. The third person then attaches the bumper arm nut and tightens down. The arm is now located onto the wing properly and is parallel. He then attaches the bumper itself again via the two nuts. The result is rewarding because although we are talking about only 2-3 mm, the bumper is now fixed properly. My wife said I was mad!

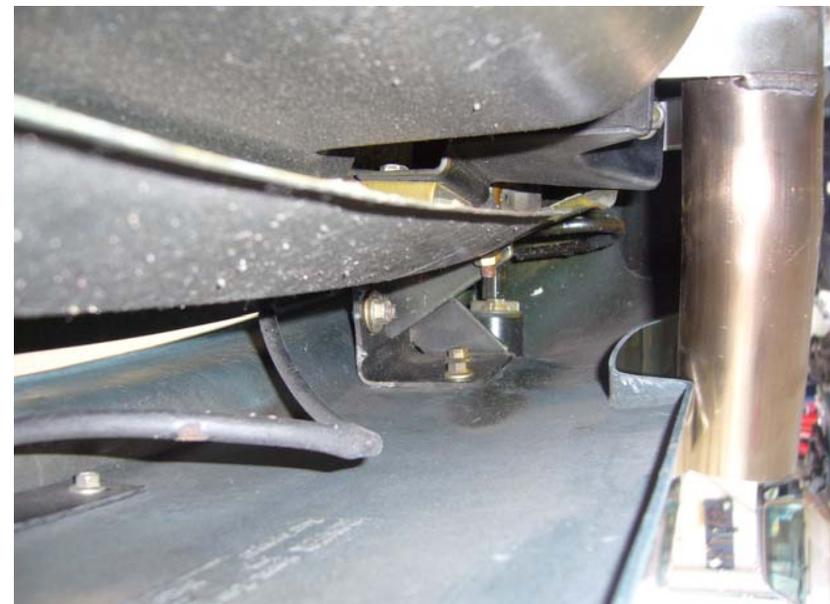
Bumper mounting bracket from underneath

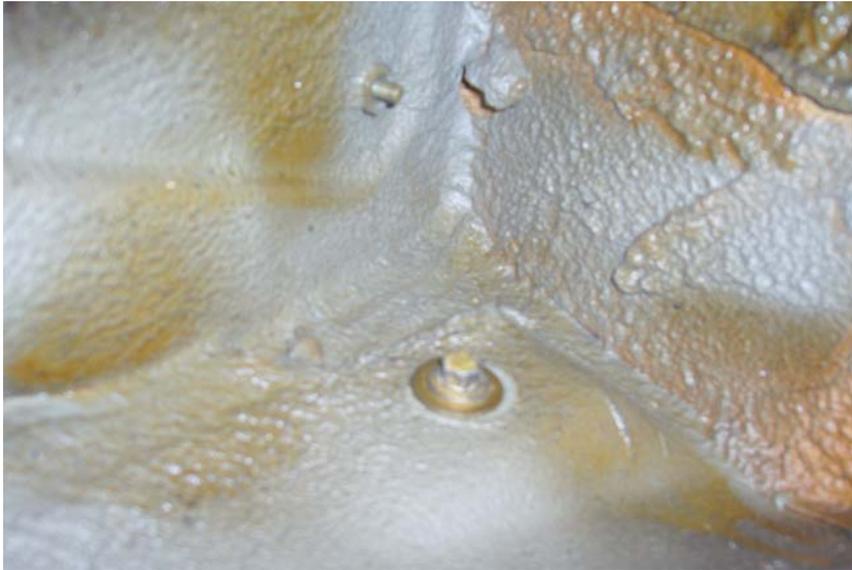
Bumper arm mounting bolt

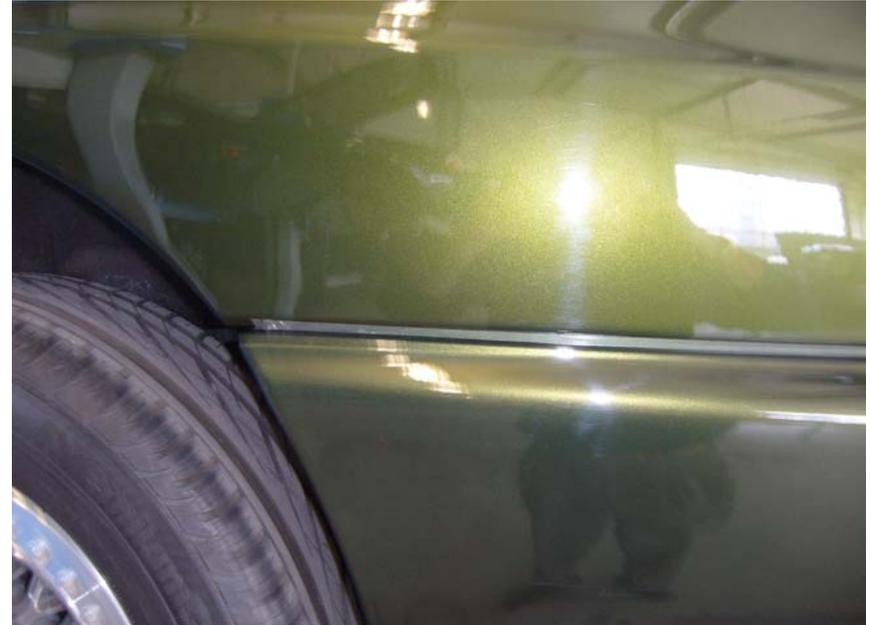
Bumper arm showing metal lip relocated and the arm now parallel

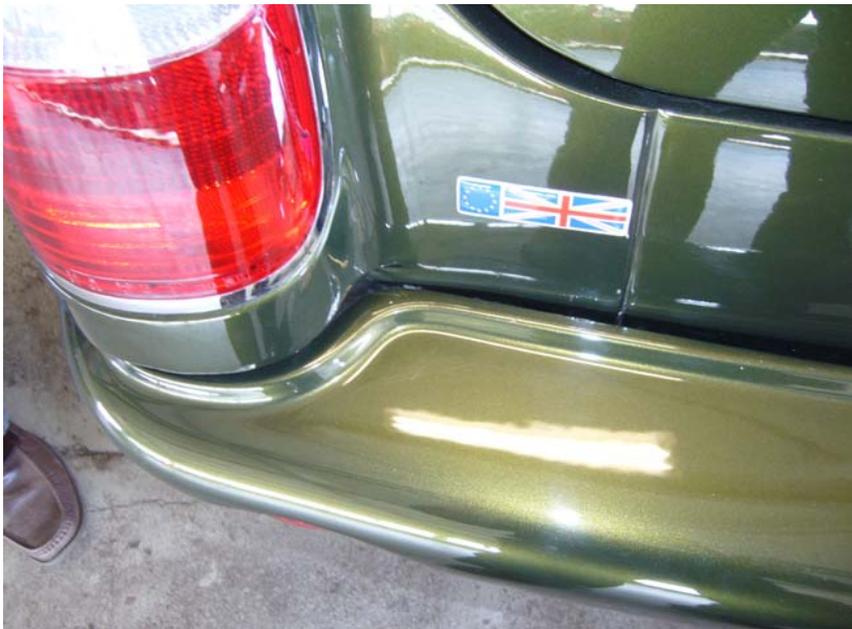
Bumper after adjustment.
