MGB V8 Roadster restoration project – Report 35

Saturday 30th May 2015

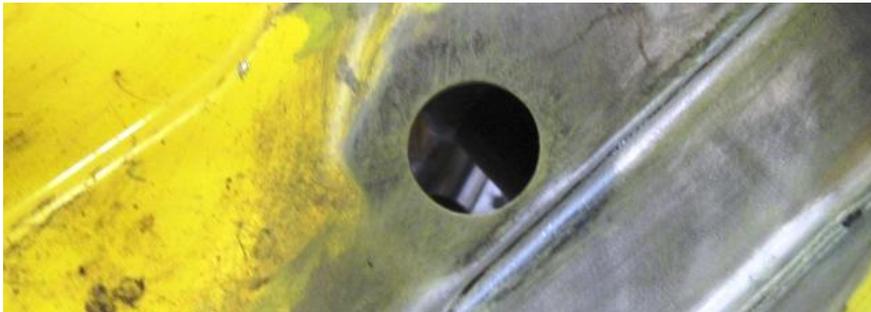
Started looking at the rear suspension and springs while I was clearing up the mess from sorting out the patterns for exhaust tail pipes and I worked out what this hole and blanking plug were for. There is one each side of the rear wheel archthere .

They are so you can top-up the original lever arm dampers from inside the car. BL, I apologise for my earlier comments!

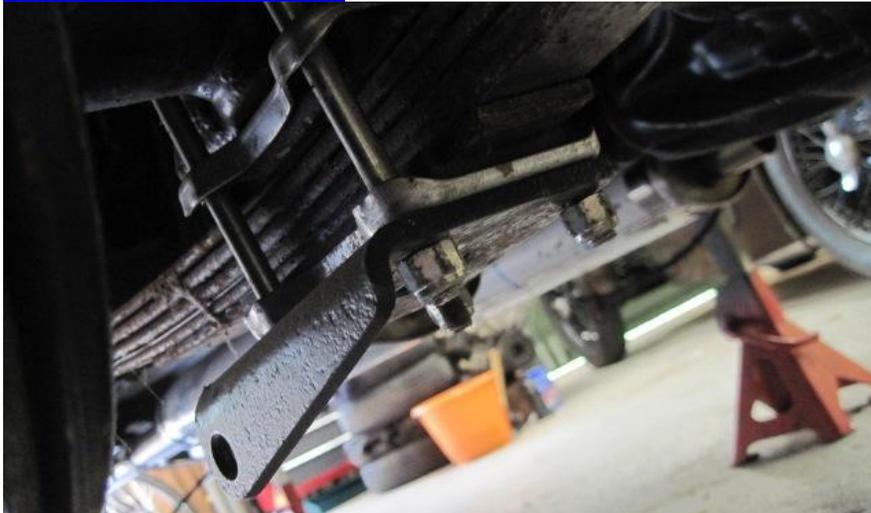
It looks as if the previous owner who started the conversion put the bottom mounting plates for the lever arm dampers on the wrong sides and I think the wrong way round. The hole in the plate should be on the inside of the spring. I think also it should be facing upwards. I'll have to look at the parts books. Anyway, it doesn't matter for the moment, as I am looking forward to the talk next Saturday on the Hoyle suspension. I will then weigh up what I am going to do with the rear suspension. By the way, the rear anti-roll bar and links are missing. Anybody got a second hand one they could sell me?

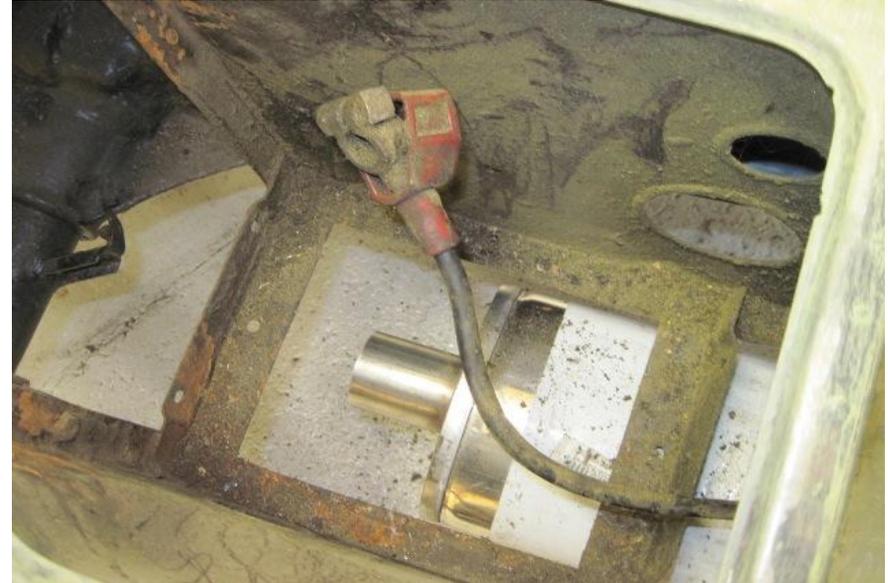
Thought I would have a go with cleaning out the area where the battery goes. Not as easy as I thought. The battery drill with a wire brush kept getting jammed across the sides. I think I need to paint strip the area first and then try the Dremel.

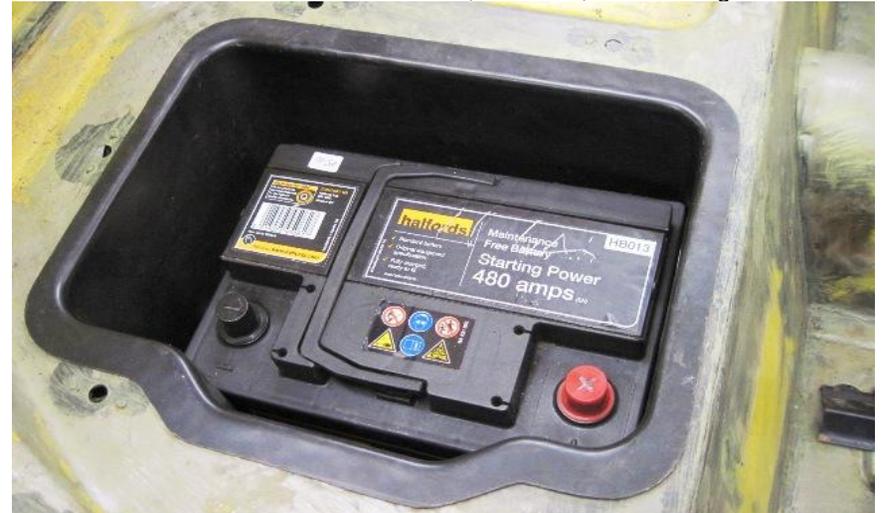
I will need to fit some heatproof material to the underside as the rear right hand silencer as it runs quite close to the bottom of the battery space. Still deciding what to do with the battery cable - do I run it inside the car or on the underside? With exhausts down both sides of the car I am leaning towards putting all the cables to the rear inside the car. Decisions, decisions; it's like being back at work.

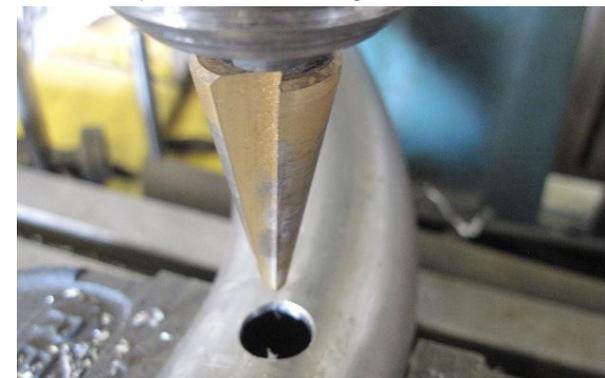
Drilling the stainless steel down pipes for the oxygen sensor collars. I did not have a drill large enough for the collars, so I had to use a taper drill. Hard work on stainless steel. If you don't put just the right pressure on the pedestal drill the taper drill either jams or hardens the stainless steel. I found

that quick 'jabs' seemed to work the best.
