September 2016, new boot floor & repair to panel by the reversing light

### Progress with an MGBGT V8 restoration

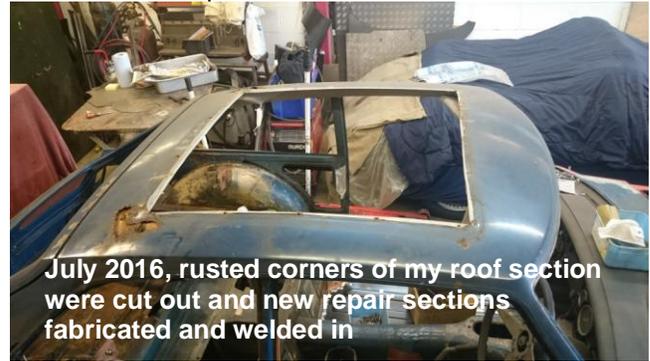
July 2016, rusted corners of my roof section were cut out and new repair sections fabricated and welded in

On the near side, a complete new front wing, new door skin, complete new sill, new floor and new lower rear wing panel below the chrome strip were required. The front inner wing was sound and looked almost like new. Some repairs were required to the structure under the rear of the front wing panel, which are not normally visible, also to the bulkhead on the passenger side. The sun roof was beyond repair, and I managed to find a very good second hand Britax sunroof which was still attached to the surrounding section of the roof panel. The **rusty corners of my roof section** were cut out and new repair sections fabricated and welded in.

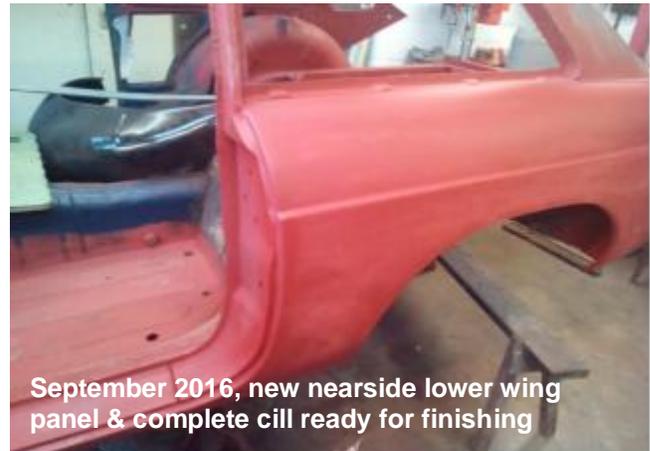
September 2016, new nearside lower wing panel & complete cill ready for finishing

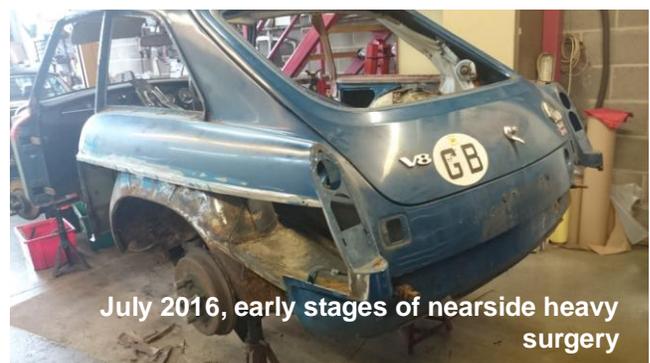
July 2016, early stages of nearside heavy surgery

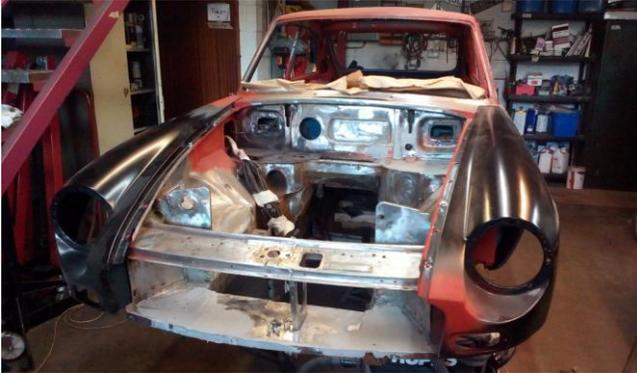
November 2016, engine bay, bonnet shut panel & oil cooler mounting panel ready for finishing plus two new wings

Some parts of the chassis legs also had to be cut off and new repair sections made up and welded in. When the paint was stripped from the bonnet, the rear of the bonnet was found to be like a piece of lace, so a **new bonnet has been ordered**. The tailgate however was found to be sound and has been refitted.

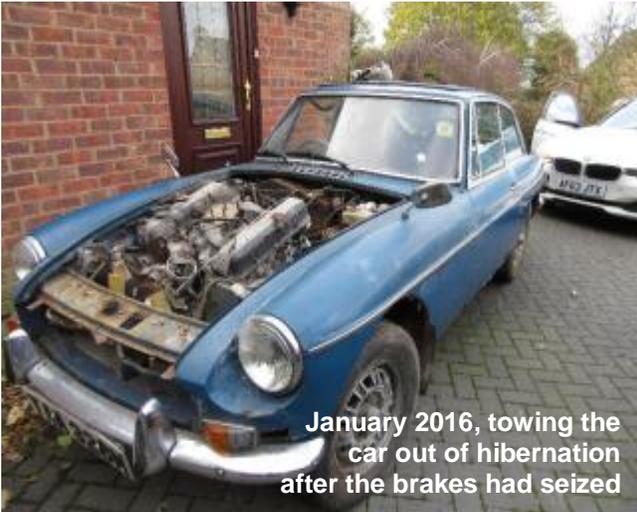
January 2016, towing the car out of hibernation after the brakes had seized

**Interestingly, the engine wasn't seized**, and turned over freely with the plugs out. However one of the valves was found to be broken, although when the car was taken off the road, the engine had been running perfectly. This is a mystery, since there wasn't a mark on the respective piston and bore, which certainly would not have been the case if the valve had broken while the engine was running. Perhaps the valve was stuck or seized in some way during the long years of inactivity, and was broken as the engine was turned over by hand. The crank and rods were found to be in very good condition, and after the bores had been honed, were fitted back in their respective locations with new pistons and rings.

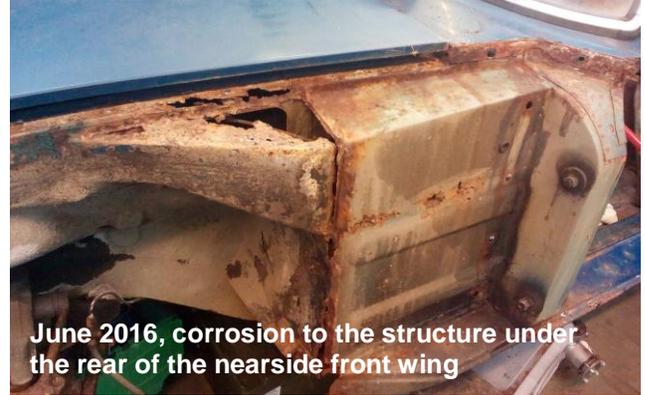
June 2016, corrosion to the structure under the rear of the nearside front wing

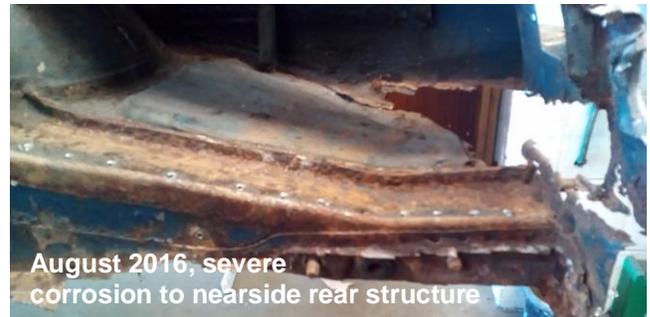
August 2016, severe corrosion to nearside rear structure

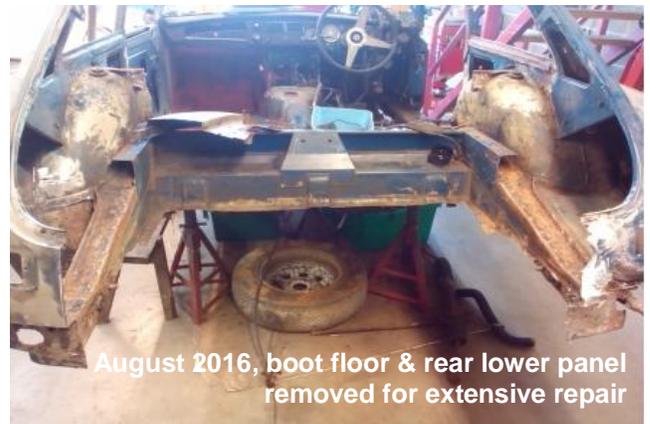
August 2016, boot floor & rear lower panel removed for extensive repair

The **boot floor had had it** and was replaced with a new floor together with new side bracing sections. The rail below the tailgate was removed and repaired around the fuel filler opening, and has been re-fitted. The off-side rear wing was

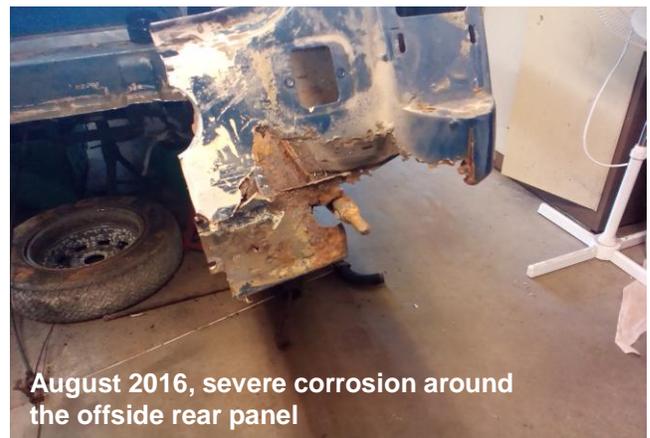
August 2016, severe corrosion around the offside rear panel

not salvageable and a complete new rear quarter panel has been fitted, along with a new floor, complete new sill and new front wing. The bulkhead on this side also needed repairs, as did the hidden section under the front wing near the 'A' post.
