MGB V8 Roadster restoration project – Report 158

24th July 2017. A DOOR MIRROR THAT RATTLES

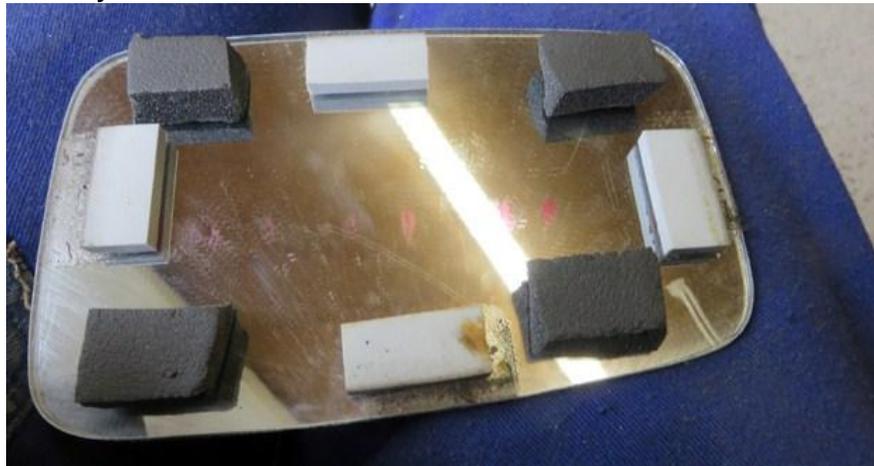
The black plastic moulding that holds the door mirror glass in place on the driver's side was loose in its stainless steel housing. Very carefully I tackled getting the black plastic part away from the glass and the housing without breaking the plastic. Eventually, it came away in one piece and was reusable. When I took the glass out the four grey flexible pads seemed to be too thin to hold the glass in place. I used four more bits of closed cell foam that I cut from some spare sound deadening material. When I refitted the glass and the black plastic moulding the mirror glass had no rattle. A cheap fix for a change!

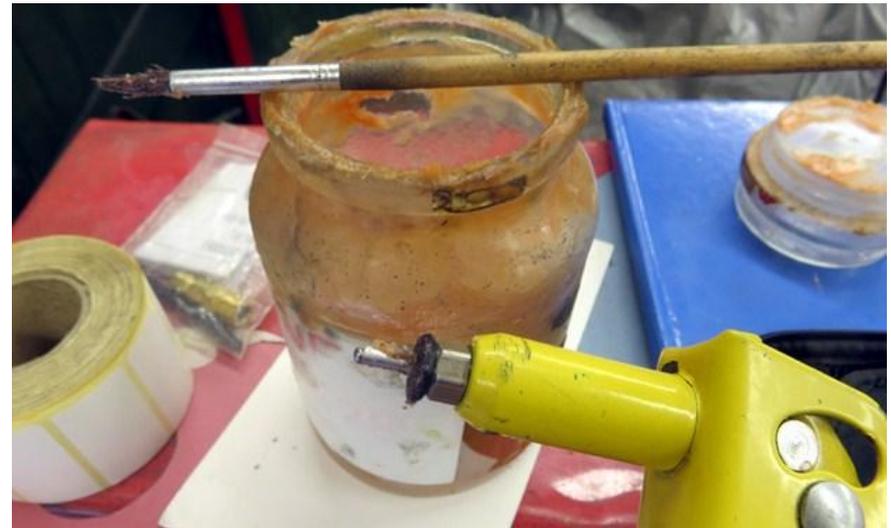
The next job on the list was to fit the front wing and door waist mouldings. To help against corrosion I coated each hole and clip with Waxoyl before fitting it. Luckily I did not need to drill any holes in the front wings for the clips, Apart from drilling one extra bolt hole for an extra trim clip at the front of the wings. With only one bolted clip at the front the trim sat about 1/8" away from the wing on the curve. Two bolted clips brought the trim in line with the wing.

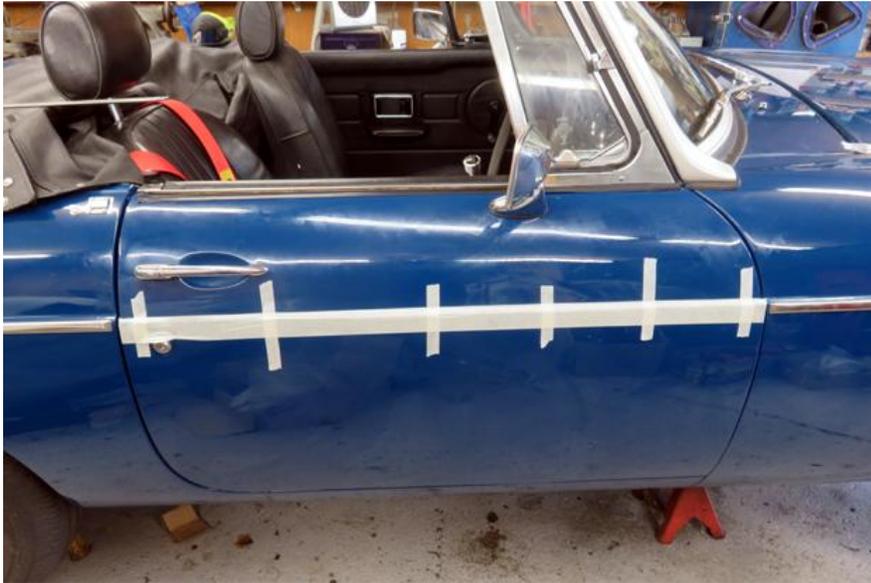
When it came to the door waist moulding the snag raised its ugly head again. It looked as if the waist moulding would not line up nicely with the front and rear mouldings, if I used the existing holes. To check this I put one pop rivet type trim clip each end of the door and pushed on the stainless steel door trim. Sure enough, it was too low at the back and too high at the front. I was happy with the door fit so it looked as if I would have to do some more body lightening by drilling some more trim clip holes in the correct places. At some time in the cars life I think it had been 'tarted up' by a dealer and a new skin fitted to the driver's door. So that I didn't drill holes in virtually the same place I put a strip of $\frac{3}{4}$ " masking tape over each existing hole to mark its position. I then put a length of wider tape along where I needed to drill the new holes. A long straight edge was placed between the top of the front wing moulding and the top of the rear wing moulding. A line was then drawn along the straight edge to show the top line of the required moulding position. The same process was then carried out under the rear wing and under the front wing mouldings. I then had the top and bottom of the waist moulding drawn on the masking tape. The centre of the gap was then measured and marked both at the front and rear of door. I could then use the straight edge to draw a line where the trim clip holes should be. The new trim hole positions were then marked, lightly centre punched and then drilled at the correct diameter for the rivets. The new holes were treated with etch primer and later clear Waxoyl. By having the masking tape on the door it not only is useful for marking on, but it also helps stop the drill slipping. Use a short drill or fit the small drill bit as far back into the drill as it will go, a sharp drill is much better than an old blunt drill that you have to push hard to make it cut. The tape was then removed and the trim clips fitted. I like to fit at least two bolt on type trim clips rather than the one on each moulding that the factory originally fitted.

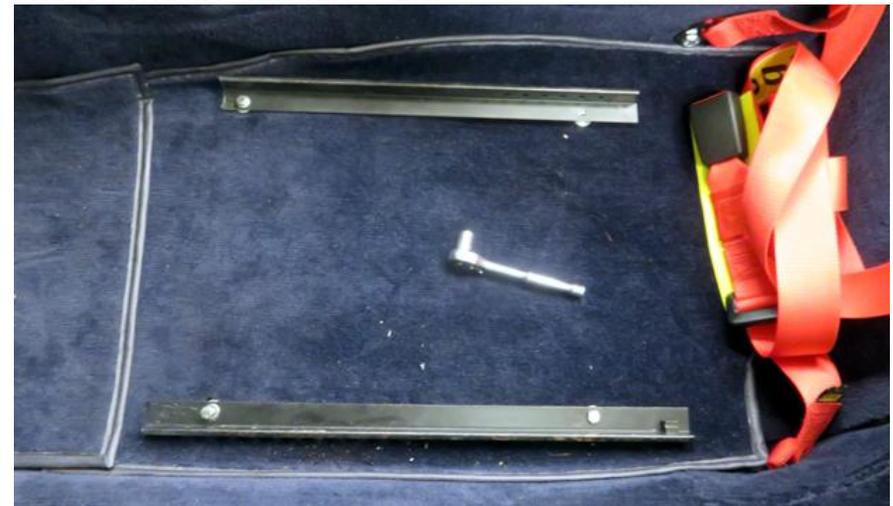
After fitting the driver's seat I thought the passenger's seat would be 'easy peasy' as there is no handbrake to get in the way on this side of the car; I was mistaken!

After trying for ages to get the rear fixings bolts in first, I then tried to get the front fixing bolts in first, still no joy. In the end out of desperation I removed the seat and put it upside down on the work mate. Took out the runners and tried fitting them without the seat. The inner rail by the transmission tunnel seemed too long and was stopping the hole in the rail from lining up with the thread nut in the box section below the floor. I cut off about 1" from the front of the rail and then the rails fitted in place. (See photo on the previous page). I then refitted the rails to the seat and decided to leave it until the next morning when hopefully I would be fresher and less tired. The next morning after about an hour and a half I managed to get one of the seat mounting bolts in place. It took me until about lunchtime to fit the other three bolts. To get to the back bolts you need to slide the seat forward and to fit the front bolts, you need to slide the seat backwards.

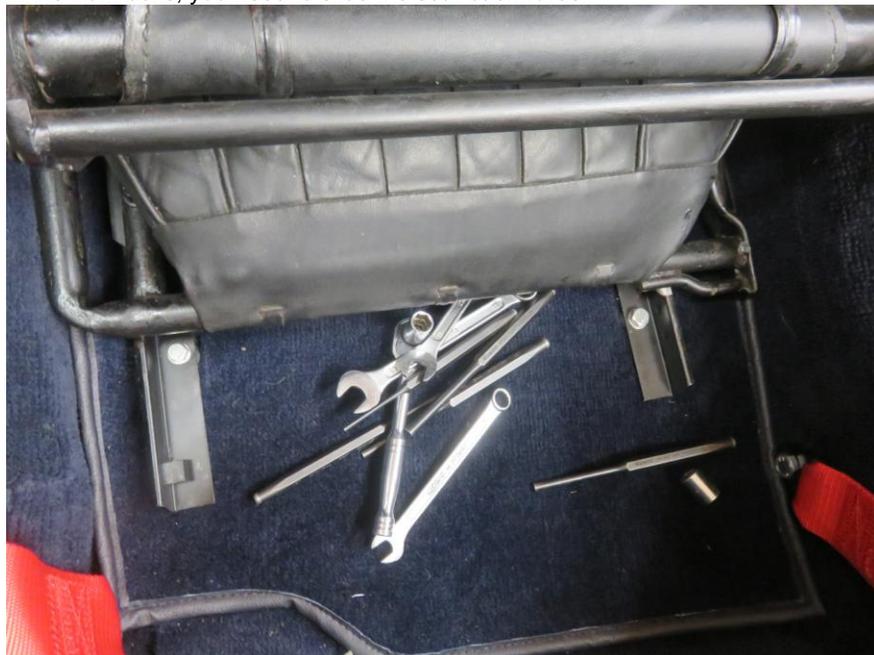
The rear set mounting bolts fitted at last. At least with these rear threaded holes you can push a scriber up from the underside first, then a drift, to use as a 'poddger', to line up the holes. With the front bolts they fit into threaded inserts that are in a closed box section so any 'lining up' has to be done from the top where the bolt goes in. In the end I had to taper the thread on the new stainless steel bolts on the bench grinder. Always put a nut on the bolt you are going to taper before you grind the bolt as the nut will 'tidy up' the thread when you take the nut off the bolt. I think moving the seat backwards and forwards is going to be difficult with the extra sound proofing in the car. I'll have to discuss with Jane the possibility of having her legs stretched or my legs shortened so that we do not have to keep moving the seat when we change drivers. I wonder if the Chamber of Horrors would let me use their torture rack to lengthen Jane's legs?

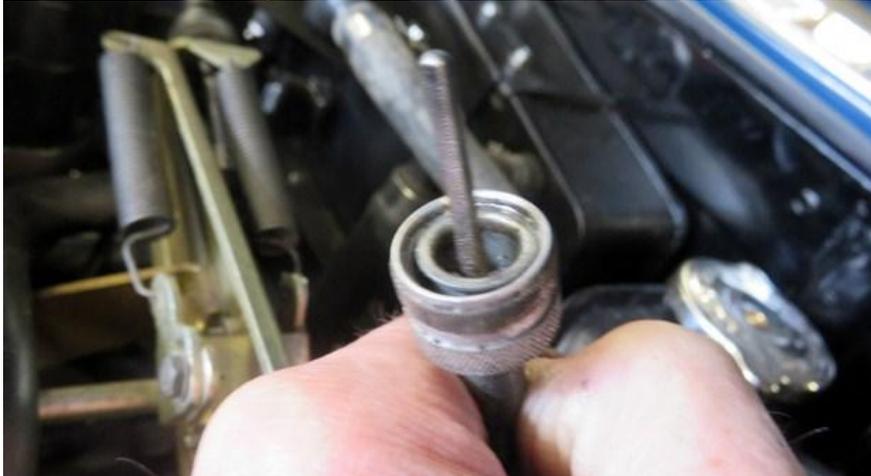
The first check was to disconnect the upper cable from the speed transducer to the speedo head at the transducer end as this was going to be a lot easier than attempting to undo the speedo cable at the speedo end. I had an old MGB speedo cable that I screwed onto the transducer and started the car and put it in gear. If it was a problem with the speedo the inner speedo cable should turn. It didn't!

Now turn off the engine and disconnect the speedo cable from the gearbox end of the speed transducer. Try again starting the engine and putting the car into a gear. Still the inner speedo cable didn't turn. The problem must be with this cable or 'heavens forbid' the speedo drive in the gearbox. Now I need to undo the cable at the gearbox end and see what I find.

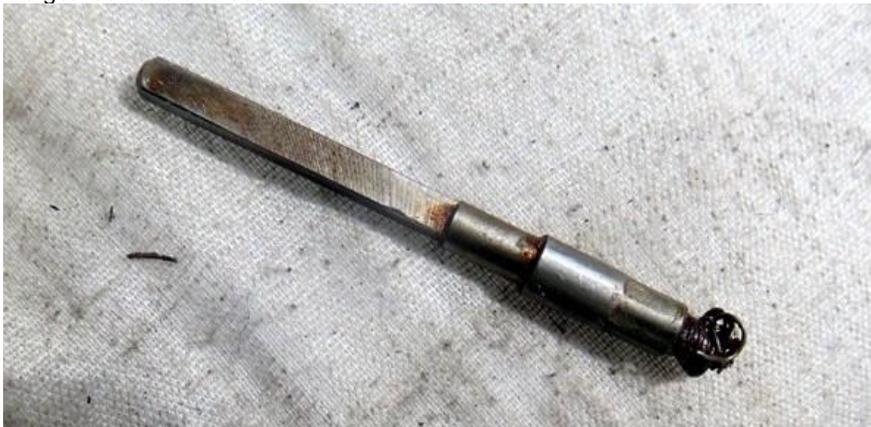
'Hey Presto' – I've found the problem, a broken inner cable at the gearbox end. I firstly I phoned Clive Weatley, but there was no reply, strange, not even an answer phone message. Panic; I had better try B&G, luckily they had one in stock and hopefully it will be with me tomorrow.
