Replacing a faulty horn on an MGBGTV8

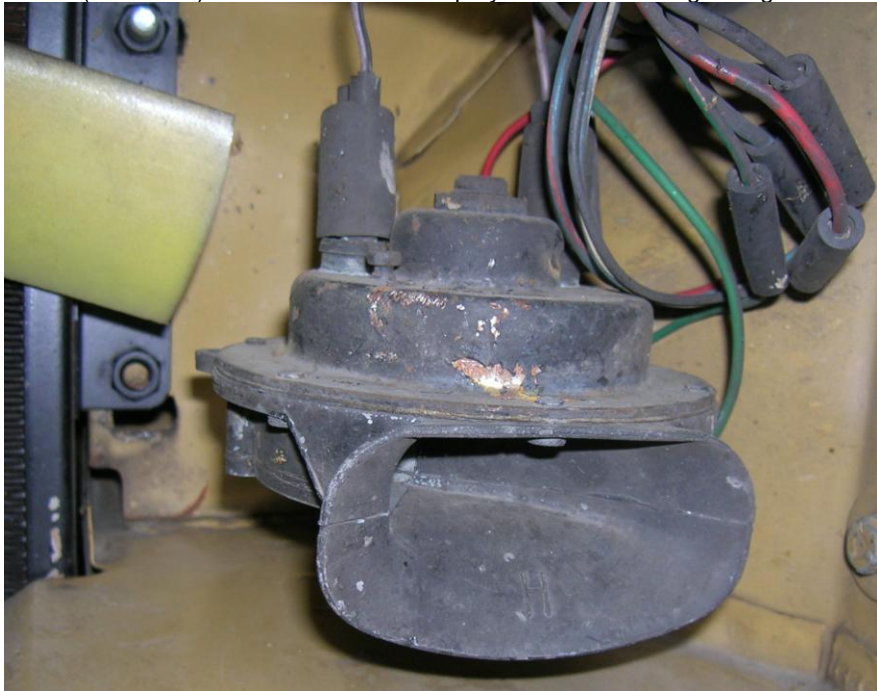
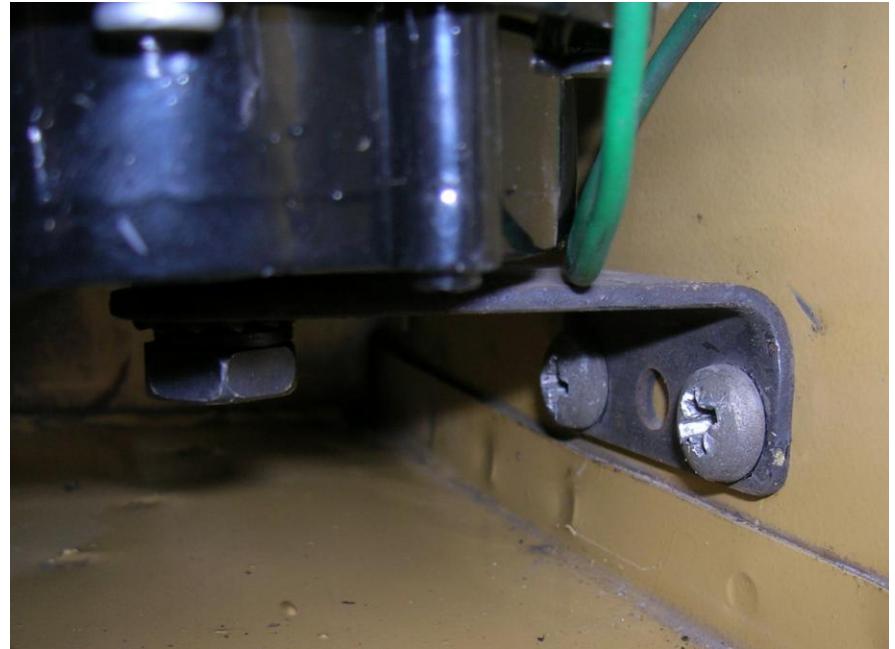
Remove the grille – remove the Philips headed bolts from the end of the top grille stays from the slam panel connecting to the top of the grille and then using an extender on a socket set unbolt the three fixings on the bottom. Ease off the two fastons connecting to the terminals on the horn- - they are under the large rubber covers (see below) to resist the mud and spray that comes through the grille.

Next unscrew the bolts securing the horn bracket to the bodywork on the side of the space behind the grille (see above).

Once the old horn is off the car **undo the bolt securing the underside of the horn to the bracket** (the large bolt under the horn in the photo above) and then take the opportunity to clean the area, not least the bodywork in the space behind the grille alongside the oil cooler ahead of the radiator. Then bolt the bracket to **the new replacement horn**. Check you have the correct horn – either the HI or LO unit. Replace the two fastons, on the terminals of the new horn, ensuring the large rubber shrouds are in place, and refix the bracket to the bodywork.
