### Clip on the damper in an HIF carburettor

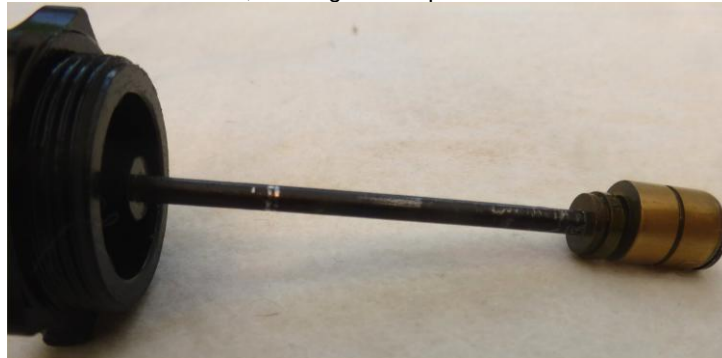
**Keith Belcher** was then in touch and sent **photos illustrating the clip on the damper** on his HIF carburetors which the V8 Webmaster referred to as a "**floral clip**". It seems this clip was fitted to the HIF carburetors fitted on the MGBGTV8 model.

come dislodged. They are difficult to re insert. When this happened again a couple of weeks ago, on investigation both clips were loose and the rods showed signs of deep scratches. On thinking about it I surmised that one clip was wedging the rod to one side causing the piston to fail to return to the bottom, causing a rise in rpm and the other carb to run weak, causing the temperature increase.

So I asked two "old school" mechanics and both said the clips were "more trouble than they are worth!" Hence the post on the V8BB. But with no useful replies I took the bull by the horns and snipped the clips off. Over the weekend and today I must have completed over 200 test miles. The tick-over has been a rock steady 900 rpm all the time, even on a long run when it was very warm. The tickover was steady even when throttle off free-wheeling at speed. It might be too early to say that I have sorted my problem, but I must say that initial findings are looking good. The clips were very easy to snip off,"

**Removing the floral clip is simple**, a snip with a pair of side cutters will enable you to remove it quickly. If you can spend more time, taking the damper assembly out and removing the tiny circlip at the bottom will allow you to slide the brass damper off and then the clip. The only downside here is that the circlip is very small and may be damaged unless care is taken when removing and replacing it.

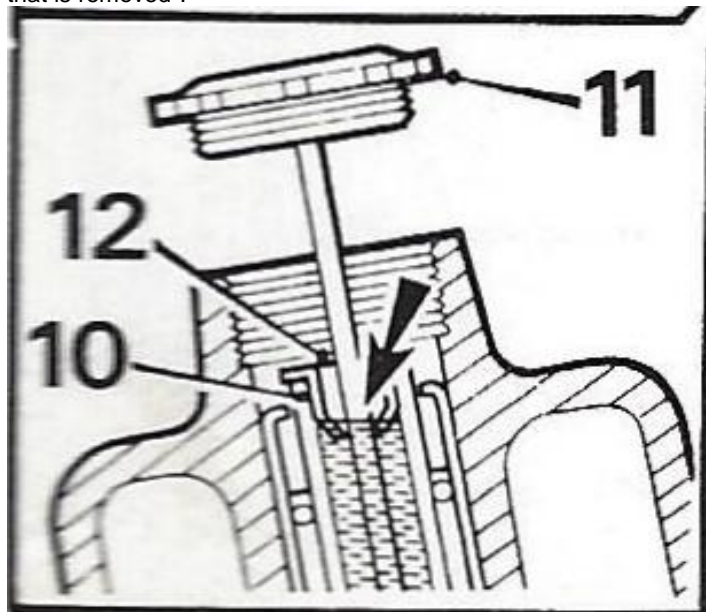
**Burlen** responded to Nic Houslip's query saying "the clip was introduced to stop the damper being lost if the cap (11) became unscrewed. The later damper caps have quite short lengths of thread. It also stops the piston falling out of the suction chamber if that is removed".

Item 10 Damper retaining clip, 11 Damper cap and 12 Retaining recess. (Carburettor (HIF) damper topping up, page 58 & 59, MGBGTV8 Driver's Handbook AKD8423 4th Edition)

On receiving the clarification from Burlin, **Nic Houslip** said "I would think it quite safe to recommend that people remove them (the clips on the floral clip) if they want to. I do not recall ever seeing

a damper coming loose, but I suppose it could. A useful caution for fellow members is "make sure they keep the damper caps tight".
