MGBGT V8 Overdrive failure

Andy Goves describes the process adopted to diagnose and successfully deal with a complete overdrive failure on his 1973 Factory launch MGBGT V8.

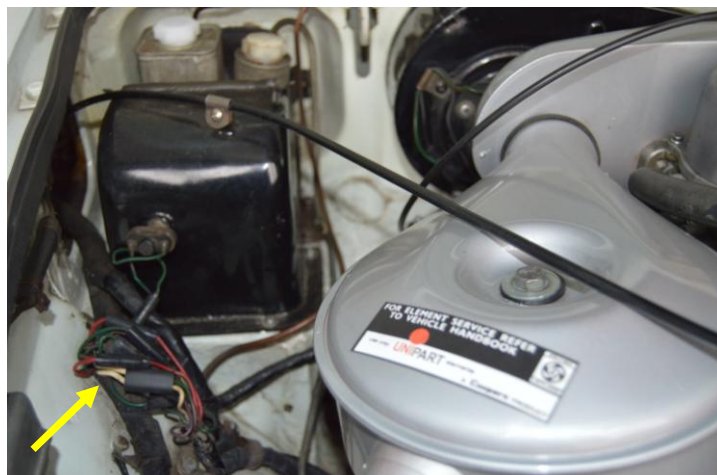
In fact I had innocently chosen an incorrect wire, confused by the ageing process with discolouration of the wires' insulation and, to add insult to injury, the 1973 bullet connection then self destructed

before my eyes. Judicious use of a soldering iron restored a temporary connection after an hour and allowed me to start the MG so I could return it to CCS Restorations the very next working day.

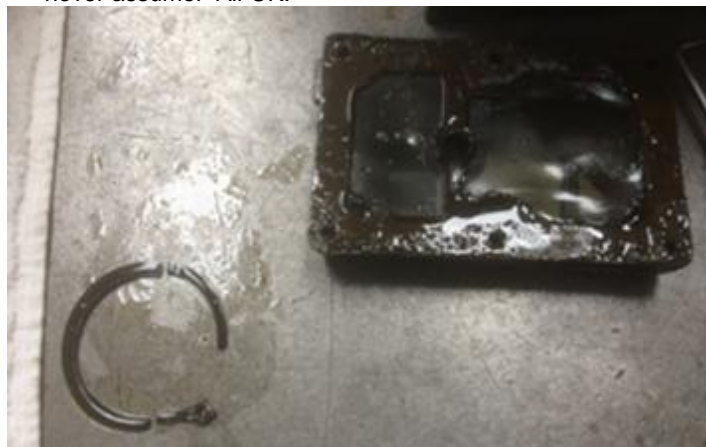
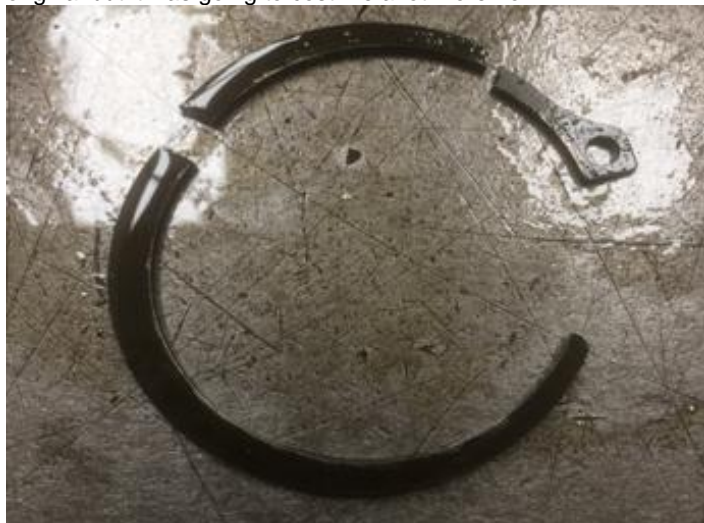
4. Dismantling started on the lower overdrive plate to inspect the filter and gauze of the overdrive unit. It immediately became apparent that the **fault lay in the fracture of one circlip** (see

the photos alongside) which should have been holding part of the overdrive oil pump together.

So, we could now confirm that the **overdrive unit was not functioning correctly due to insufficient oil pressure to the unit.**

The **diagnosis now meant the engine and gearbox had to be removed** to facilitate fitting the 'new' overdrive unit - but first you need to locate its replacement! Moss Europe had just one reconditioned unit in stock in Bristol - their stock dwindled to zero as I purchased it there and then, with a guaranteed 24 hour delivery slot.

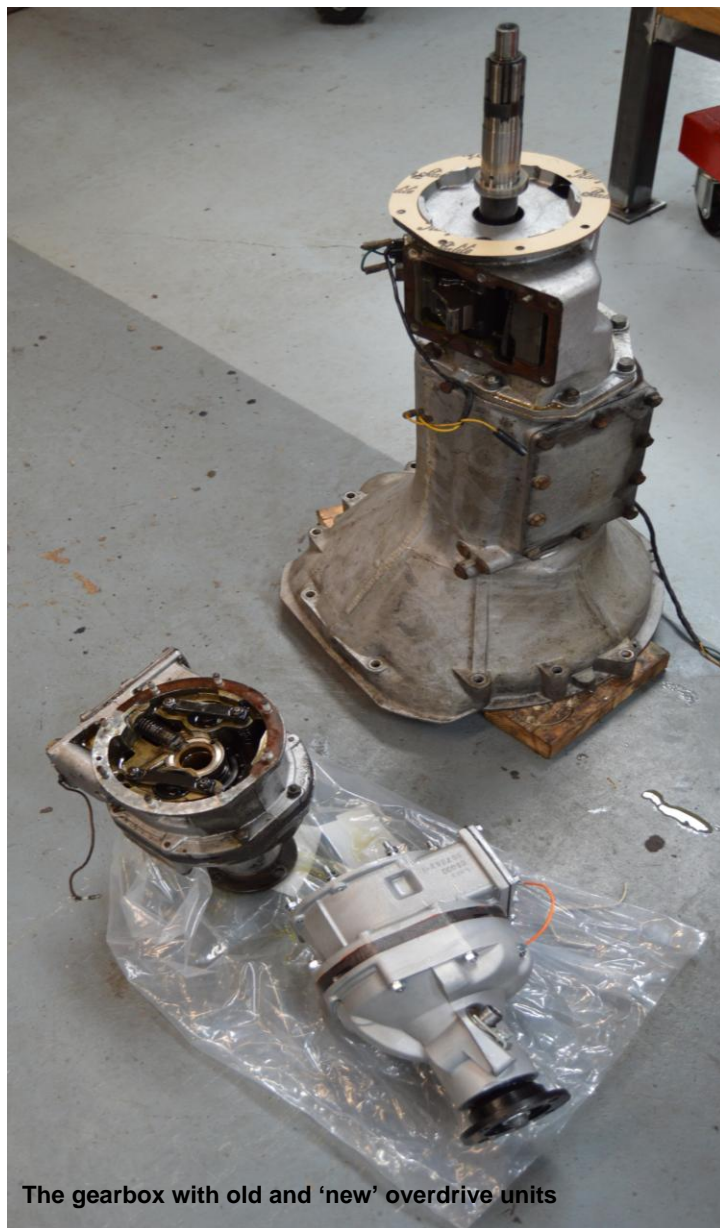
The gearbox with old and 'new' overdrive units

In the space of just over 72 hours, the replacement overdrive unit, complete with engine and gearbox had been refitted and I was able to collect the MG and drive her home. The reduction in engine revs, plus the reduced ambient noise made for a much more relaxed journey and the MG has taken yet another step towards maintaining its originality criteria!
