Ignition problems again

In 2015 Peter Spurrs had serious ignition problems. Sometimes the car would run well, but at other times not at all and at random times in-between it would fail. There was always a slight hesitancy when accelerating, but he took that to be normal. The previous owner had fitted Aldon ignition, but everything else was pretty much original. He re-made all of the earth connections – no change. The vacuum advance was seized; he replaced it - no difference. He then replaced the spark plugs, rotor arm and distributor, and then fitted Magnacor plug leads and an Aldon Flame-Thrower coil - still no improvement. The solution turned out to be an intermittent fault in an earth lead. He ended up with a working ignition system with lots of new parts. In 2019, half way through a 50 mile journey, the car went from running smoothly to spluttering, then a few minutes later, it backfired a few times and stopped. After a while it restarted, but it had no power and stopped. A recovery vehicle got him home. Here he explains how the problem was solved.

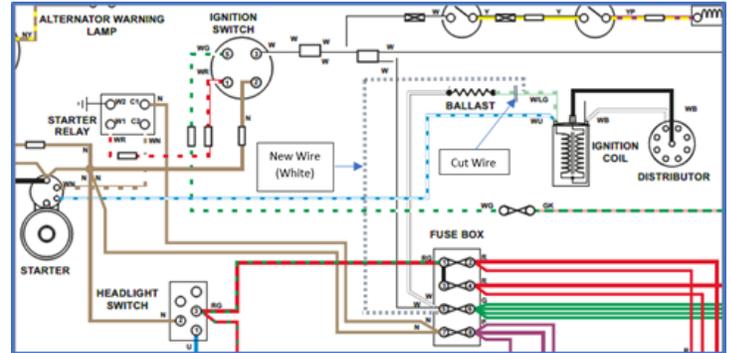
See a full size copy of this diagram on page 3. Please note that there is an error in the wiring diagram. The feed from the negative coil terminal to the tachometer has been omitted.

I chose to leave as much of the original wiring in place and connected as possible. The spade connector at the fusebox remains attached and the supply via the starter is all in place. Only the supply via the ballasted line has been cut at the coil end. The single spade connector at the positive terminal of the coil connects both current sources, so I chose to use it by connecting the new wire to it.

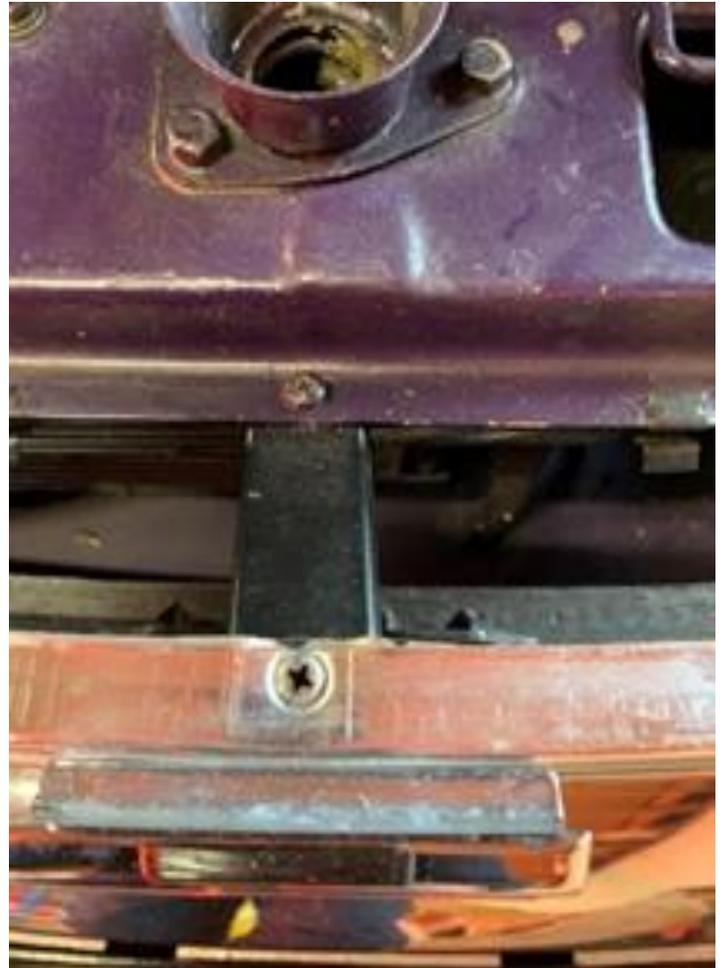
I first removed the radiator grille. The top is held in place by three screws.

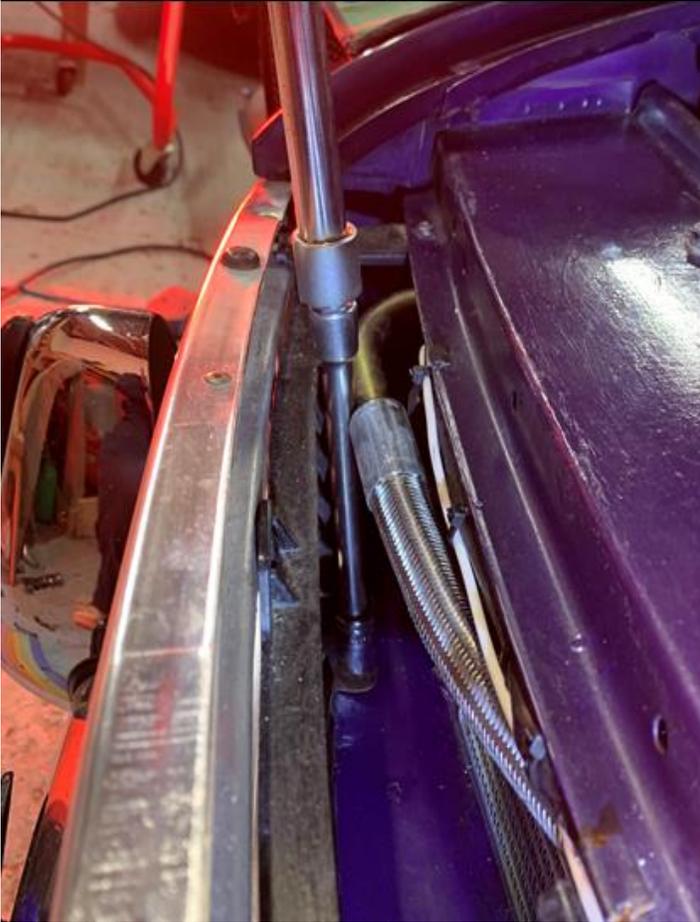
There are also three bolts at the bottom, none of which is easy to extract. The offside is the most difficult for two reasons, the oil

cooler hose is in the way and the bolt head is very close to the grille. I found a 3/8" drive socket worked – just.

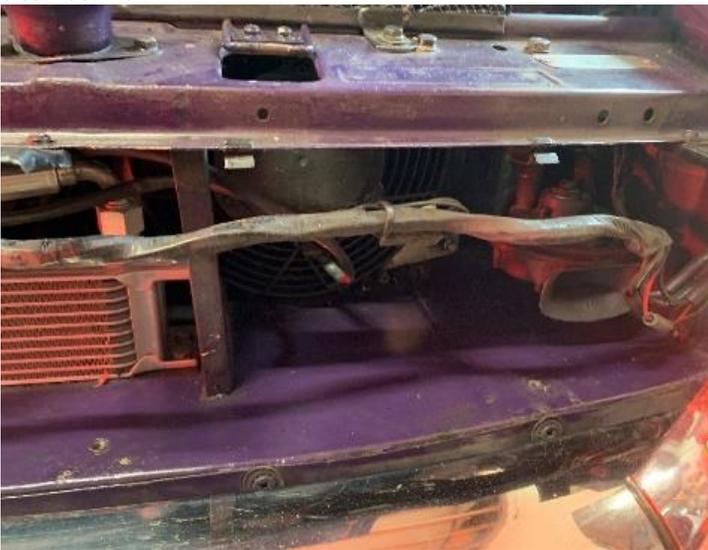
The ballasted wire was cut at a convenient point where it emerges from the loom on the nearside of the car. The feed from the fusebox was made electrically safe and a bullet connector fitted to the feed to the coil. The new wire and the old connection to the coil were joined.

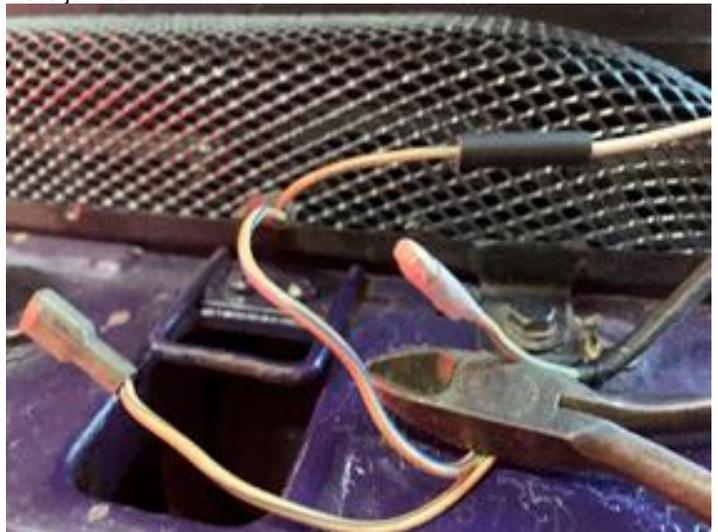
The next task was to cut a length of white wire to run from the fuse box to the coil. The fusebox end needed a spade connector and the coil end a bullet connector. I then connected the white wire to the spare terminal next to the two white wires which supplies the coil.

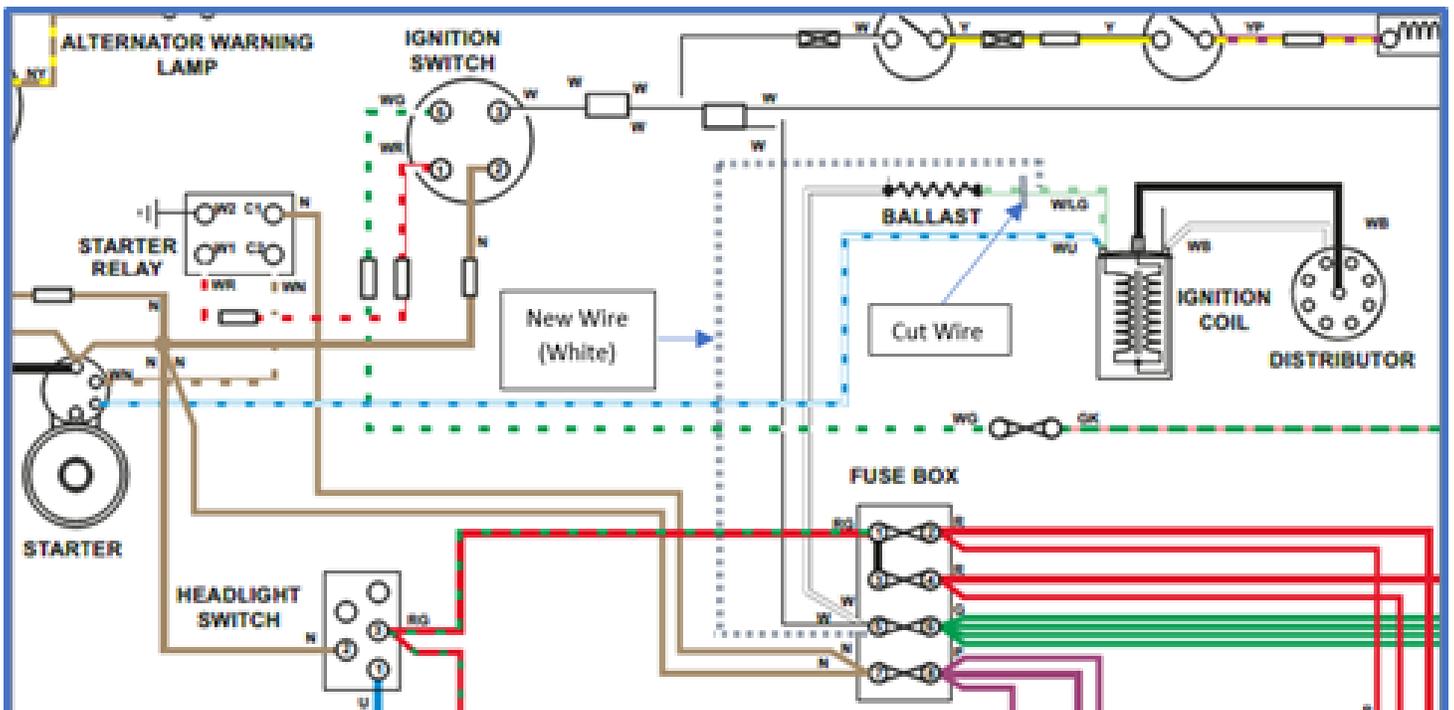
Wiring diagram

Please note that there is an error in the wiring diagram below. The feed from the negative coil terminal to the tachometer has been omitted.
