MGBGTV8 Hazard Warning Switch

In 2017, MGBGTV8 owner Peter Spurrs had a problem with his **hazard warning lights**. The indicators worked correctly at all times, but the hazards were unreliable – sometimes working and other times not and to no clear pattern.

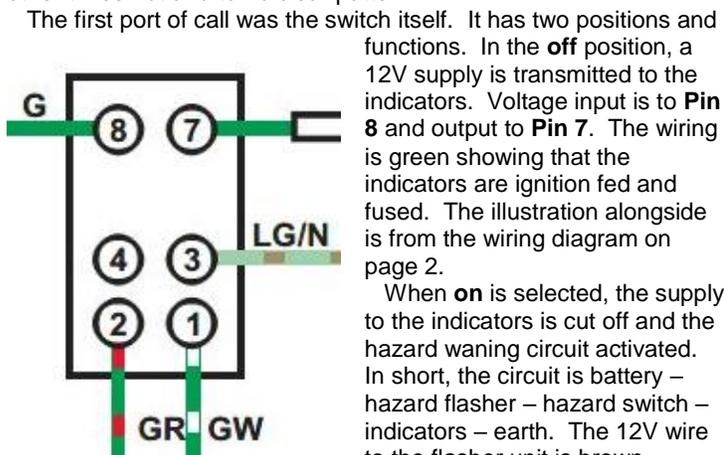
The first port of call was the switch itself. It has two positions and functions. In the **off** position, a 12V supply is transmitted to the indicators. Voltage input is to **Pin 8** and output to **Pin 7**. The wiring is green showing that the indicators are ignition fed and fused. The illustration alongside is from the wiring diagram on page 2.
