MGBGT V8 – Strategy for Dealing with a Sheared Engine Fastener

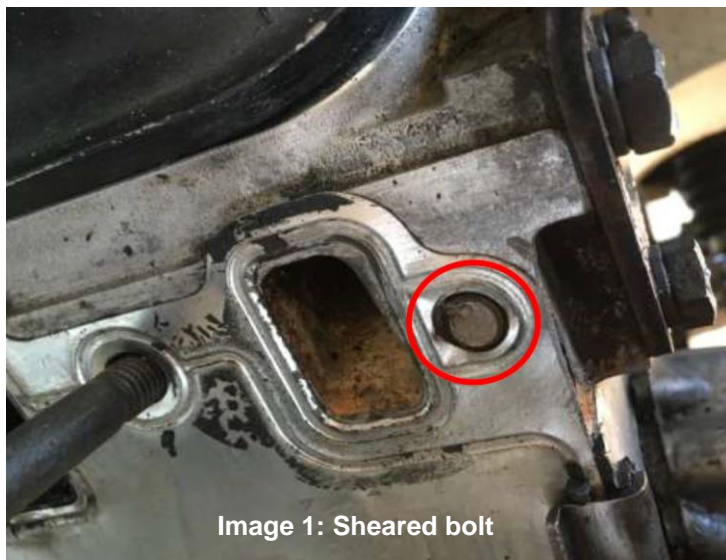
Image 1: Sheared bolt

The bolt, failure of which prompted the writing of this article, is one of the 12 inlet manifold to cylinder head fasteners – see **Image 1**. The bolts are 3/8" UNC with the front two on each bank being 2" long while the remainder are 1½" long. The installation is unusual in that the tapping axis is not at right angles to the joint face which complicates the repair process – see **Image 2**. The front and rear bolts seal water passages which makes them more susceptible to corrosion damage should the seal fail. The bolt sheared flush with the cylinder head surface with no opportunity to grip a projecting stub for removal.

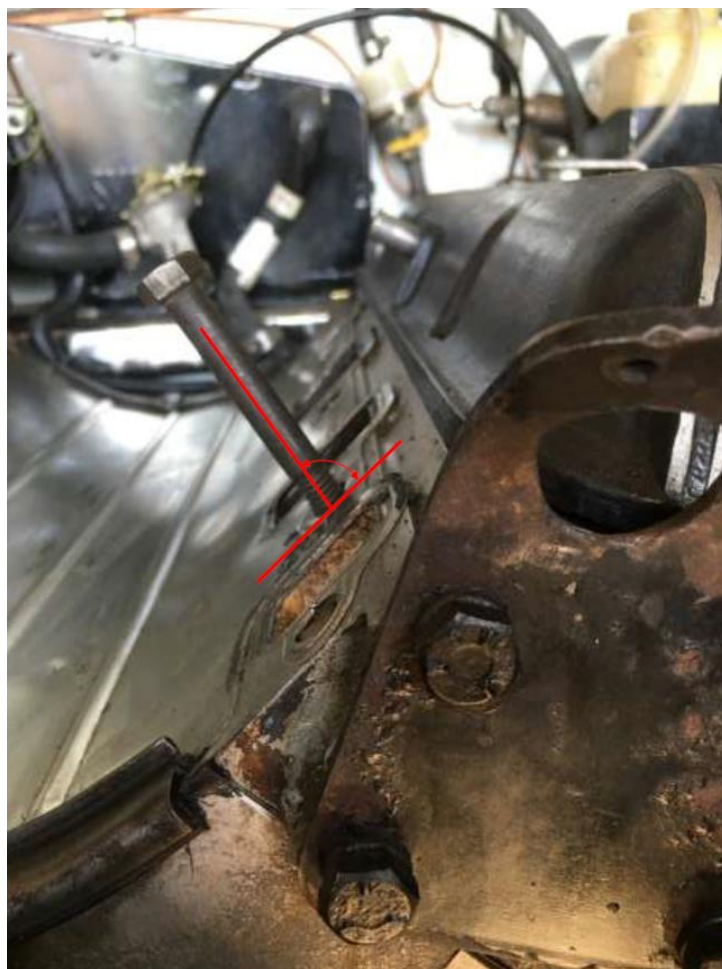
Image 2: Guide bolt demonstrating angle to joint face

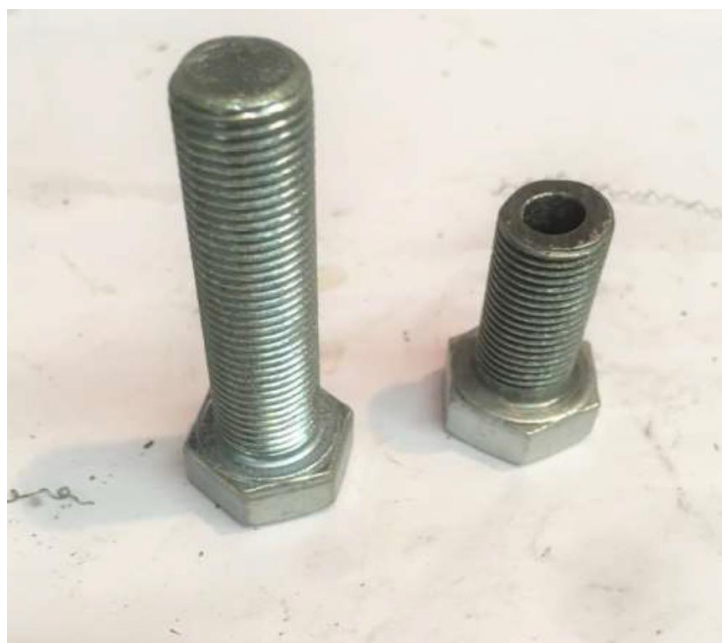
Image 3: Drill bush manufactured from ½" setscrew

Procure a ½" bolt and cut it to length - 1" is suitable for the front bolt hole of the manifold. A 12mm bolt may be used but the fit in the inlet manifold will be less precise. If possible, mount the bolt in a lathe and drill with a 6.4mm bit, this being the size of the author's first left-hand drill. Otherwise, carefully mark the centre of the hexagon head and drill. It is important that the drilling is coaxial with the bolt shank if technique 7 is to be successful. The author made several attempts using a pillar drill before an acceptable bush was produced. For the resulting bush see **Image 3**.

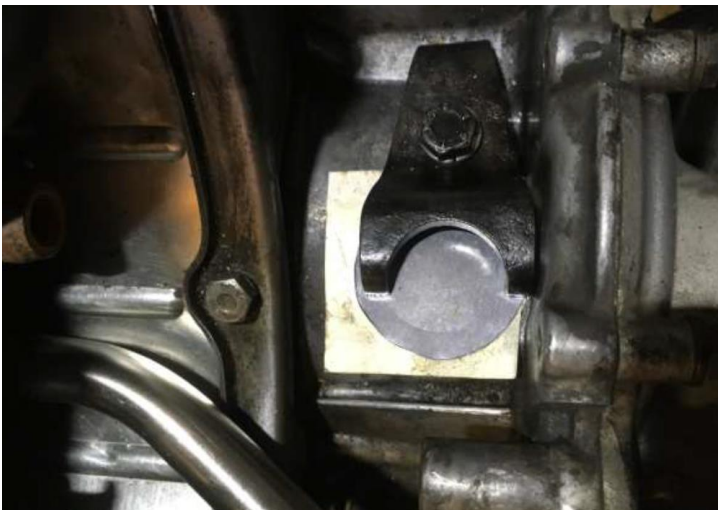
Image 5: Sealing the distributor aperture

2. **Remove the distributor** and seal the openings in the timing cover – see **Image 5**.
3. **Replace the inlet manifold and lightly tighten the bolts** – the manifold is not dowel located and more accurate positioning is achieved by sleeving a couple of opposing bolts – see **Image 6**.

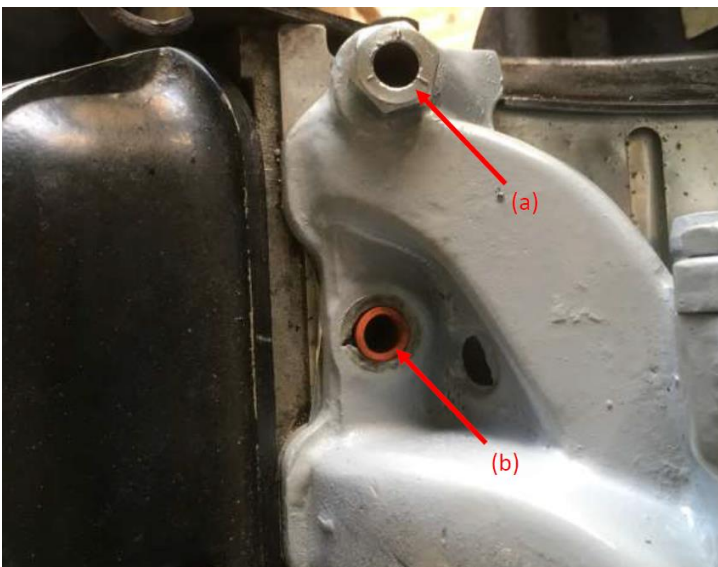
Image 6: Drill bush (a) in position with plastic sleeve (b) in adjacent hole

4. **Fit the drill bush in the bolt hole** over the sheared stub – see **Image 6**.
5. Drill using the 6.4mm left-hand drill until the stub is loose or drilled through – see **Image 7**. If not loosened, proceed to the next step.

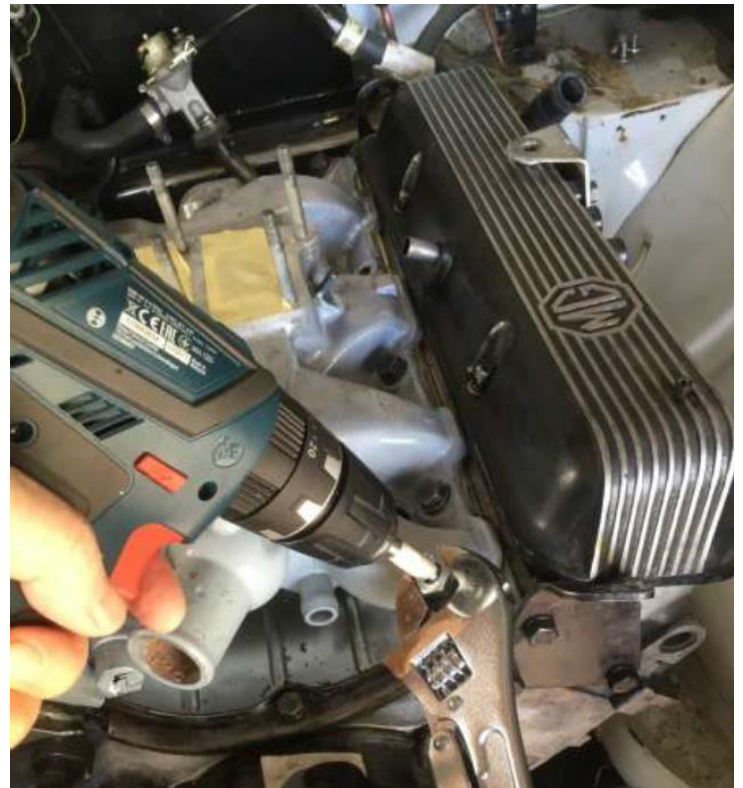
Image 7: Drilling through the bush (with wrench to prevent rotation)

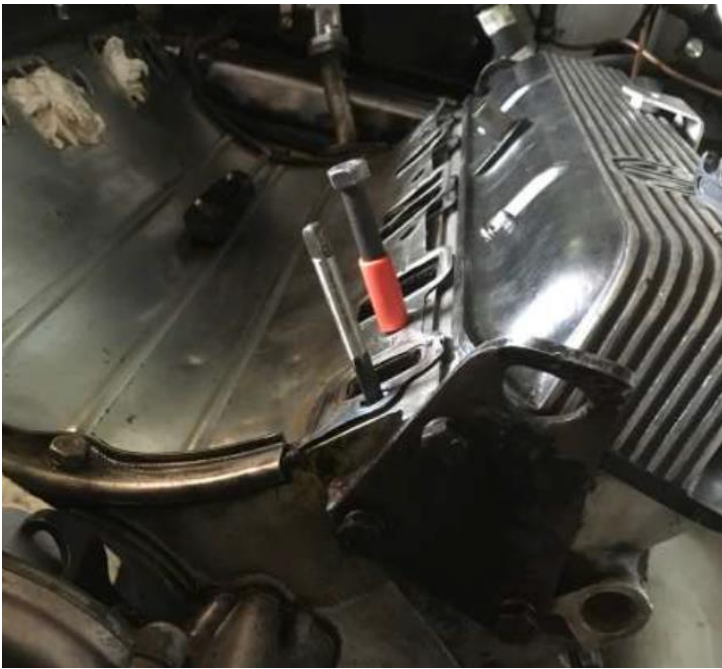
Image 9: 1/4" extractor in position

6. **Insert the ¼" extractor into the stub** and try to rotate anti-clockwise – do not use excessive force as a sheared extractor is to be avoided at all costs - see **Images 8 & 9**. If this is not successful proceed to the next step.

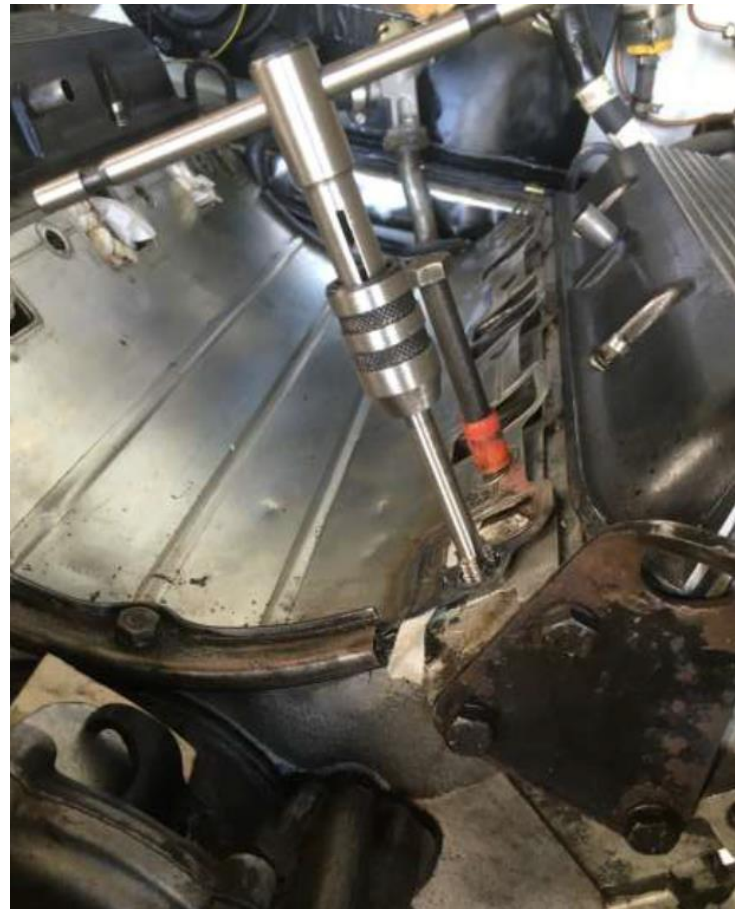
Image 11: Tapping for insert using guide bolt to aid alignment

12. **Using the drill bush drill the hole to its original depth** using the drill provided in the insert kit
13. **Insert a long 3/8" UNC bolt in the adjacent bolt hole** to aid alignment and carefully tap the hole with the insert tap – see **Image 11**.

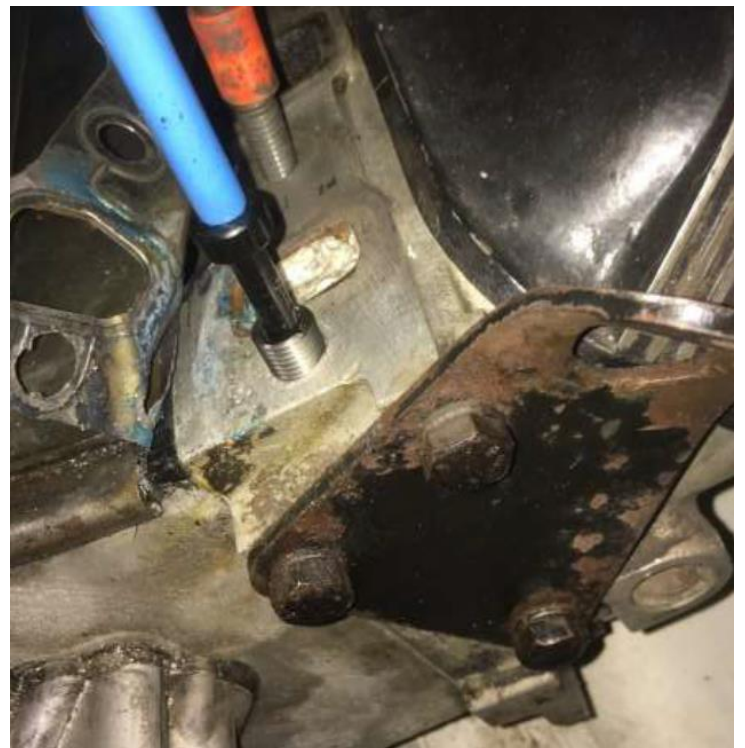
Image 12: Installing the insert

14. **Remove all debris and check the thread.**
15. Fit a 3 x D (= 1.1/8") 3/8" UNC insert to the insertion tool and wind into the tapping until it is a half turn under flush – see **Image 12**.
