Door mirror instability

Peter Spurrs found the two door mirror fixings on his MGBGTV8 were unstable. Here is how he resolved the problem.

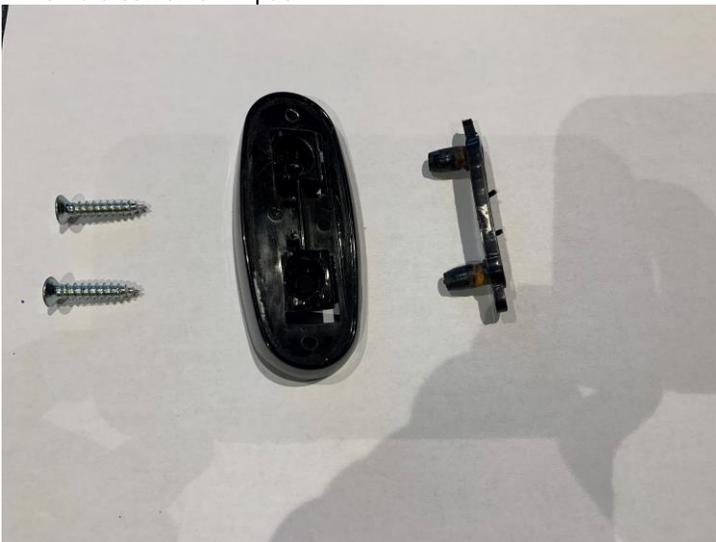
Firstly, on the production line, the two plugs on the plastic base plate were fitted into the two holes in the door. Next, the mounting plate was held in place with two self-tapping screws. Finally, a single screw held the mirror in place on the mounting plate. The single screw is on the rear facing side of the mirror to allow the mirror to break off on impact.

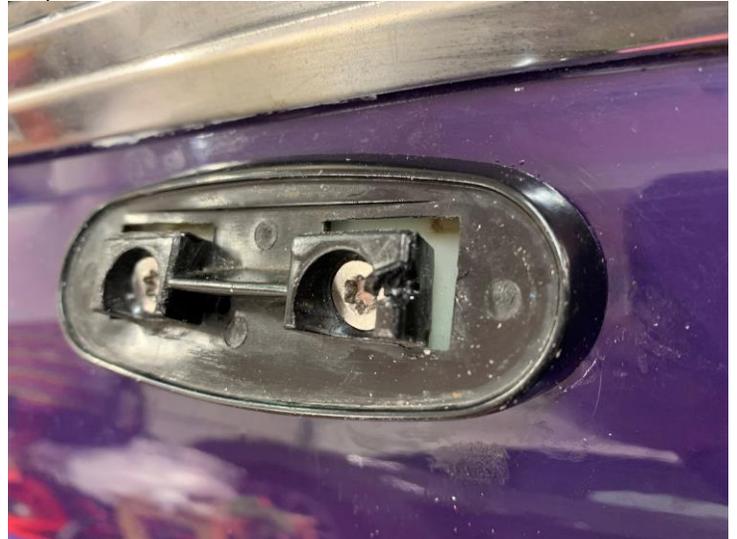
1. The fixing for the mirror relies on a wedge fit at the front and a pointed grub screw at the rear. The screw penetrates the plastic mount to hold the mirror in place. In practice, the way the parts

fit together, the screw does not bite into the middle of the plastic, but the top. The screw then tends to work its way over the top of the plate and becomes loose. The more the grub screw is turned to tighten the mirror, the more the deformation of the plastic and the looser the mirror. Net result – an unstable mirror.

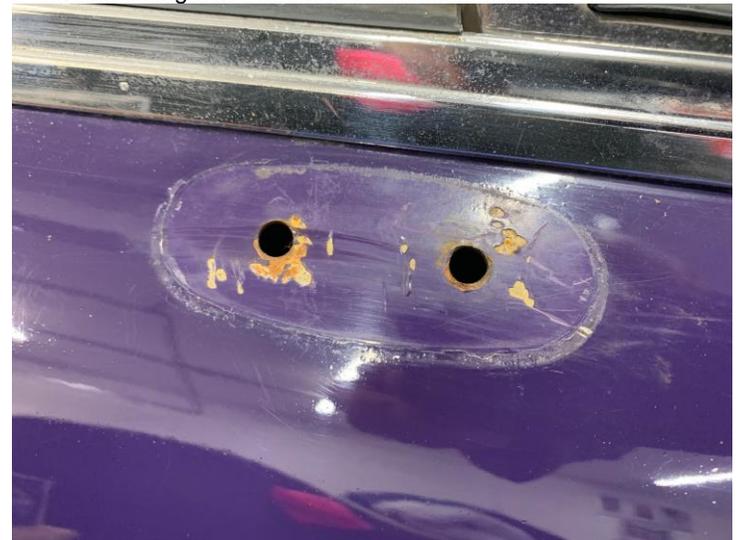
4. The door lock surround is in two pieces which can be pushed apart. The upper surround needs to be fed carefully over the trim strip to avoid damage.
5. With all of the components taken off, the door card can be removed. It is held in place with a number of plastic push-on clips. In my case, finger pressure around the edge of the door was adequate. It may be necessary to use a lever of some sort. Whatever it is, some padding may be needed to prevent damage to the door paint.
6. The final layer is a plastic sheet used to form a waterproof barrier between the door card and the door inner. It is glued in place. Careful removal will allow it to be reused.
7. Repair any damage and corrosion. In my case, the rust around the mounting holes needed to be addressed.

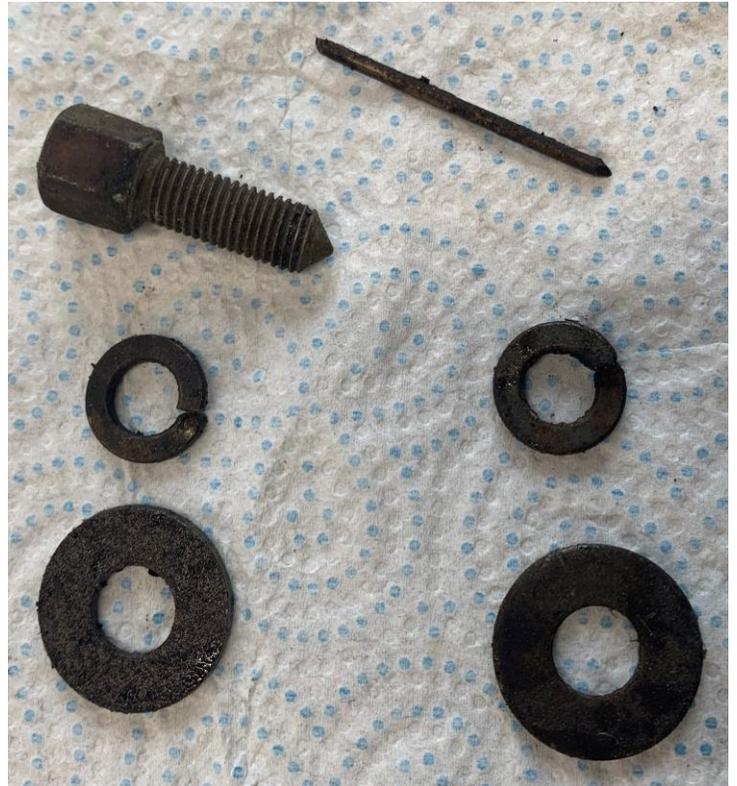
Footnote – Peter adds the items in the photo above are the debris he found when he was working in the nearside door. Clearly the assembly line worker was having a clumsy day!
