Rebuilding an MGBGTV8 – Damask 0450 (Part 23 of a series of reports)

(7.6.10)

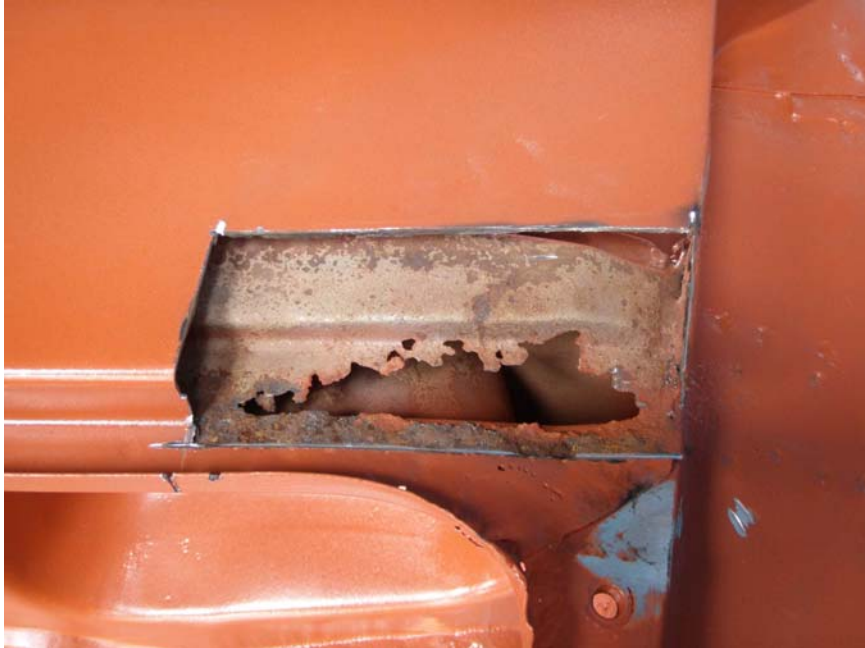
The end is in sight. However, when preparing Damask 0450 for priming and painting, one last area of rust became apparent. An internal stiffener had corroded, just above the nearside bonnet hinge. Unfortunately, this area is only accessible from outside, so a small area of good metal had to be removed in order to access the problem. I attach a series of photos showing how it was done.

Top left: corrosion exposed by cutting out an access hole.

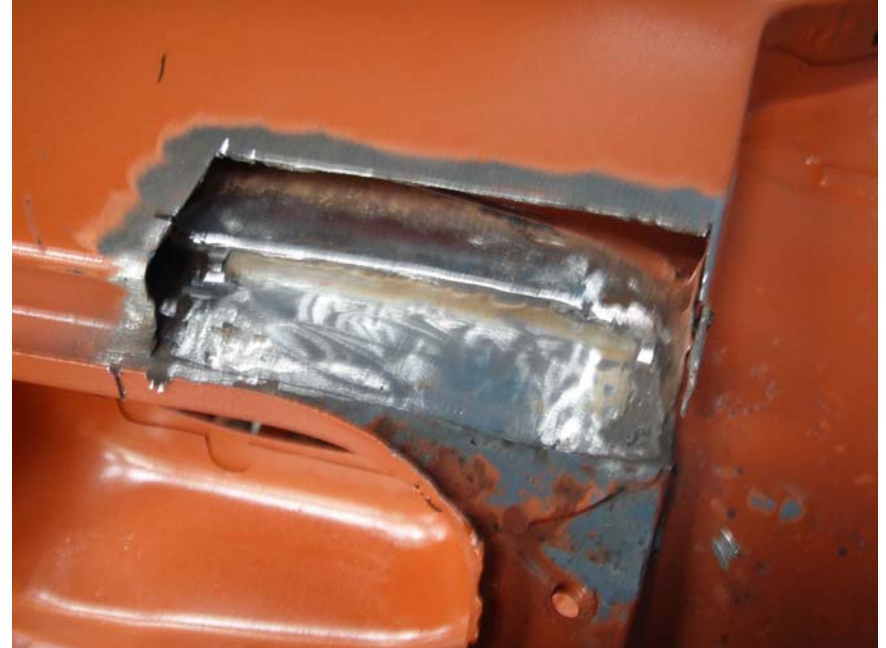
Top right: corrosion dealt with.

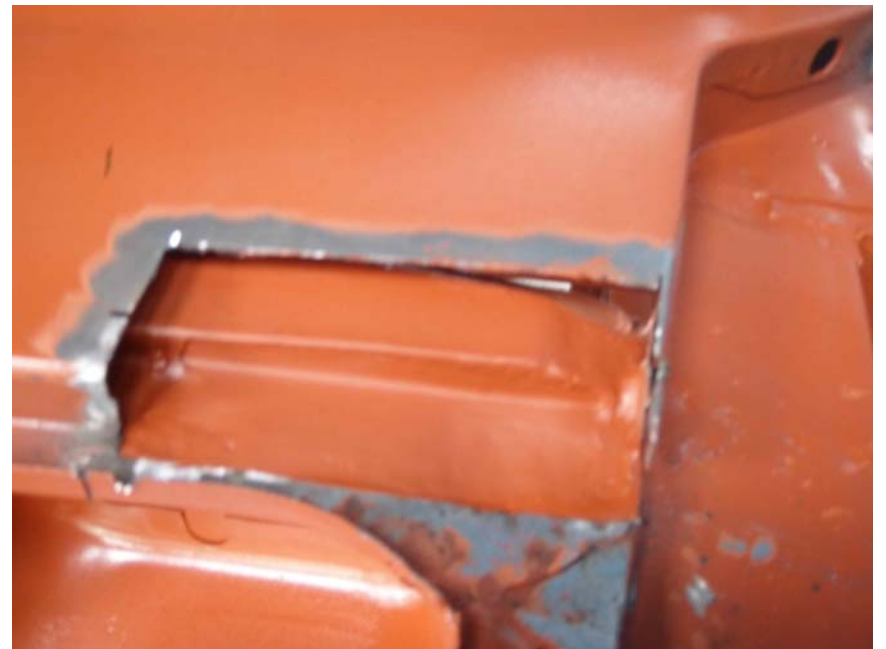
Bottom right: inner repair painted.

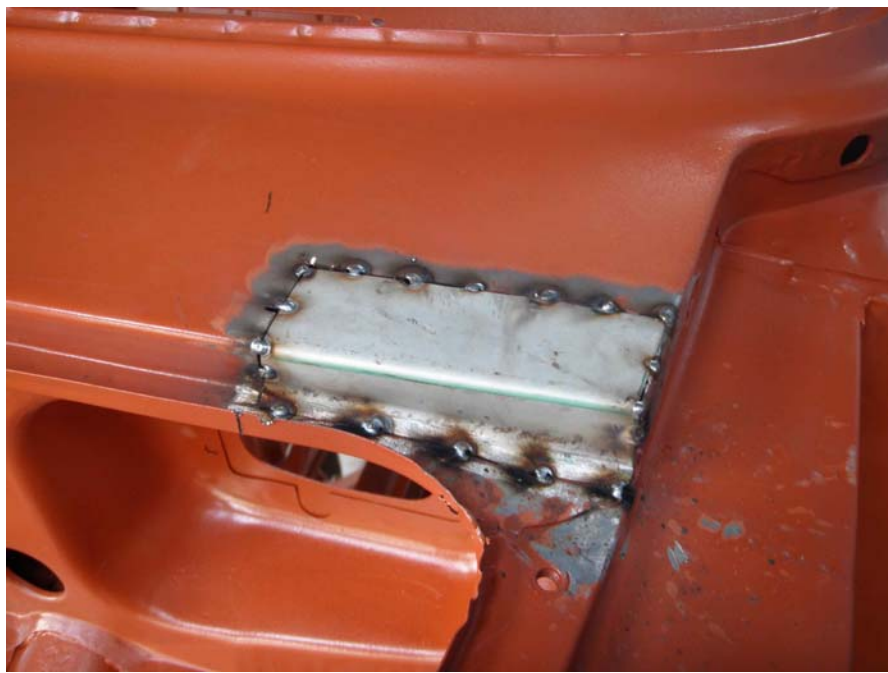
Above: metal panel welded in.

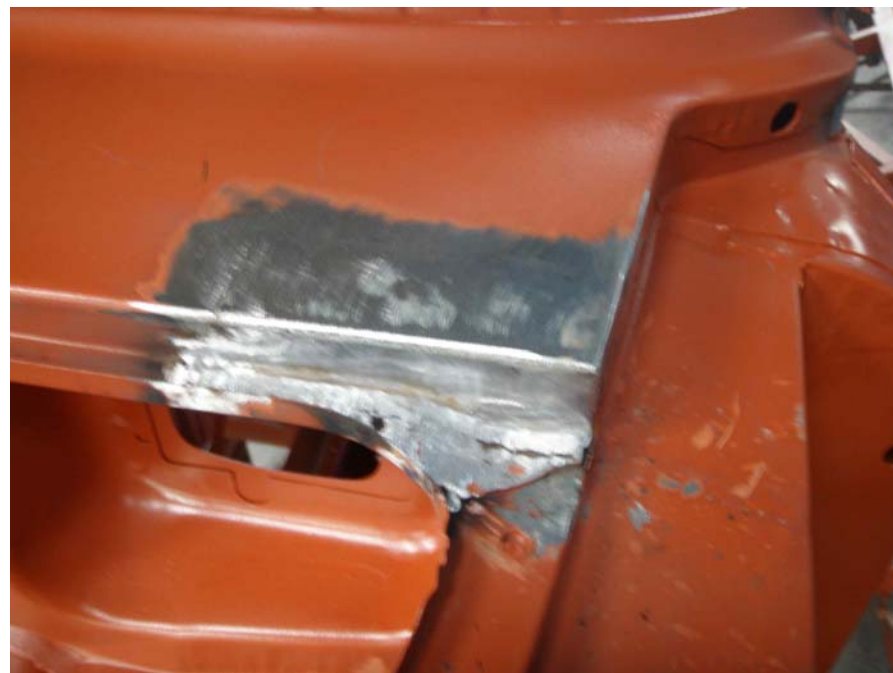
Above: repair panel made good ready for painting.
