Rebuilding an MGBGT V8 – Damask 0450 (Part 32 of a series of reports)

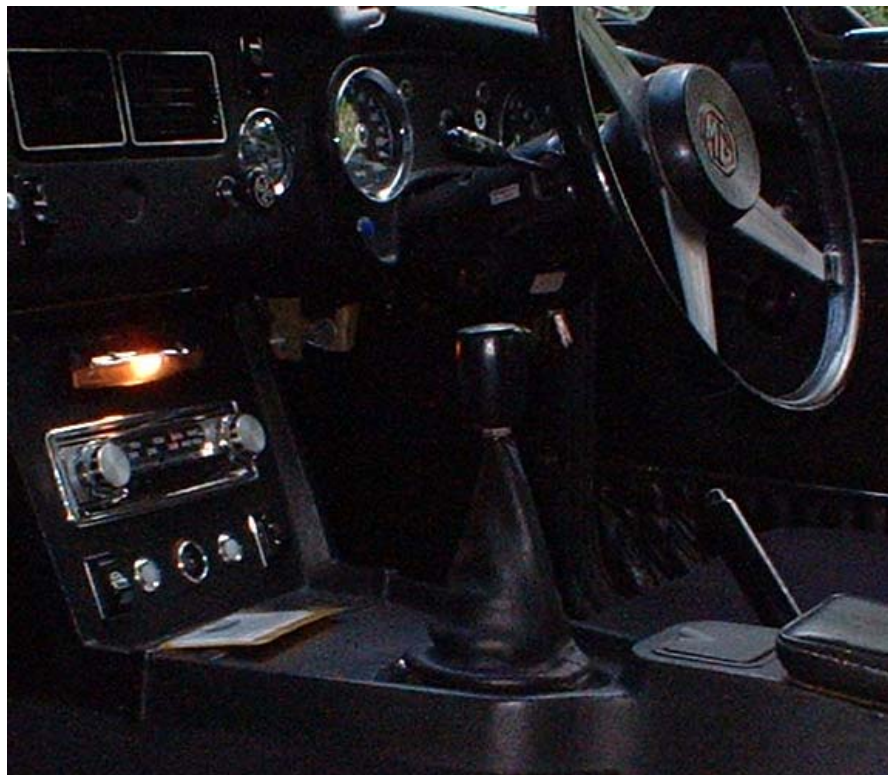
Take care when refitting the gearbox crossmember – it's got a left and right side!

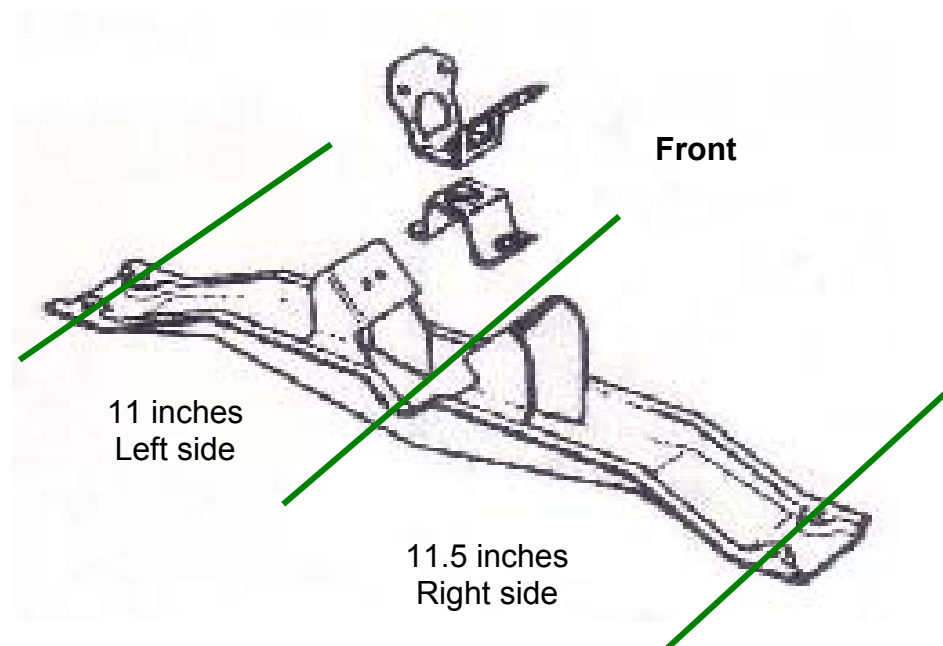
Fortunately he has an inspection pit, so he was able to measure the width of the removable crossmember that supports the rear of the gearbox. Lo and behold, it is not symmetrical. To the left of centre it was about 11 inches, but to the right it was more like 11½ inches, so there was half inch difference, the source of the misalignment Barrie had seen from inside the car. During the rebuild the crossmember had been fitted with the shorter side on the righthand side, so Barrie needed to refit it.

Gearbox crossmember AHH8430 with the lower gearbox bracket AHH8432 above and the top bracket AHH8431 above that.

He supported the gearbox on a jack, spreading the load with a block of wood. He then removed the cross-member and re-fitted it the other way round. This is quite a fiddly job because the speedometer cable and the exhaust pipe both need to be

disconnected, and the tie-rod mechanism is only just accessible using a ¼ inch drive socket.

Climbing back into the car Barrie was delighted to find that the gearknob was now central in the chrome ring – problem solved.
