Rebuilding an MGBGTV8 – Damask 0450 (Part 11 of a series of reports)

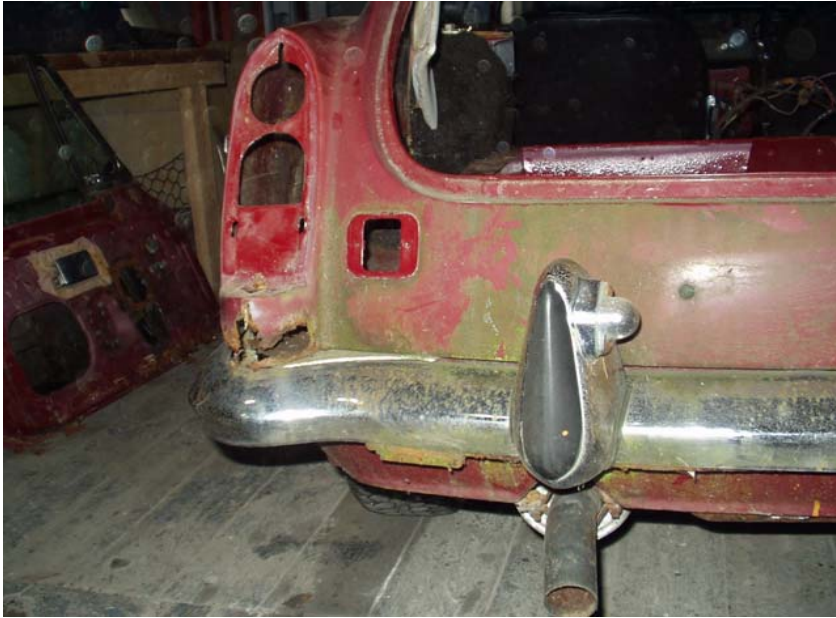
Rear nearside wing was badly rusted out around the tail lamp, particularly below the light fitting

At the rear of Damask 450, the wing was found to be badly rusted around the tail lamp. After removing the bumper and cleaning up, more rust was found underneath the lamp, all the way along the edge where the alloy trim panel was attached. Unfortunately, this panel is only available if you buy a complete rear wing including the 'C' post, and they cost more than £400. Since a full outer rear wing (to the beading) only costs £72, I searched around for an alternative.

There are breakers that specialise in the MGB, and I found one who was willing to cut the necessary panel from a GT that he was breaking, for only £25 plus postage. It was Andy Jennings MG Spares at Curbridge in Hampshire. I have known Andy for 20 years, and have always found him willing to help in any way he can. Highly recommended.

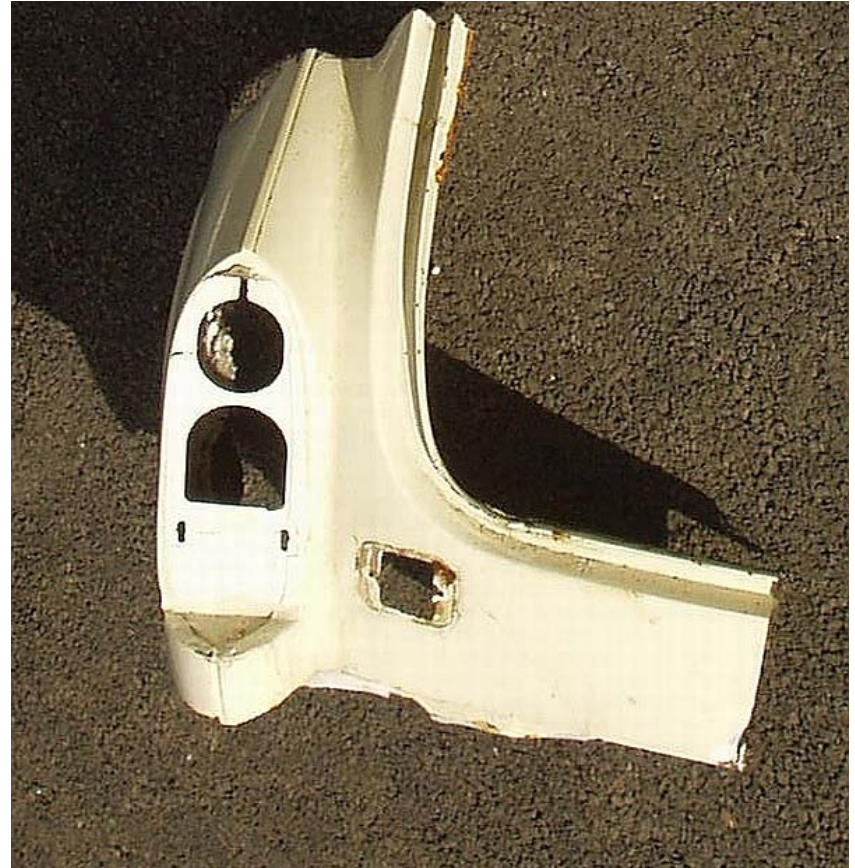
Rear wing section that Barrie obtained from a breaker for £25!
