Rebuilding an MGBGT V8 – Damask 0450 (Part 12 of a series of reports)

Separating the overdrive unit from the gearbox

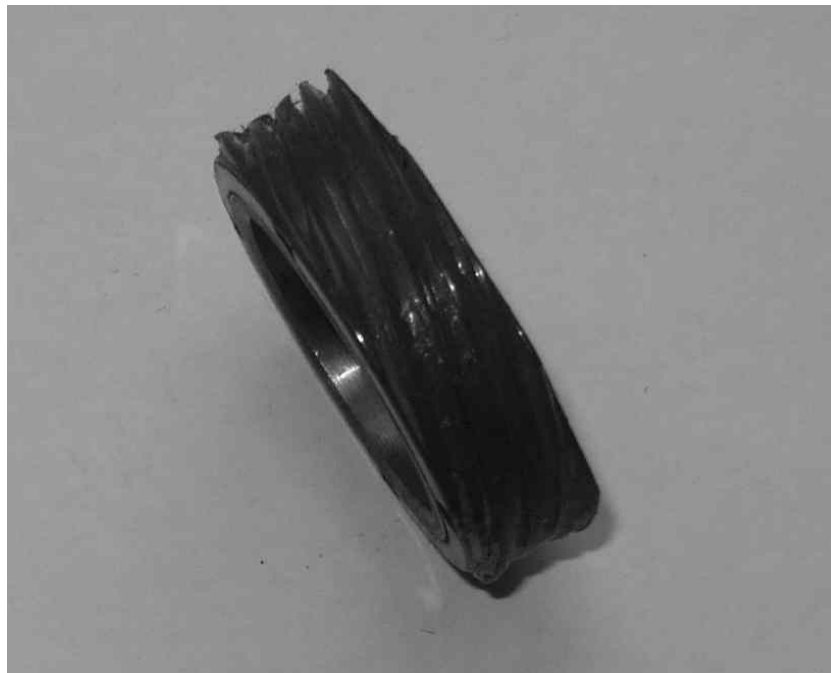
I also inspected the speedometer gears, which are located at the rear of the overdrive. They consist of a small nylon pinion gear (which is easily removable) and an internal nylon speedometer drive gear (which is not). Why on earth they didn't make the internal gear of metal I have never fathomed. If the speedometer cable gets kinked and difficult to turn, these gears invariably strip their teeth, and fitting a new pinion gear by itself will not cure the problem. Alongside is a photo of a stripped speedometer drive gear:

Photo of a stripped speedo gear. (Barrie Jones)
