Rebuilding an MGBGT V8 – Damask 0450 (Part 15 of a series of reports)

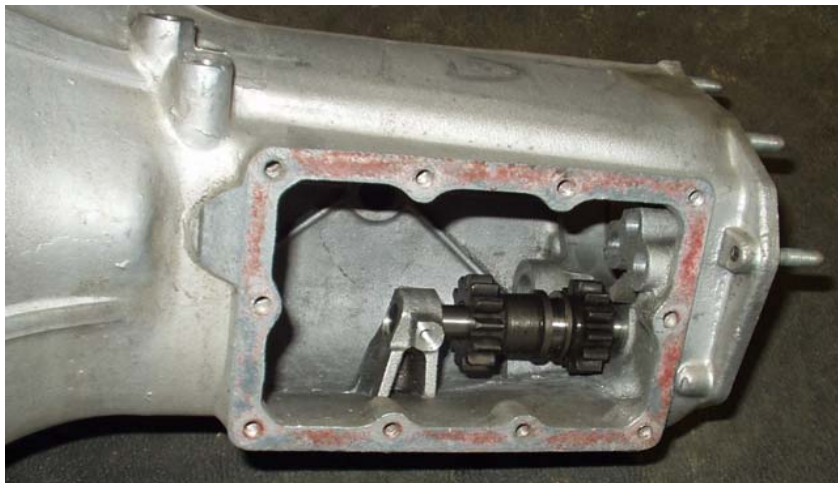
I have taken a photo of the main casing which clearly shows a weak point. Looking through the side access plate you can see the support pillar for the reverse gear shaft. Notice how it attaches to the bottom of the casing. During my training as an engineer, I was taught that there should always be a radius at such joints. The larger the radius, the less likelihood there is that the joint will fracture. So far as I can see, there is no radius at all, so the local forces would be extreme.

I have seen several V8 gearcases with hairline fractures on the outside, corresponding to the location of the support pillar on the inside, and my local MG specialist assures me that he has seen a few where the entire pillar has ripped out, complete with part of the casing. I intend to get a local specialist to provide fillets of alloy weld around the base of the pillar to provide additional strengthening.

Main casing which clearly shows a weak point. Looking through the side access plate you can see the support pillar for the reverse gear shaft. Notice how it attaches to the bottom of the casing.

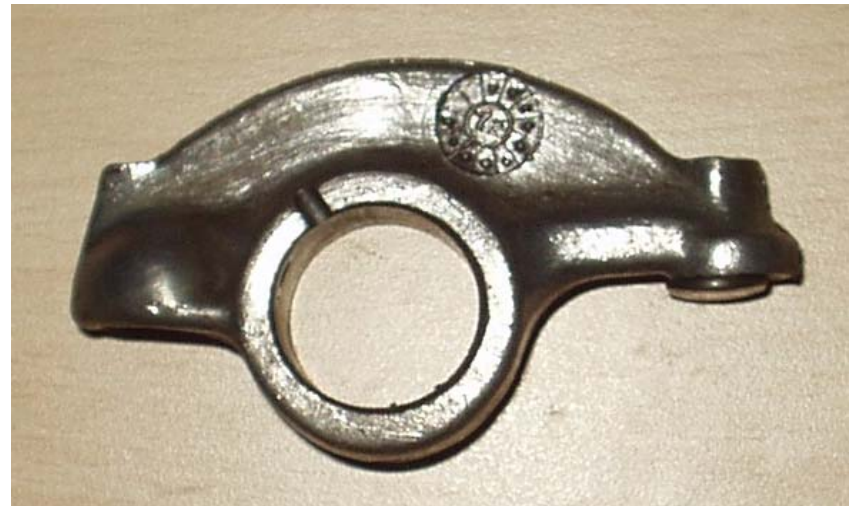
rockers. Everything was covered in a thick black deposit, so I can only assume that this engine has not enjoyed regular oil changes.

After cleaning the rockers, I took the following photo, which clearly shows a date mark. There is a circle with the number 72 inside it, and around the edge there are 12 segments, like a dartboard. Ten of these segments have a dot inside, which tells me that these rockers were made in October 1972. This gives me an indication of when the engine was built, just about right for a car made in the Spring of 1973.

Rocker with circular date mark.

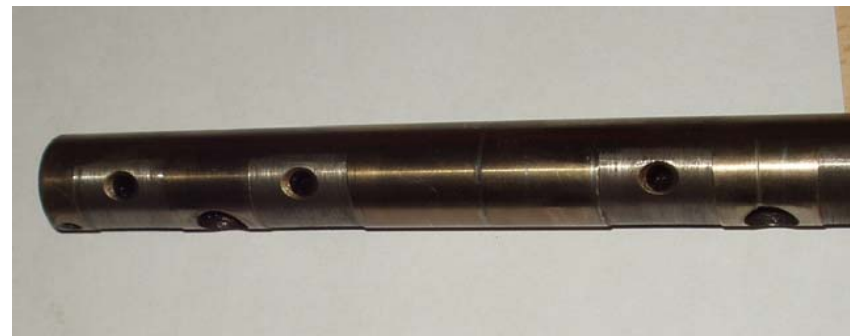
The following photo shows the rocker shaft. You can clearly see where the rockers have worn a deep groove into the base of the shaft. Obviously, the shafts will have to be replaced.
