## Rebuilding an MGBGTV8 – Damask 0450 (Part 16 of a series of reports)

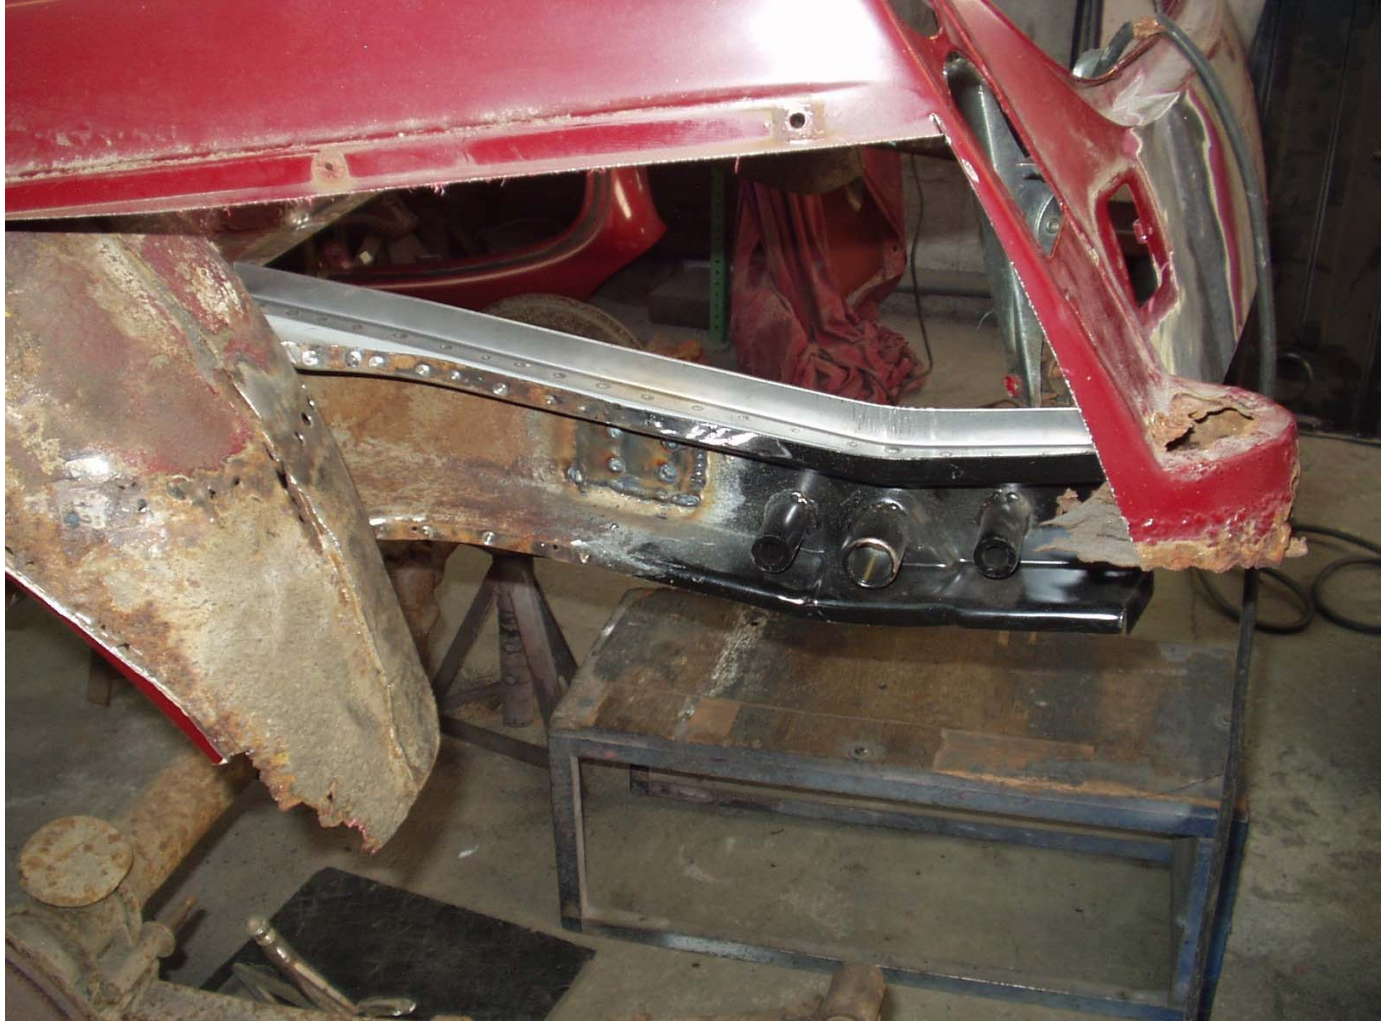
An earlier wire brushing revealed several rust holes in this section. Also, one of the bolts holding the rear bumper iron could not be removed, so it was cut off, leaving part of the bolt inside the old chassis rail.

Here we see a repair section of chassis rail has been inserted, a new top rail has been fabricated, and a plate has been inserted to reinforce the join.

From the photo, you can see that this is a chrome bumper repair panel. There are 3 tubes, two for the rear bumper iron, plus a third for the rear spring shackle.

These repair sections come as an inner and an outer, so the next step is to weld the outer closure panel in place.
