## Rebuilding an MGBGTV8 – Damask 0450 (Part 17 of a series of reports)

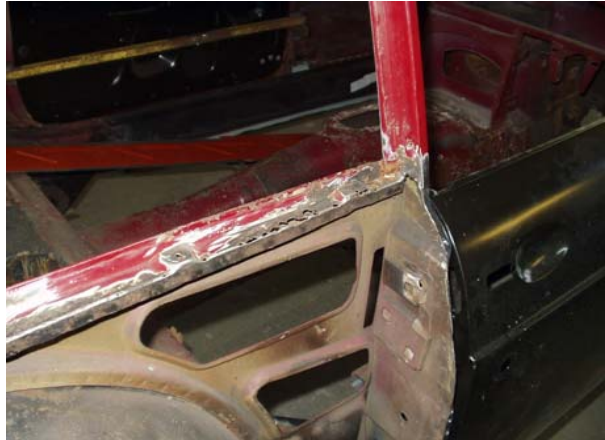
When cleaning up the surround for the rear quarter light, it became obvious that the panels were holed in several places. The small panel underneath the window is not available separately, so I have had to get a specialist MG breaker to cut this part out of a scrap GT.

**Under OSR window** - the area behind the rain channel is also a common rust area, and this one proved to be no exception.

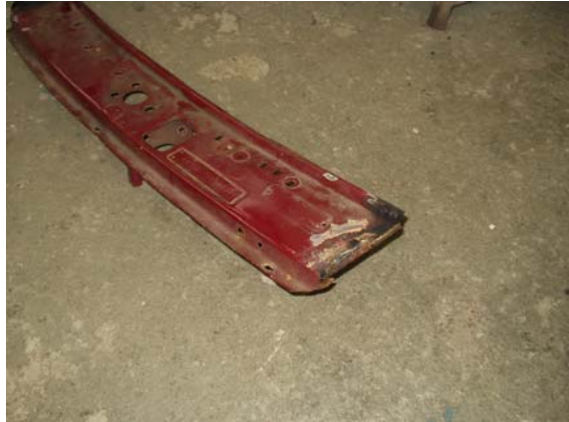
**Front slam panel**

There is some evidence of accident damage to the nearside front of the vehicle, and when the bonnet slam

panel was removed, it was found to be attached by brazing, not welding.

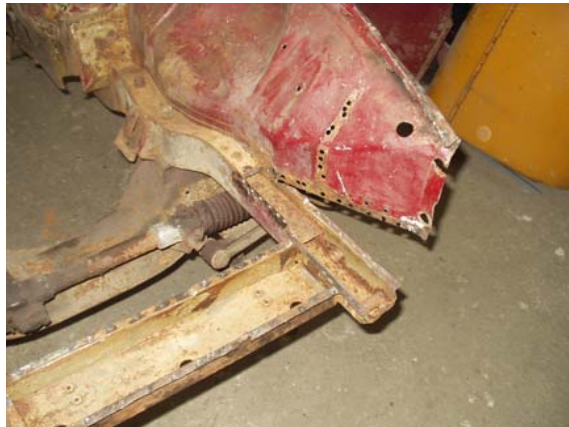
**NSF radiator duct panel removed**

The radiator duct panel underneath this was also badly buckled, so a new one will be fitted. Here we see the space below this panel, with the front cross-member visible. Note the two pairs of captive nuts inside. It appears that 1973 V8s were already receiving a modification that would not appear until rubber bumpers arrived in September 1974 – moving the oil cooler underneath the crossmember.

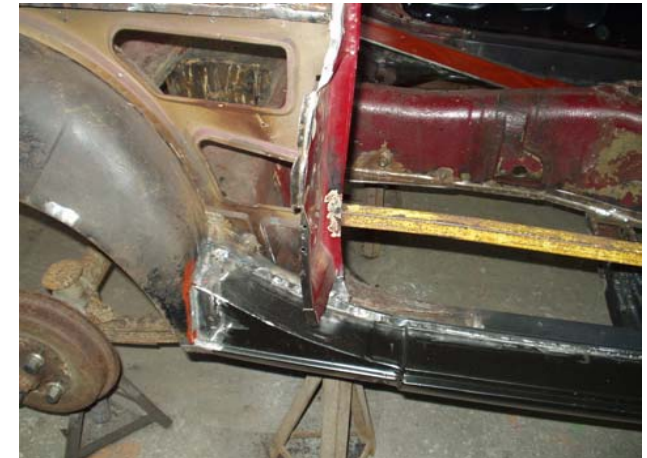
**New OS sill extended**

As work now begins to fit new panels, the quality and fit of the replacement panels has been found to be fairly poor. For example, a genuine Heritage outer sill

panel needed to be cut and extended by approximately 40mm because it was too short.

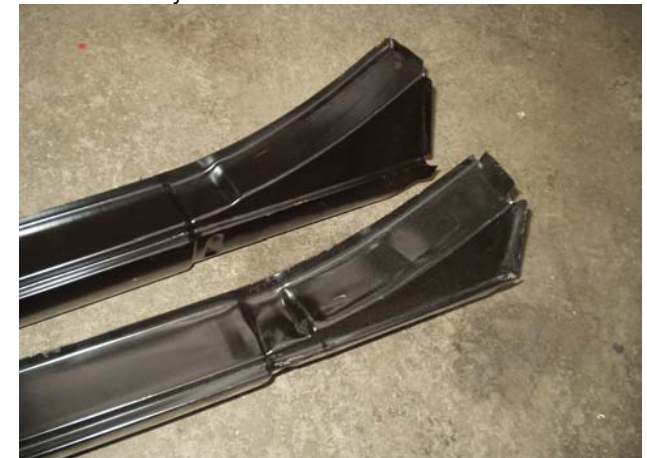
**Sill panel quality**

On the other side, things were even worse. I bought a sill which was not a genuine Heritage panel, and it was 5mm shorter again. Not only that, but the pressing was poorly done and mis-shapen. I have now bought a genuine Heritage panel, and placed them alongside one another. Here you can see the difference.
