## Rebuilding an MGBGTV8 - Damask 0450 (Part 18 of a series of reports)

www.v8register.net 190209 Damask 0450 rebuild report 18 Photos: Barrie Jones 1

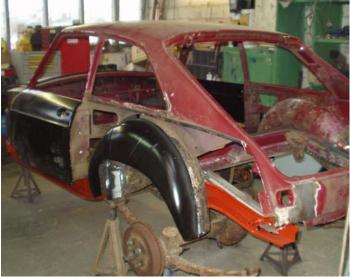
The new doors have been hung in order to provide a reference point for the outer sills, and the inner wheel arches have been welded into their final positions.

The rebuild begins

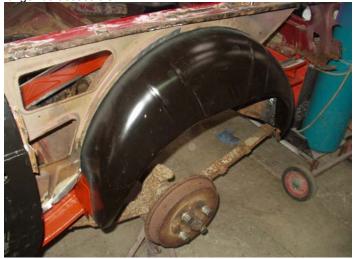
Note that the inner sill panels and the rear chassis rail have been given a good coat of rust inhibiting epoxy primer. Once the next layer goes on, these panels will no longer be accessible.

New NSR wheel arch
