## Rebuilding an MGBGTV8 – Damask 0450 (Part 19 of a series of reports)

### The rebuild resumes

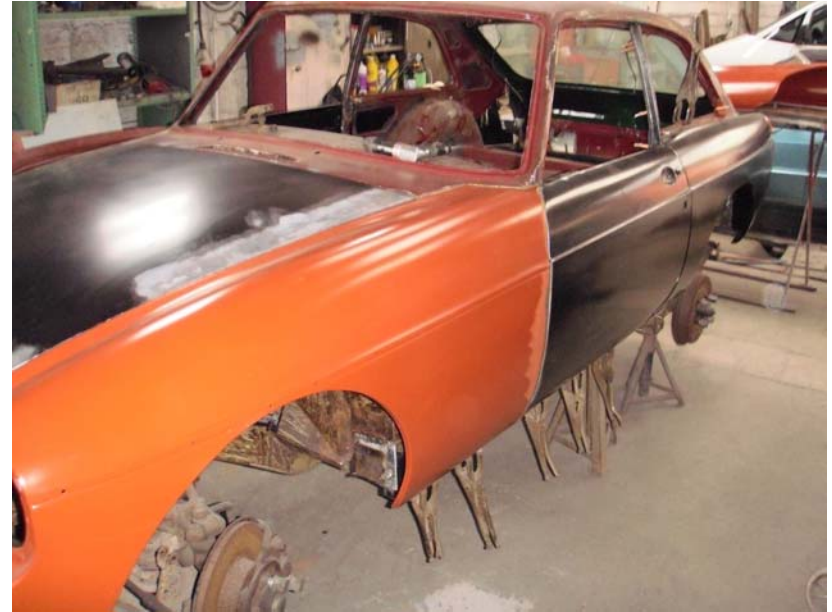
Above: all the non-structural panels (doors, wings, bonnet and tailgate) have been test-fitted and the panel gaps adjusted to suit. Below: bonnet after fettling.

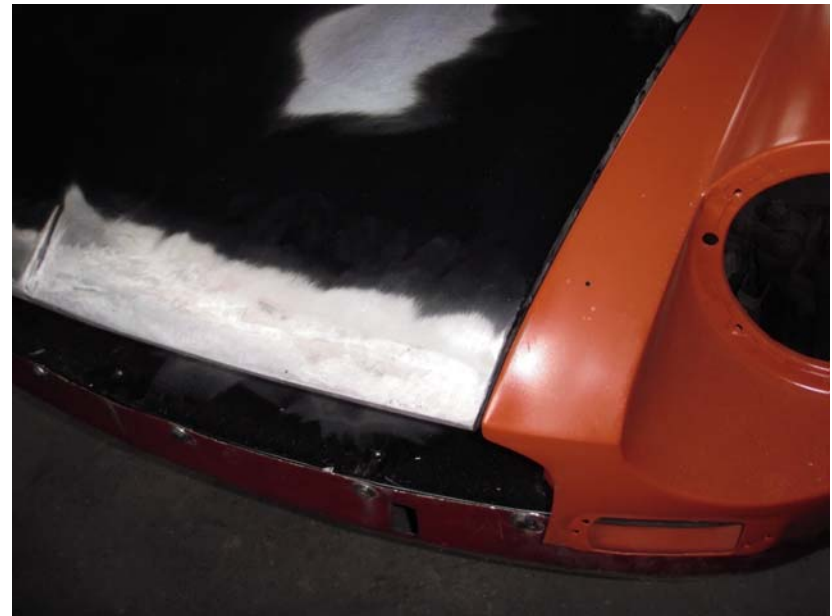
The bonnet was a particularly poor fit. It needed to be lengthened by 10mm, and one side needed to be straightened in the centre by 4mm. This was done the same way that a plasterer makes an edge in a house wall. First, the correct shape was outlined with a rod of welding wire. This was tacked into place and used as an edge, the gap being filled with molten lead. The lead was then cut back with a metal plane, so that only a very light skim of filler will be needed.
