## Rebuilding an MGBGTV8 – Damask 0450 (Part 7 of a series of reports)

This is the seventh report from Barrie Jones, part of a series on his major rebuild of Damask 0450.

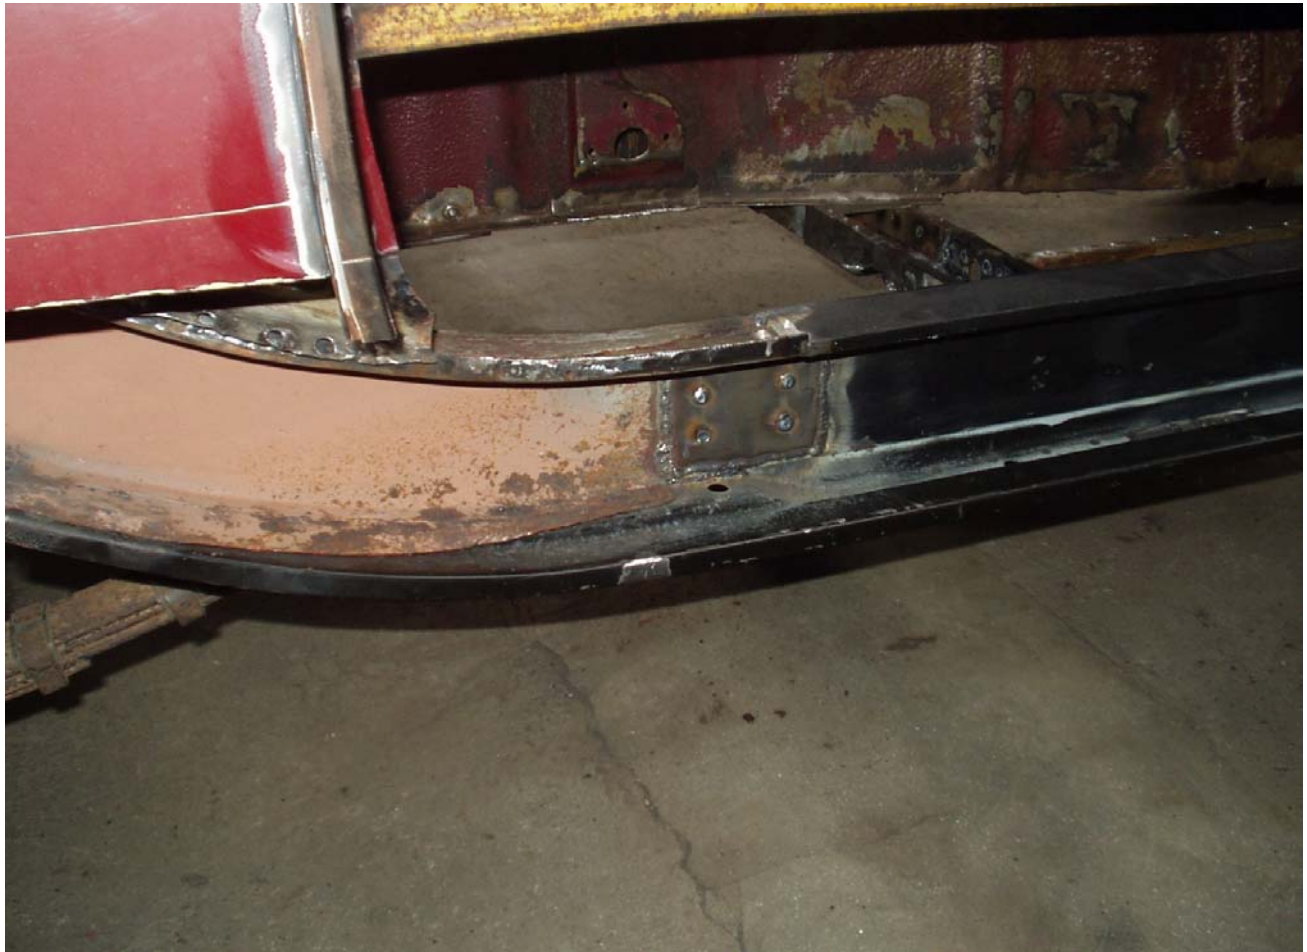
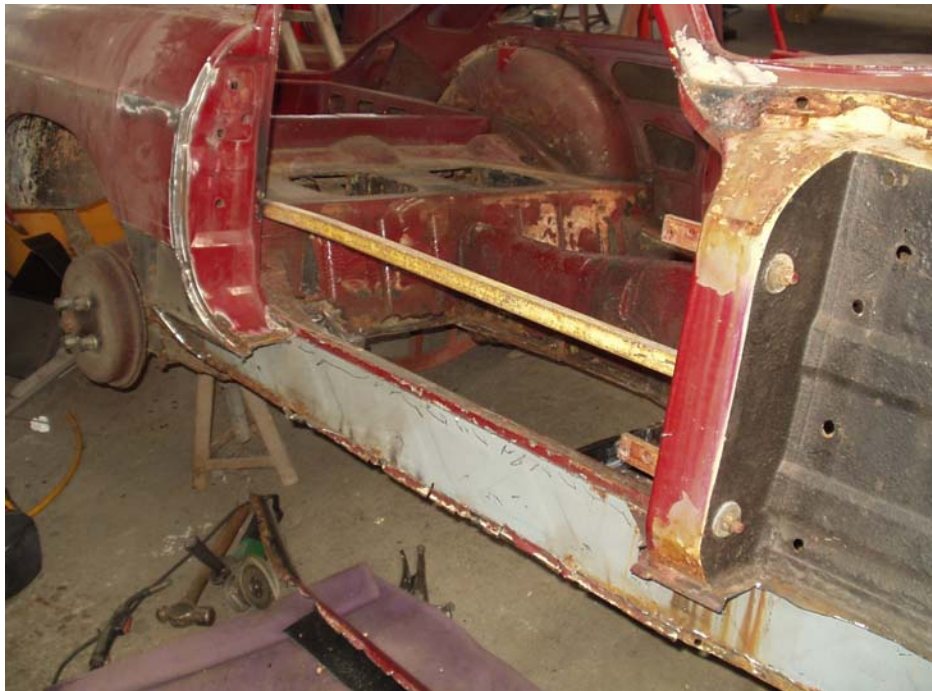
The driver's inner step sill was holed in two places, so it needed replacing. There is a repair section available that is 4 feet long and avoids the need to remove the rearmost part. However, this does require a butt weld, which would create a weak point. In order to overcome this, a strengthening plate has been welded over the join. This completes the preparation of the driver's side, prior to sand blasting.
