Rebuilding an MGBGTV8 – Damask 0450 (Part 8 of a series of reports)

This is the eighth report from Barrie Jones, part of a series on his major rebuild of Damask 0450.

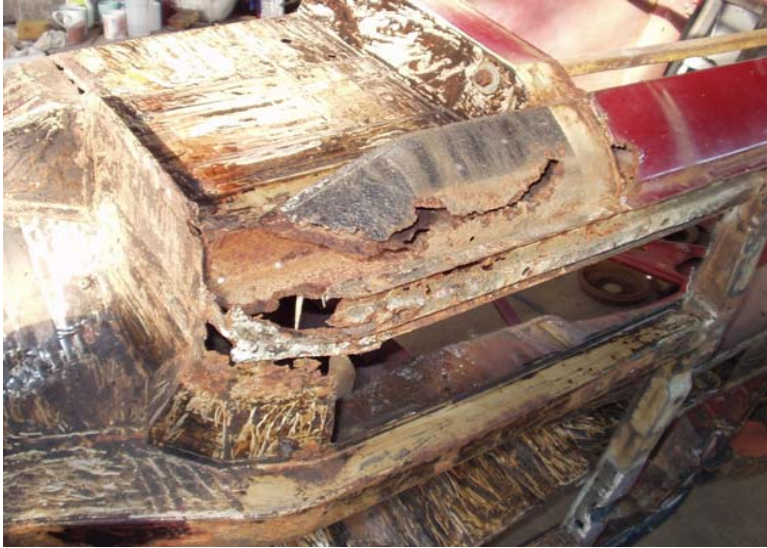
Turning my attention to the passenger side, I wondered if it would be a repeat of the driver's side. However, it had a few surprises in store. Another steel bar has been inserted across the door frame as a temporary measure, in order to preserve the rigidity of the shell, after which the floor pan has been cut out. Behind the front wing, both the sill and the castle section have corroded badly - far worse than it seemed before the wing was removed.

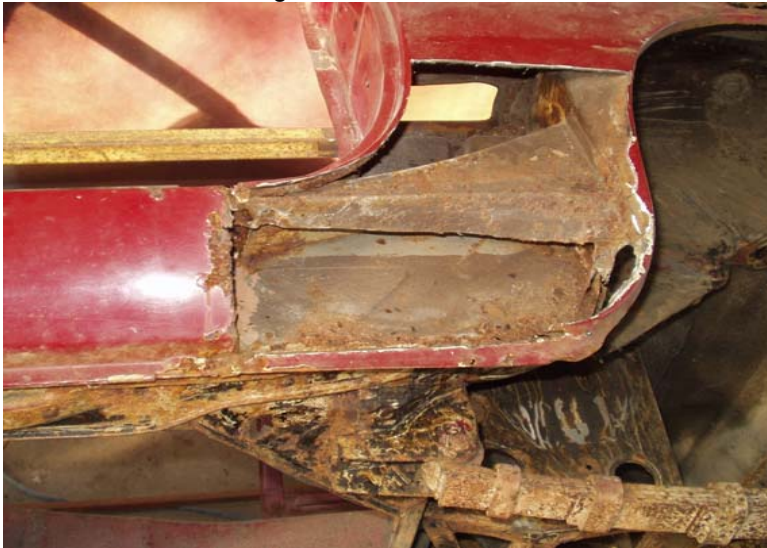
In order to insert a complete new outer sill, it is necessary to remove a small section of the rear wing. This revealed that the rear part of the sill had been cut away but not replaced when the sill was previously repaired some years ago.

It is not unusual to find poor repairs hidden behind the wings. This was an example of very bad practice, because it seriously weakened the structure of the entire vehicle. The front spring hanger reinforcement plate looked sound, but one tap with a small hammer was all it took to put a hole in it.
