## Rebuilding an MGBGTV8 – Damask 0450 (Part 9 of a series of reports)

This is the ninth report from Barrie Jones, part of a series on his major rebuild of Damask 0450.

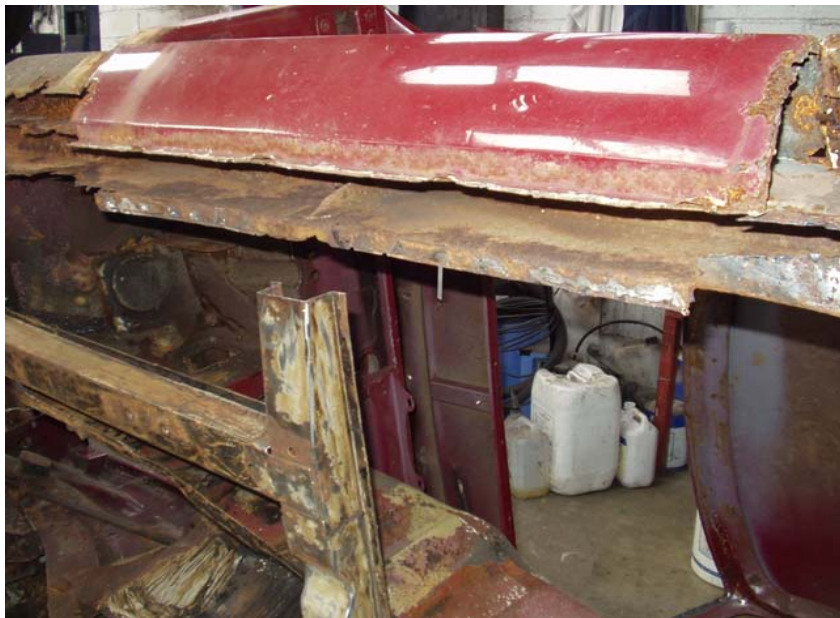
The floor has been removed from the nearside, along with the remains of the jacking point. Where it meets the inner sill, the cross-member was found not to be sound, needing a small repair at the very end.

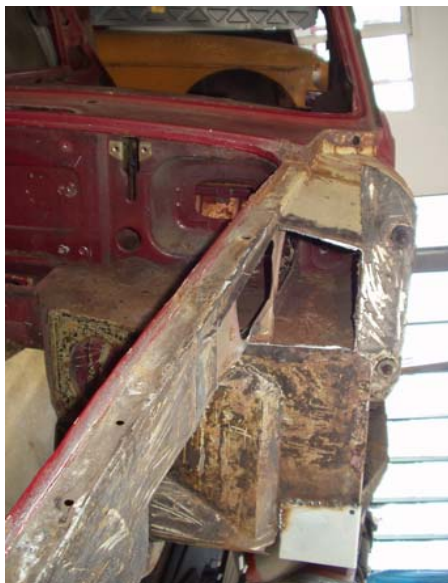
As usual, the wing reinforcement panel (which I usually refer to as a 'trumpet') was in need of replacement. Normally, this panel rots out at the top where mud from the front wheels is thrown up. However, in this case it was rusted out at the bottom with urine, where a mouse had made a nest.

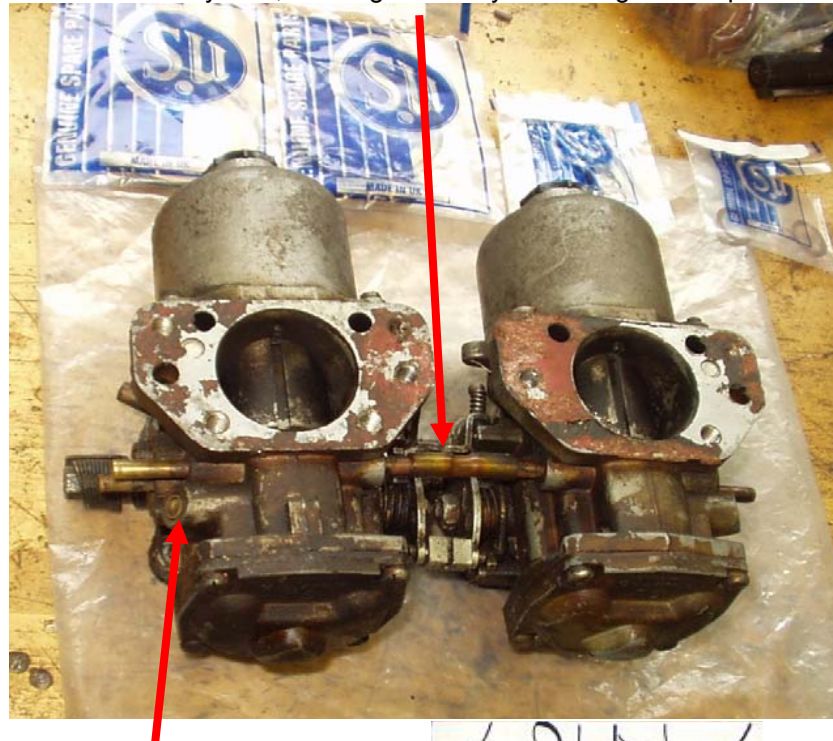
The car has been standing for 10 years, so all the fuel system components require cleaning, inspecting for wear, and replacement of seals and gaskets. The SU carburettors in the following photo show two items of interest.

Also, the **short fuel hose** between the carburettors has been replaced with a length of clear plastic hose. This was merely pushed on, with no hose clips. I regard this as a very dangerous bodge, because it could have failed at any time, flooding the valley of the engine with petrol.

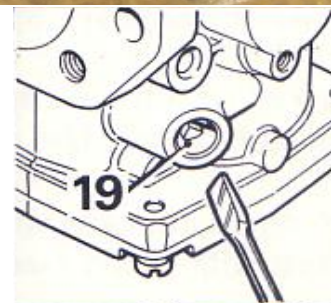
Diagram from page 59, MGBGTV8 Driver's Handbook AKD8423

The **mixture adjustment screws are still covered with tamper-proof caps**. This was probably done to all new V8s before they left the Factory. After I fit new jets and needles I will have to remove these caps in order to adjust the mixture.
