WELCOME TO THE V8 NEWSLETTER

MGBTV8 – Gearbox Remote Control Housing repair of a stripped thread

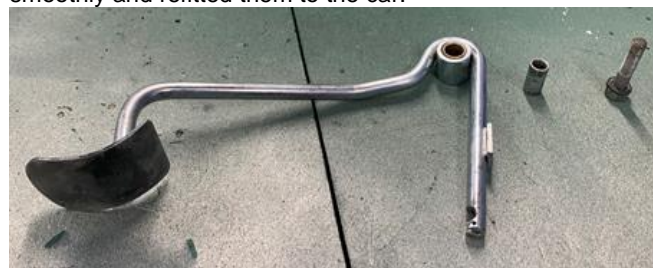
Once removed, the bearing surfaces can be examined. As can be seen from the next photograph, the system comprises pedal, bolt and roller. The components are over-specified when compared with the load they need to carry. As a result, there was no noticeable wear. Having said that, the car has covered only 39,000 miles so there may be some wear on vehicles with a higher mileage. When cleaned, I applied some light grease to the rotating parts, ensured they rotated smoothly and refitted them to the car.

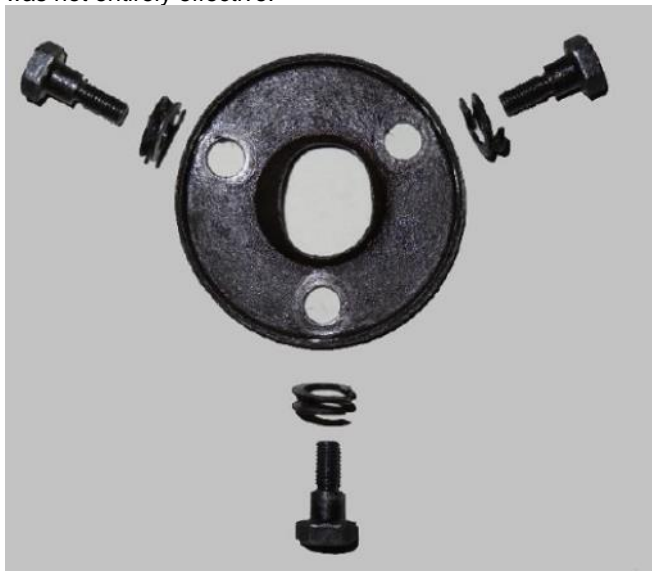
The **first feature** is achieved by securing the gear lever ball by a cover plate fixed to the housing by three shouldered bolts. A consistent clamp load is achieved by assembling with double coil spring washers (commonly known as thackeray washers – see Appendix 2). As the shoulder diameters are smaller than the holes in the cover plate the clamping load on the latter is determined by the stiffness of the spring washers and their level of compression (see Appendix 1). It was the tapping for one of these bolts which had stripped and required repair.

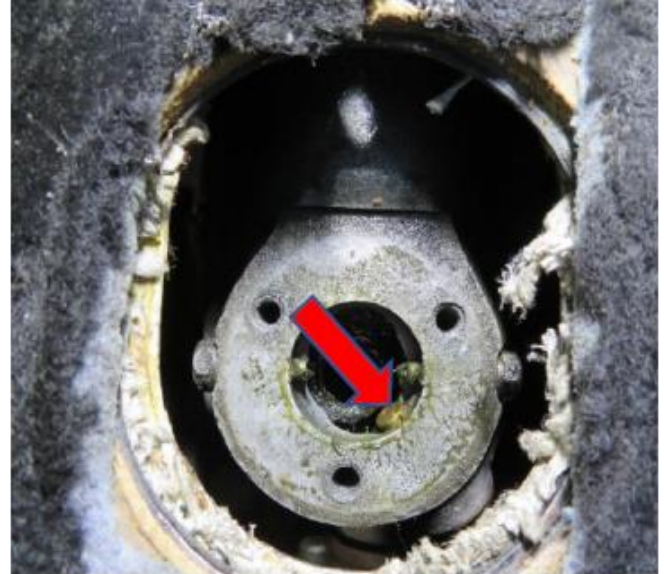
The **second feature** is not directly associated with the repair but was revealed when the gear lever was removed. It takes the form of a hollow brass plunger which with its attendant spring is fitted in a threaded housing at the five o'clock position relative to the lever aperture. The blind end of the plunger bears on the lever ball and helps attenuate vibration. Apparently, this is frequently missing as it has the habit of springing out when the lever is removed and is worth replacing.

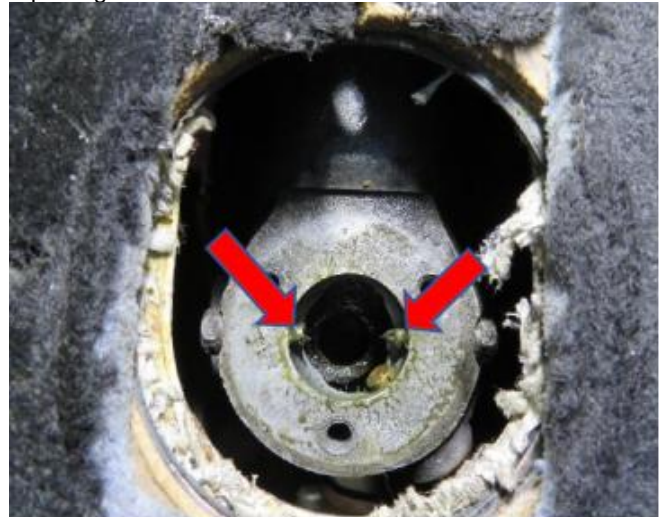
The **third feature** comprises two pins (highlighted above) screwed into the housing at the three and nine o'clock positions. Their function is to control the movement of the gear lever which they do by engaging their dog points in opposing slots in the lever ball.
