REGISTERS

V8

RV8 Exhaust Clamp Clash with Front Tyre – Safety Issue!

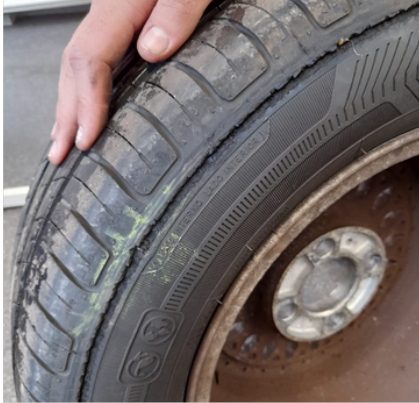
Peter Berry reports “a good friend of mine recently had his RV8 fail the MoT test on account of the front offside tyre being worn down to the cords from a cut into the side wall. It seems that an exhaust bracket had been fouling the inside wall with the steering wheel on a right-hand lock. A blowout could have been quite imminent with disastrous consequences had this not been picked

up. The exhaust clamp has now been loosened, rotated and retightened to prevent further damage and a new tyre fitted. The photo shows the extent of the cut into the tyre wall.” Peter was interested to know if anyone else has come across this on an RV8.

Peter believes all RV8 owners need to be made aware of this safety risk and carry out an inspection to check if a non-original replacement exhaust pipe, with clamp, has been

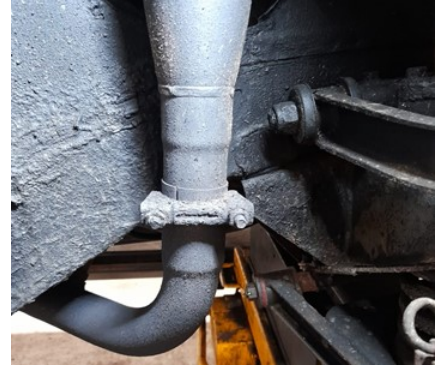
After- market replacement part:

An RV8 servicing and parts specialist reviewed the photo of the exhaust downpipe and commented that this clamp indicates that the manifolds fitted to that RV8 are aftermarket items. With the original part the downpipe is part of the manifold with no clamp where it passes through the inner wing opening. Another RV8 servicing specialist reviewed the photo of the RV8 exhaust pipe clamp and commented “the exhaust should be a single piece on each side from the manifold back to the straight lower section. Apparently, they are difficult to obtain these days and require a fair degree of patience to fit - which is why the jointed version has become so much more preferable”.
