V8

RV8 rear lamp repair

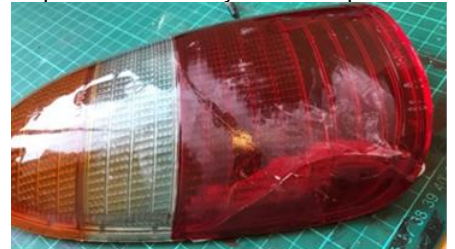
Aidan says the photo alongside shows the damage to the tail light with some parts dislodged – fortunately I was able to collect all of them. On inspection I found that some of the parts needed to be fitted from inside the light. There was also a reflector inside the light that had become dislodged, therefore I needed to take the light apart.

To get the lens off the main body of the lamp unit, I needed to remove the mushroom ends of the red plastic pins while trying to retain as much of the pin as possible. I used a Dremel with a bur tip. Not all the pins survived but I was able to disassemble the light. I initially tried gluing the broken parts together with super glue. However this proved to

be problematic because the parts would not fit together neatly and the cracks were highly visible. On closer inspection I found the parts didn't fit together well. This is because when the plastic breaks it tears and stretches, as a result the mating edges don't match. Therefore I needed to trim some of the pieces to get a better fit. Unfortunately this did leave some gaps.

I put the super glue aside and found that the better solution was plastic hobby glue. But there were gaps which I filled with a red material which once hardened I wet sanded with grades of grit paper. I followed this up with polishing compound until I was satisfied with the look. Cracks are still visible but it was looking much better. The last step was reassembly of the lamp unit.
