MGV8 sump gaskets

A thread on the V8 Bulletin Board in May 2016 discussed the suitability of several sump gaskets for the RV8. One contributor, Tony Lake, mentioned how a problem with the pressed steel sump is the light steel section used. He noted "the V8 sump is one of the best candidates I've seen for leakage, along with the valley cover". He then mentioned he had some sketches of the stiffening pieces he had made to overcome the problem and solve the leaks.

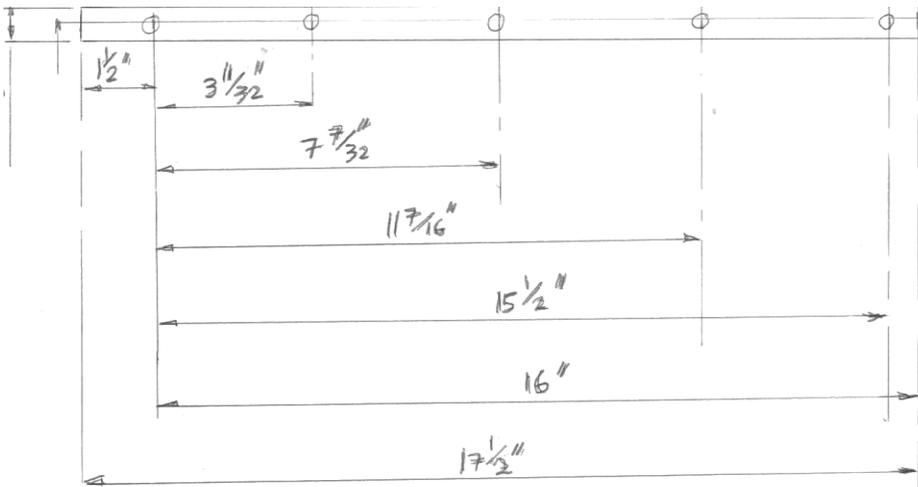
5 HOLES $3/8"$ ϕ .

2 OFF! STIFFENING STRIP MADE FROM $1/4 \times 3/16$ M.S OR NEAREST.

$1/2$ SCA

Oil leaks from the sump leak are generally caused by distortion of the pressed steel sump and/or overtightening of the bolts. When a leak occurs the natural reaction is to tighten the bolts, this distorts the sump further and tends to increase the leak. The solution is to remove the sump and clean any sealant off and correct any distortion of the joint face before reassembly with a gasket or sealant – but not both.

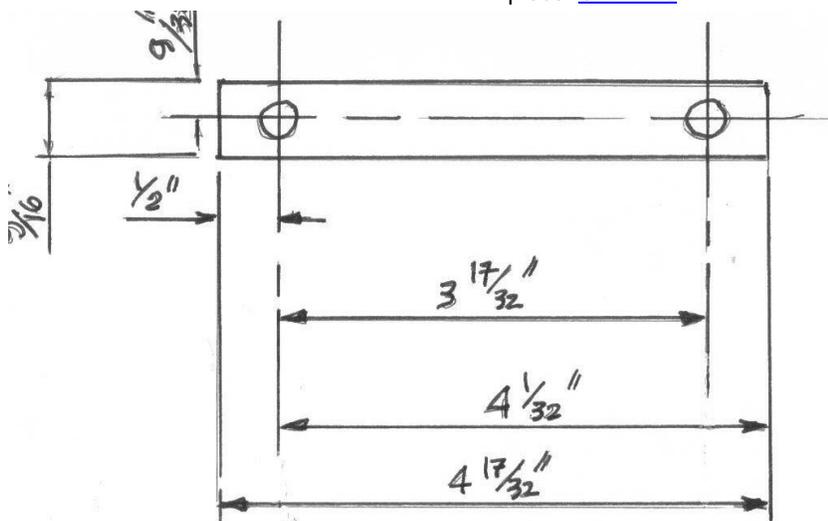
2 x HOLES $3/8"$ ϕ .

FULL SCALE

LONG STIFFENING STRIP MADE FROM $1/2" \times 9/16"$ M.S OR NEAREST

I built another 3.5 engine for my Factory MGBGTV8 five years ago. A local machinist made up some longitudinal stiffening pieces to fit inside the sump flange, just like the stiffening piece that fits at the rear of the sump. I used 0.25"x .56" mild steel strip. That allows 0.25" longer bolts to be fitted which provides more stretch for the same torque and gives a bit more margin to deal with the different rates of expansion of steel and aluminium.
