MGBGT V8 – confirming the position of the Top Dead Centre Identification

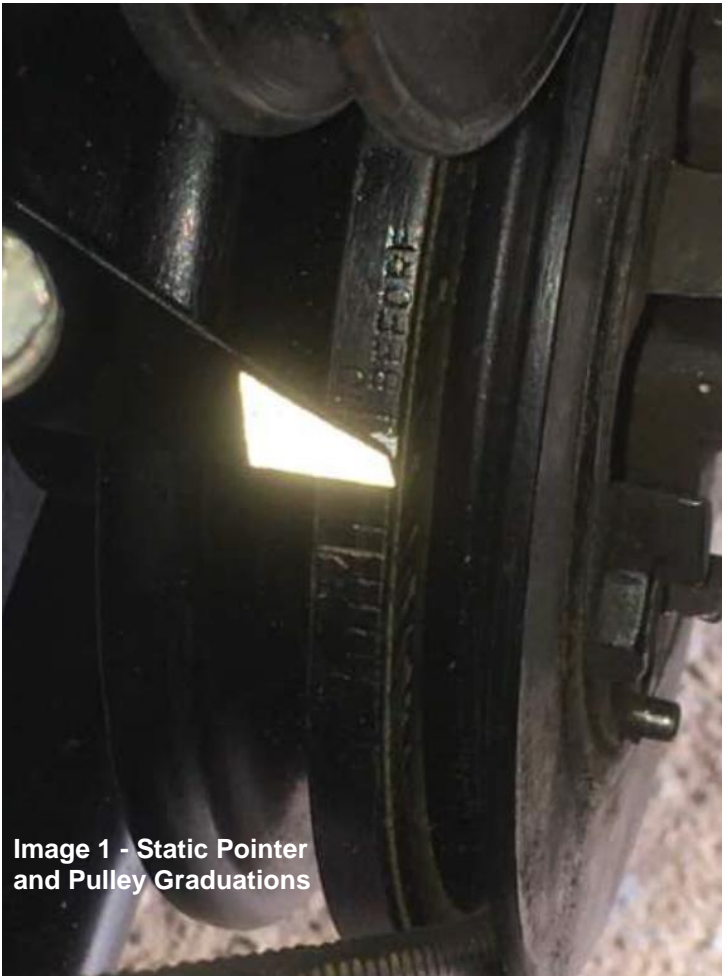
Image 1 - Static Pointer and Pulley Graduations

- This is an opportunity to clean, derust and paint the static pointer and crankshaft pulley and reapply any highlighter to them – **Image 1**.
 - Clockwise rotation of the crankshaft is specified throughout the procedure. The reason is to avoid any risk of loosening the pulley bolt if a socket is used to rotate the engine and to eliminate backlash in the powertrain. Either eventuality is highly unlikely in this instance.

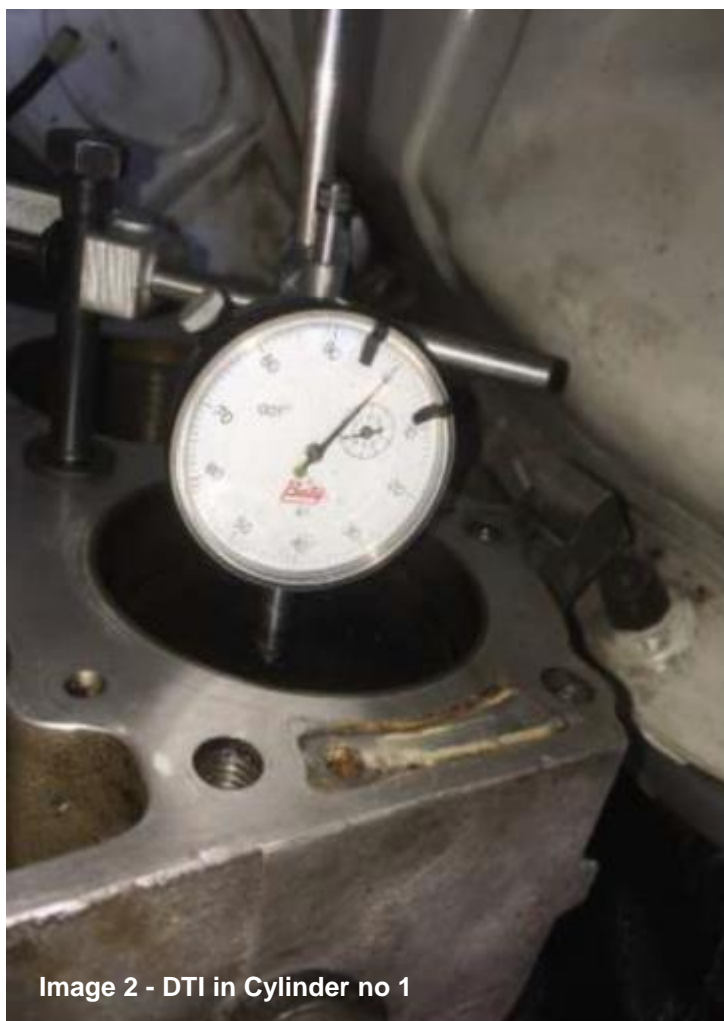
Image 2 - DTI in Cylinder no 1

4. Position the DTI to contact the piston crown and zero the dial – **Image 2**.
5. Mark the crankshaft pulley in line with the static pointer. This is position 1 – **Image 3**.

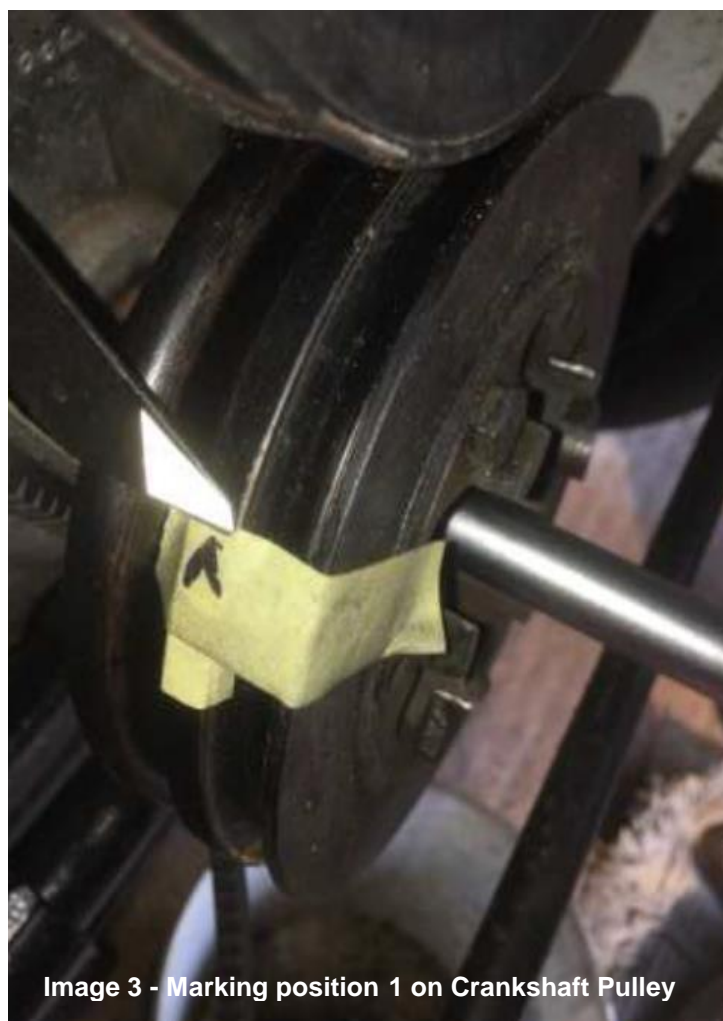
Image 3 - Marking position 1 on Crankshaft Pulley

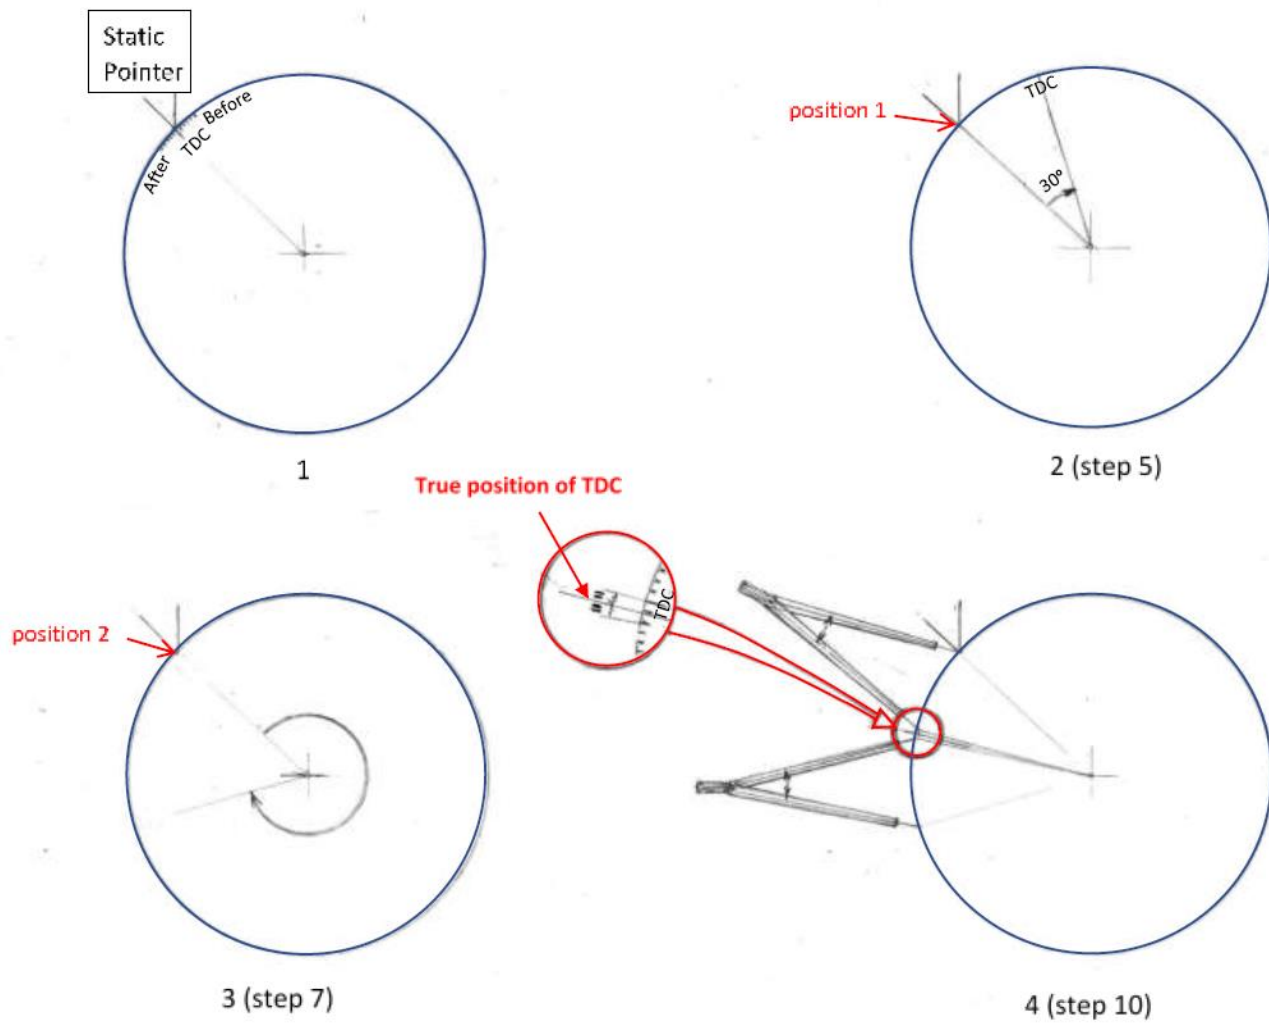
10. The true position of TDC is midway between the original TDC identification and the scribed mark.
11. Temporarily mark this position – **Image 4**.
12. Repeat this process and, when satisfied, establish a consistent position for the temporary mark.

In the author's case the results showed a reassuring small error ($<1^\circ$ after TDC) which would probably not be significant in the setting of ignition timing.

Image 4 - Schematic of the Process

13. Remove the indicator and rotate the engine clockwise until the pointer aligns with the temporary mark made in step 12.
14. Realign the static pointer with the original TDC mark on the pulley. It may be necessary to elongate the two mounting holes.
