## MGBGV8 – Cylinder Head Removal and Replacement

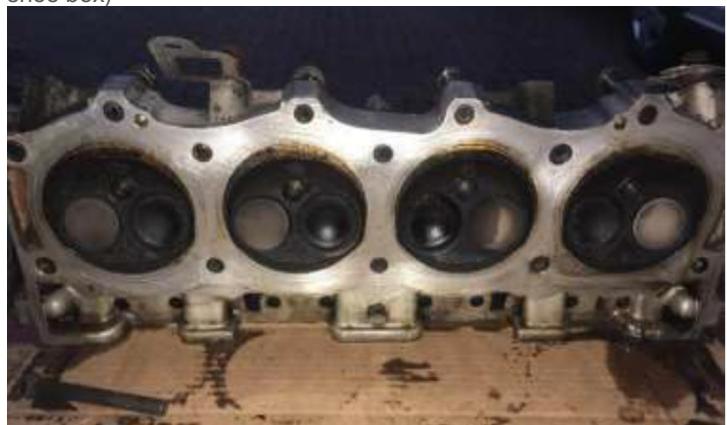
**Image 5:** Cylinder head surface inspection

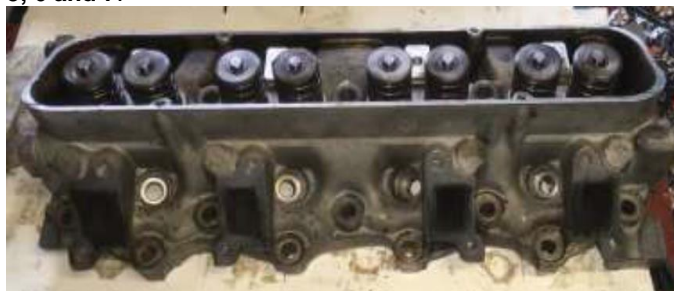
**Image 6:** Exhaust port inspection (note the leakage on cylinders 1 and 7)

9. To cure the exhaust port leakage the writer assembled the tubular manifold with new 3/8" UNC x 1.1/8" stainless steel bolts and tightened them until the gap was closed. The torque required was significantly under the safe limit for a 3/8" UNC bolt.
10. On the inlet side the writer used black silicon sealant sparingly on both end seals and round the water passages. This had been used on the previous engine build and appeared to have been effective. The gasket was preformed into the shape of the mating surface and assembled before the sealant cured. It was held in place by the bolts in the end clamps while the manifold

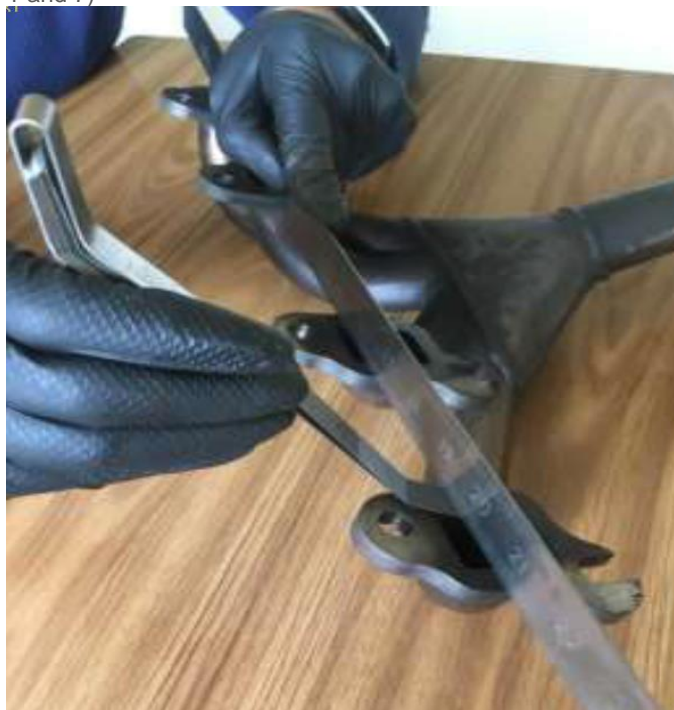
**Image 7:** Exhaust manifold inspection
