What do you do to restore overdrive on third gear?

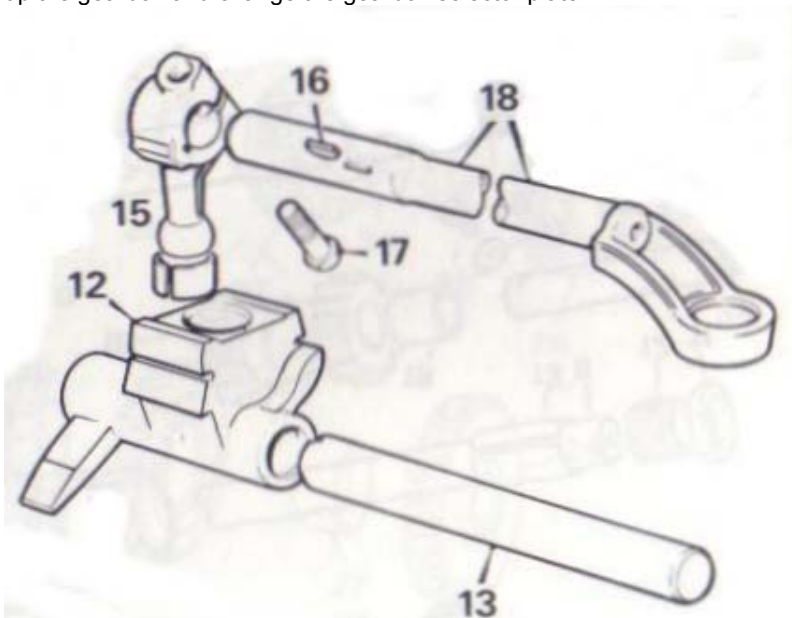
Gearbox selector plate 22B386, later replaced by 22B726, is item 12 in this diagram. Item 18 is the remote control shaft which transmits the gear lever movements to the selector plate when you select gear. (Diagram from page 108-C44 Parts Catalogue AKM0039)

When the MGBGT V8 was launched in 1973 it was fitted with the gearbox selector plate 22B386 already in use in the MGB 1800 which was also in production at Abingdon at that time. The selector plate in the remote gearchange activates the plunger isolation switch 22B406. When that switch is engaged it cuts off the electrical power feed to the overdrive solenoid in any gear other than third or fourth for the earlier cars. The plunger isolation switch was necessary to prevent the overdrive being left engaged for the lower gears and most important, to ensure it was not engaged whilst in reverse gear as the unidirectional clutch in the overdrive will not take kindly to being driven in the wrong direction!

damaged overdrive usually requiring a replacement unit under warranty. The high torque from the V8 engine in third gear was identified as the cause, so a production modification was introduced removing the overdrive option from third gear so the V8 model then had overdrive only on top gear. That change point was from **gearbox A 1404** when the gearbox selector plate was replaced by part number **22B726** and the plunger isolation switch by **22B727**.

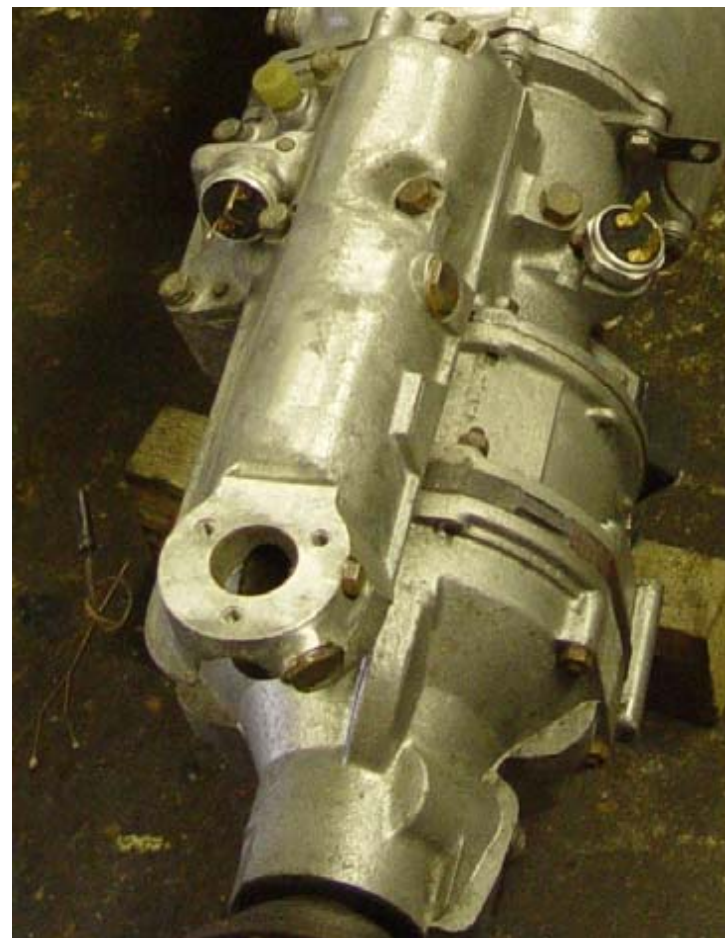
Circular opening at the back of the gearbox is for the gear lever which connects with the end of the remote control shaft that transmits the gear lever movements to the selector plate when you select gear. On either side of the gearbox are the twin terminals of two switches – on the offside the reverse light switch and on the other the overdrive isolation switch. (Photo: Gavin Bailey)
