Tips on fitting a new water pump

Bob Owen has recently been refurbishing the engine in his MGBGTV8 and has a couple of useful tips. (Apr 11)

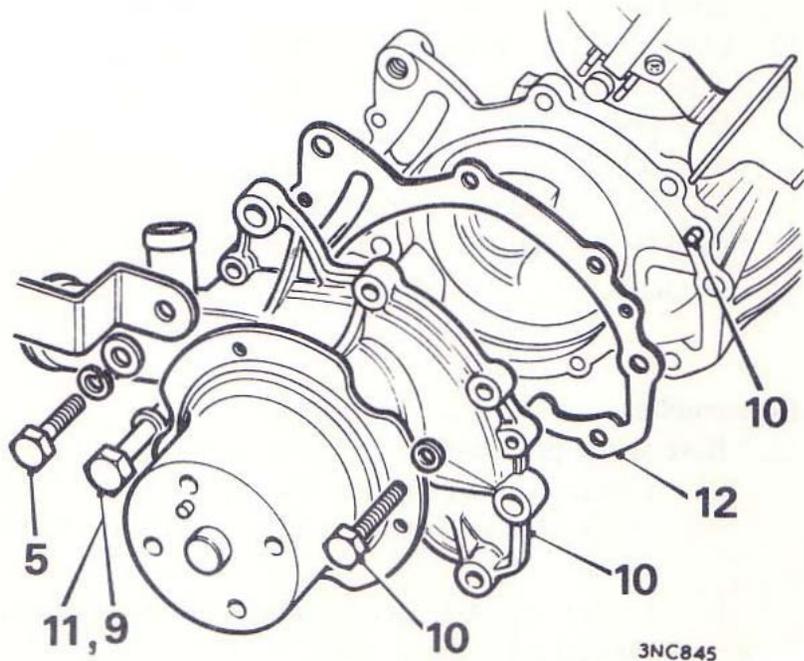
Source: V8 Workshop Manual Supplement AKD8468 page 26.50.01 Issue 1

Firstly, although the pump is of Chinese origin, all appeared to be fine except that I had problems with the fan belt pulley fixing - the original bolts were binding but the bolt and pump thread forms looked clean. I wondered if they had actually used metric threads and in fact the "1/4" UNC" threads were actually M6 - so M6 bolts went in by finger, as they should (1/4" UNC thread dia 6.3mm, pitch 1.27mm; M6 thread dia 6mm, pitch 1.0mm). This caution may apply to other aftermarket components, especially if they are fitted to later metricated models - that is not the case for this pump.

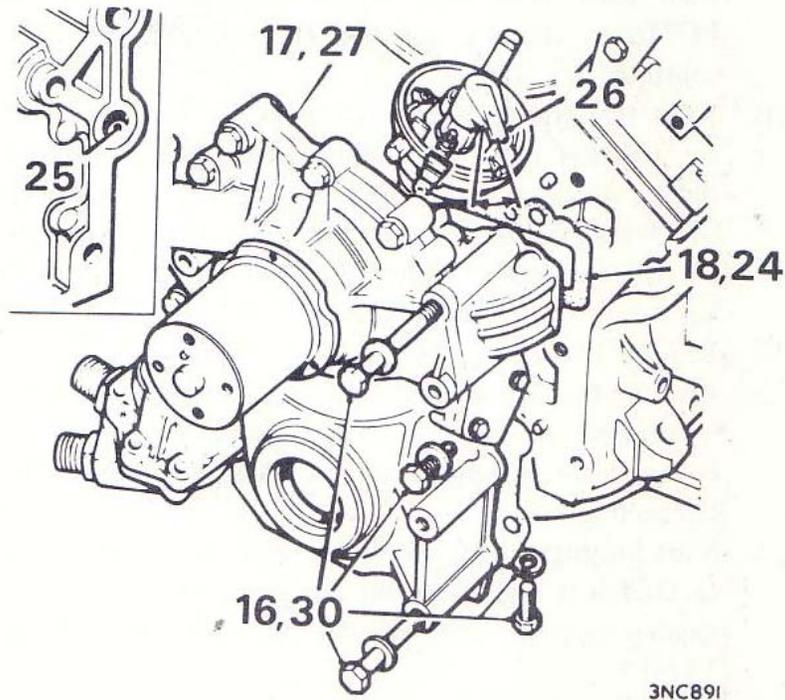
Source: V8 Workshop Manual Supplement AKD8468 page 12.65.05 Issue 2

Secondly, the dreaded long timing cover bolts tend to seize and one of mine sheared off near the head. The fact that it sheared off near the head showed that it

was corroded into the timing housing not (or as well as) into the block. I believe the engine to be untouched since 1974 so it appears that BL did not follow their own advice on thread sealants at their engine assembly plant. The special sealant specified by BL/MG-Rover is no longer available, but it wouldn't have been made by them anyway. So I investigated the ubiquitous Loctite offerings. A suitable thread **sealant** is Loctite 567- this seals and locks but not to high torque (ie the lock is easily broken). So I applied this to each bolt on the threaded section that enters the block.

I also wondered why the shanks of these bolts are such a close fit in the timing housing when the housing is located in the block by dowels, so the sole function of the bolts is to secure the cover, not locate it. So I drilled out the timing cover bolt holes 0.5mm oversize to both clean them out and enlarge them. Then I used Loctite 8150 thread **lubricant** on the shanks. In fact I had bought this for the exhaust manifold studs. So hopefully there will never again be a problem in dismantling my water pump and/or timing cover.
