Curing a leaking heater matrix

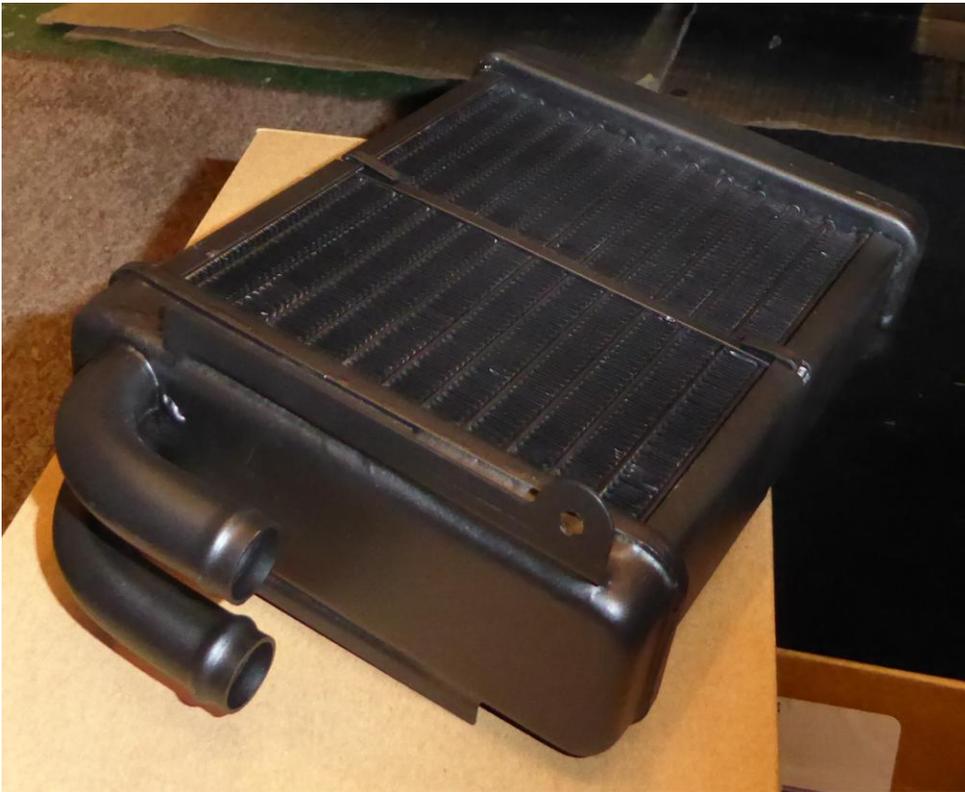
Barry West sought help with a heater matrix leak on his Japanese spec RV8 in a V8BB post saying "on a recent local trip on switching the engine off (the heater was on) a small amount of steam drifted up through the windscreen vent on drivers side. There is no leak around the heater control valve that I can see and no coolant loss visible. The next thing I was going to do was attempt to remove and check heater matrix for flow. Does anyone have any advice/tips?"

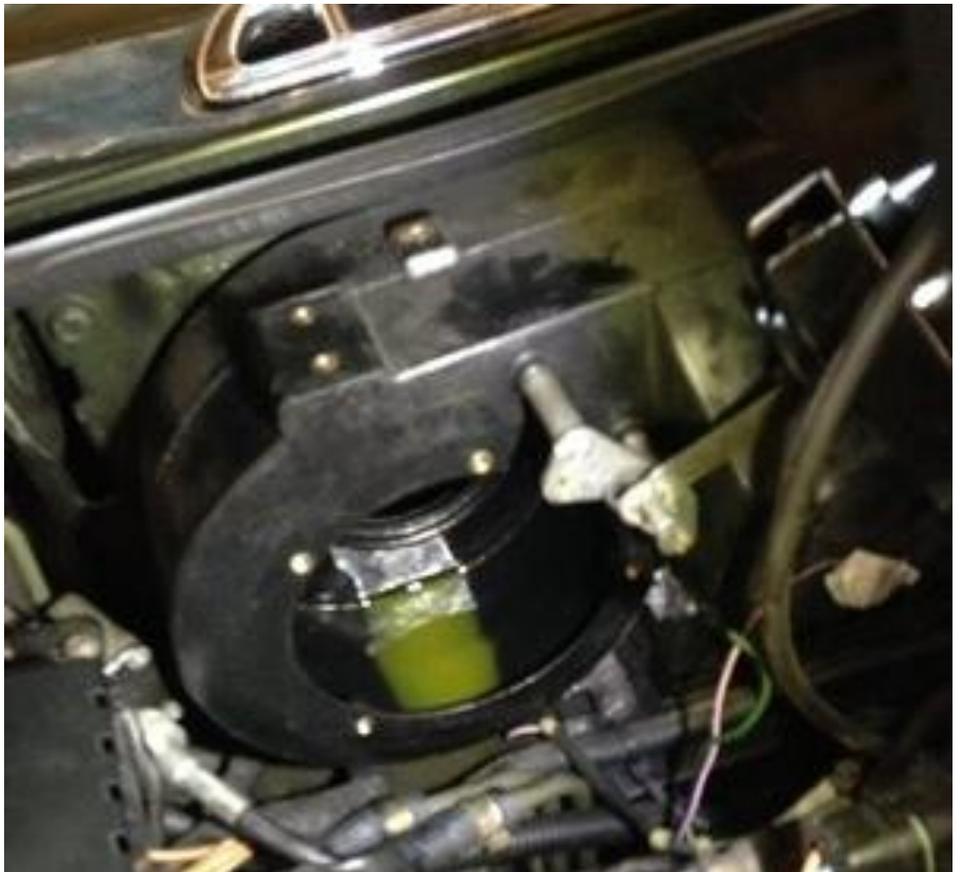
Barry West said "I have searched this forum and scanned all the RV8NOTES and there doesn't seem to be much information on this subject. Before I attempt to start dismantling I looked at the microfiche and it looks like there may be one or two fixings securing the heater box in situ depending on the VIN number with two fixings after VIN 0971". He later posted an update saying "have now taken the heater motor out after discovering a small amount of antifreeze in the driver's footwell coming from the bottom of the steering column as it goes through the bulkhead. There is half an inch of coolant in the bottom of the heater box (see photo alongside) so it is definitely a leak from the matrix or pipework in the bulkhead".

Paul Atkinson later reported "I also experienced a leaking heater matrix on my RV8. This was manifested by coolant loss

which on one or two occasions resulted in small pools on floor at both sides of car and

also by failure to demist and, even worse, more mist being created! This latter happened in a torrential storm last October whilst returning to the UK through Switzerland and left a slightly oily residue on the inside of the windscreen. I had long worried about the slight coolant loss which had seemed untraceable.

Replacement of the matrix is easy involving moving the washer bottle, carbon canister and immobiliser unit to the side (without complete detachment from the car) then undoing the hoses and the two screws which hold the matrix into the heater box. The heater box etc. remains in situ, but I took the opportunity to clear the debris from the deteriorated foam seal with a powerful vacuum cleaner. Everything goes back in reverse order. It is worth knowing that the matrix is from the last versions of the Rover Mini and Metro and is thus reasonably easy to obtain. A word of caution; the first replacement I bought for under £20 was a poor fit as the plastic securing flange on the inlet/outlet end through which the two screws mentioned above pass was a couple of millimetres shy all round and thus did not seal properly. I then bought an all metal matrix for £45 from Motorads Online of Redditch and this fitted perfectly.
