### Solving an alternator problem

Nic Houslip enjoys track days and sprints with his RV8 and V8 Roadster and here relates a tale of how a problem developed with his alternator on the RV8 at a sprint. Nic's article provides useful information on solving the problem for fellow members.

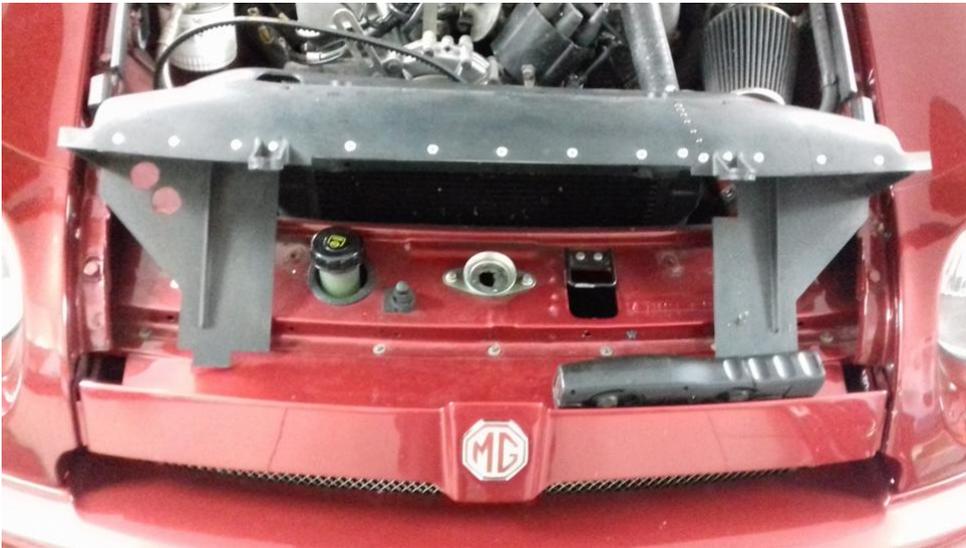
- **First remove the battery negative lead** or turn off the isolator switch if the car is fitted with one (as mine is) to avoid big sparks under the bonnet.
- **Remove the radiator cowl.** This is large plastic bit that directs air through the radiator rather than around it and which frequently cracks with age. You will note that mine has a line of Frankenstein stitches of stainless steel locking wire on the left side from the driver's seat and also a strip of aluminium pop riveted to

function - it locates the radiator in its correct position using the two large rubber grommets and the two pins on the radiator. If the shroud is not in place, the water pump spindle will rub on the radiator fan housing! If you happen to lose these rubber grommets, or they are perished they are available from your local Land Rover dealer. The RV8 radiator seems to be much like the Land Rover Defender radiator and the rubber grommets are identical!

**Warning**, do not be tempted to start the engine before you refit the radiator shroud. It has an important, but not so obvious

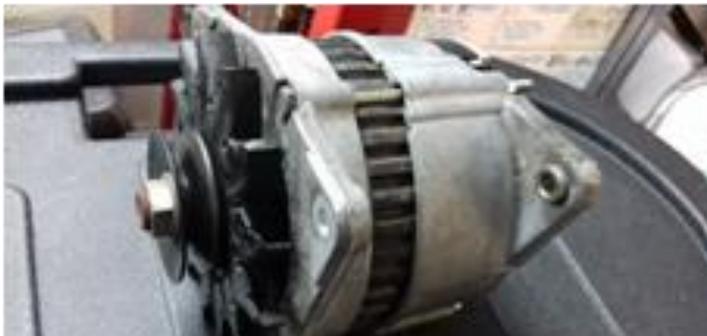
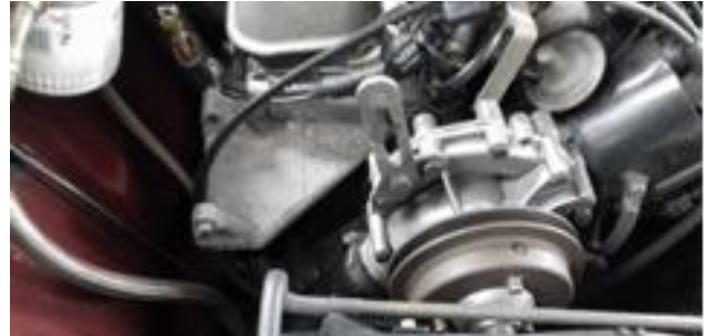
When you get the alternator out it should look like this . . . . . and the location it came from looks like this. The cradle bolts to the RH cylinder head and supports the alternator by two bolts.

- **Remove the electrical connections**, noting which goes where, not too difficult as there should only be two and they are different sizes.
- **Now remove the bolt that secures the alternator to the metal strip that allows you to adjust belt tension**, remove the belt and then remove the two other fixings below the alternator that holds it to the cradle. Take care, the alternator is quite heavy and you can pinch your fingers if you let it drop from its mountings.

Please be very careful when removing the nuts bolts and washers, noting where they came from so that you can put them back in their right positions. This is **IMPORTANT**. If you do not put the washers back where they belong the belt pulleys might not be aligned correctly and lots of trouble will ensue that will cost, you a great deal of money to rectify.

Replacing the alternator is just a reverse of the removal, again the workshop manual
