MGB V8 Roadster restoration project – Report 7

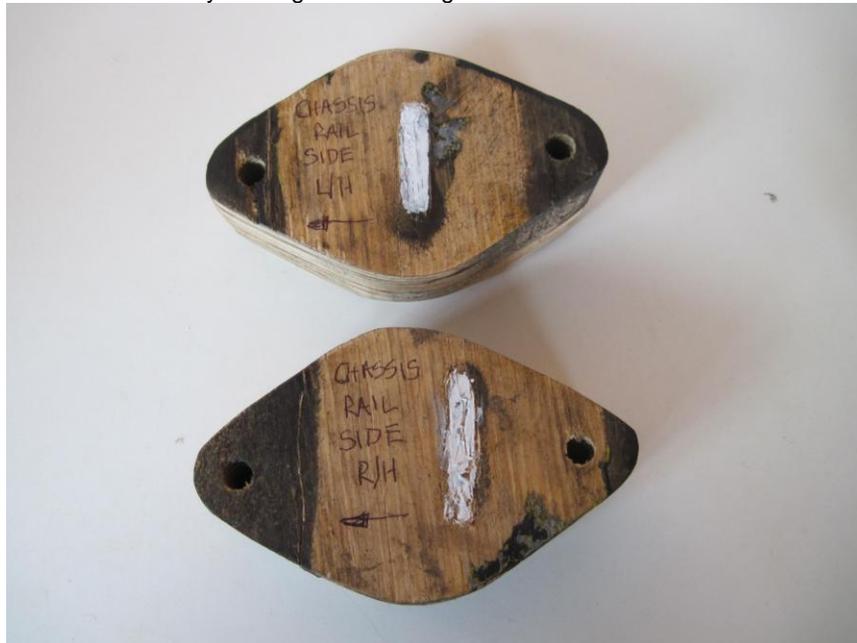
Below is a photo of the **plywood temporary 'rubber' engine mountings** that I used to find out why the engine was sitting too far forward.

I have marked the position where the slot position on the metal chassis rail mounting points are. I have highlighted it with Tippex so it shows up in the photo. The slot should be in the middle between the two holes. By the way, the arrows point to the back of the car. It seems that the last owner, who started the conversion, got the positions wrong when he decided to move the original mounting plates on the chassis rails. Although I can't move them at the moment because the engine is in the way, at least I can mark the position on the chassis rails where they should go. Maybe the whole conversion job may have been easier had I bought a late date 1800 MGB Roadster and then bought the parts to convert it to V8?!

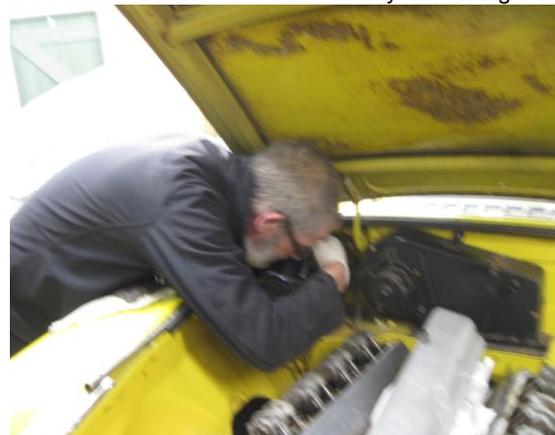
The next step was **checking that the holes in the inner wing were in the correct place for the RV8 type exhaust manifolds**. The left-hand manifold fitted reasonably well, just a little fettling needed where the collector box welding on the manifold touches the inner wings. The right-hand manifold is a real pain! It would

not fit unless the brake servo assembly was removed. I noted in my note book that right-hand manifold will need to be fitted before the servo assembly. To remove the servo assembly was also a pain getting to the bolts. We had to remove the wiper mounting and the rev counter to be able to get to the bolts. A job that we thought would take 10mins turned into nearly a morning's work!

Left: John struggling with the brake servo removal. Below removing the steering column.

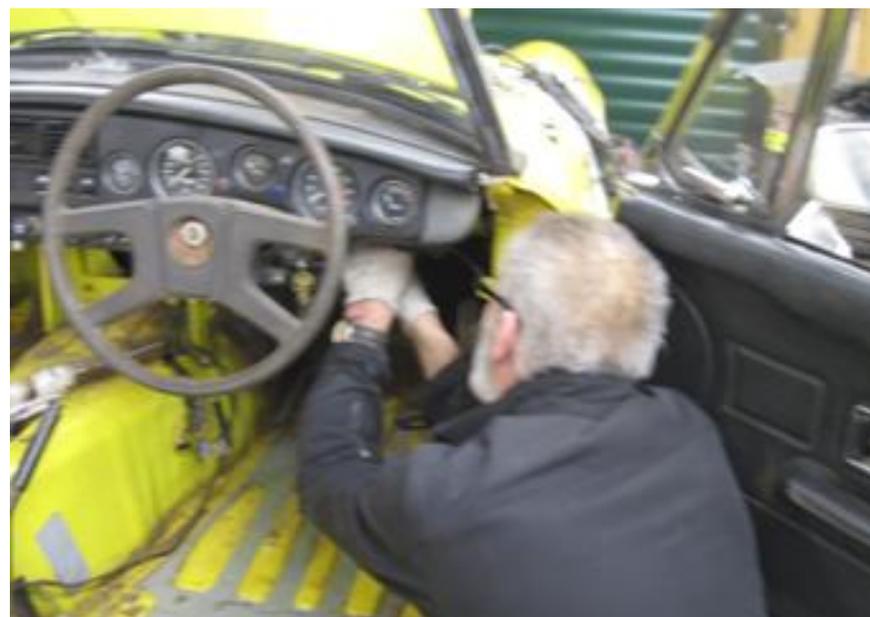
The next problem was the **steering column**. The pin that is used to hold the lower steering column to the upper steering column had sheared off. This meant dismantling the steering column to replace the shear pin. In fairness the column needed to come apart anyway as the lower bush was knackered.

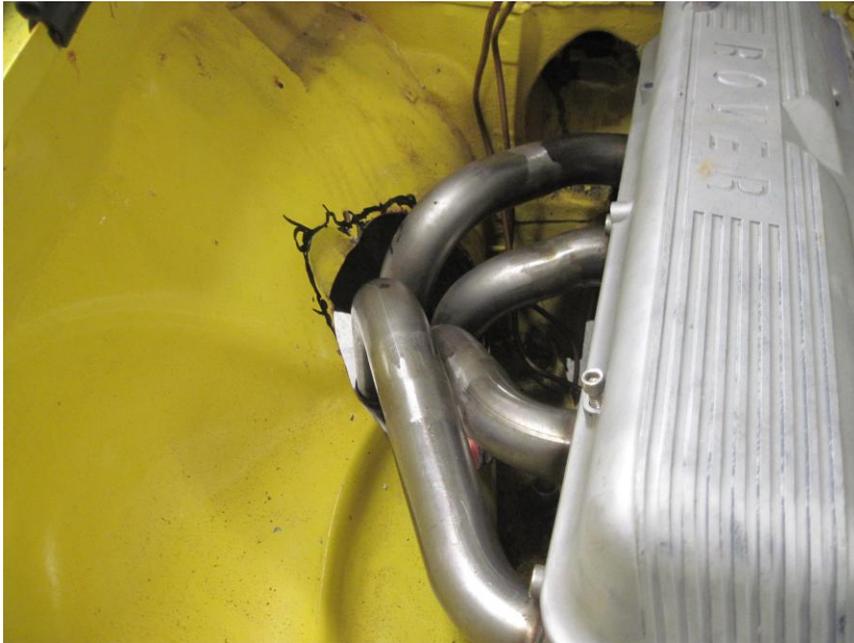
Eventually, we managed to **fit the right-hand the manifold in place**. The same problem with the weld on the manifold collector touching the inner wing happened on this side as well. The black marks on the inner wing are where the hole in the inner wing needs opening up so that the manifolds can be removed without jacking up the engine.

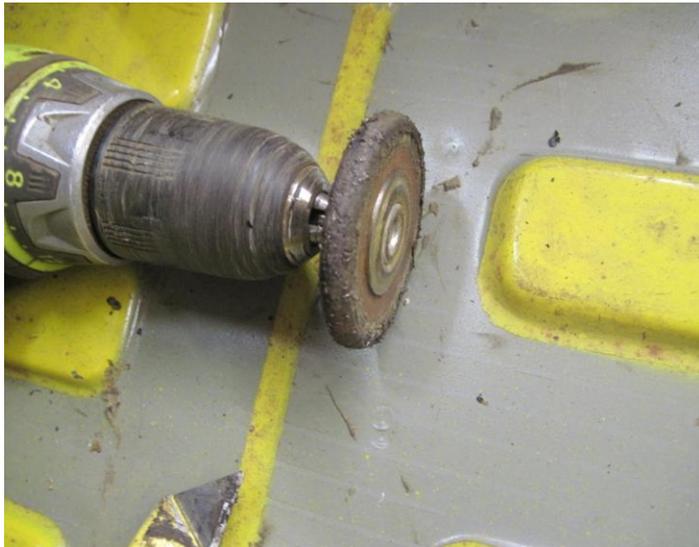
Going back to bodywork, this tool is called a **Muleskinner** and is ideal for removing rust and paint. It is a wire brush encapsulated in resin. I used only one on the complete restoration of Dugald's MGBGTV8.

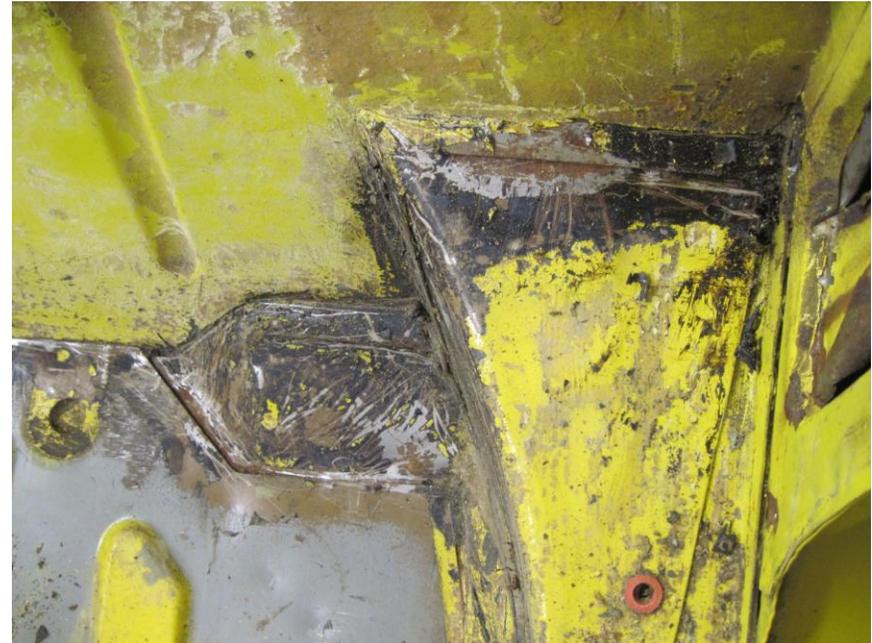
Here I have cut away the thick black seam sealer that BL used. You can see that rust has developed in the seam and needs to be treated before new, more modern seam sealer is applied.

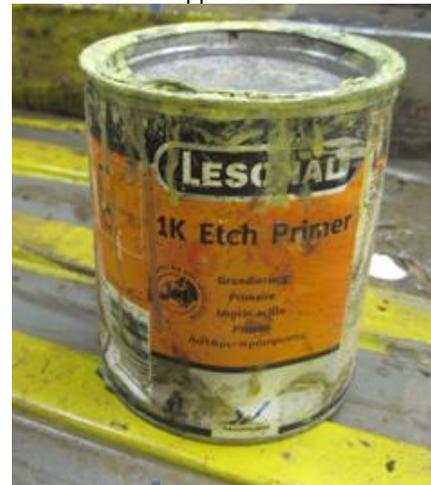
Any bare metal needs to be treated with a thin coat of acid etch primer as soon as possible after grinding, sanding or paint removal. This will stop any rust developing before you have a chance to paint with primer and topcoat. A 1-litre tin will last for a long time. I only used half a litre on the MGBGTV8 restoration.
