MGB V8 Roadster restoration project – Report 39

Thursday 18th June 2015 – Continued

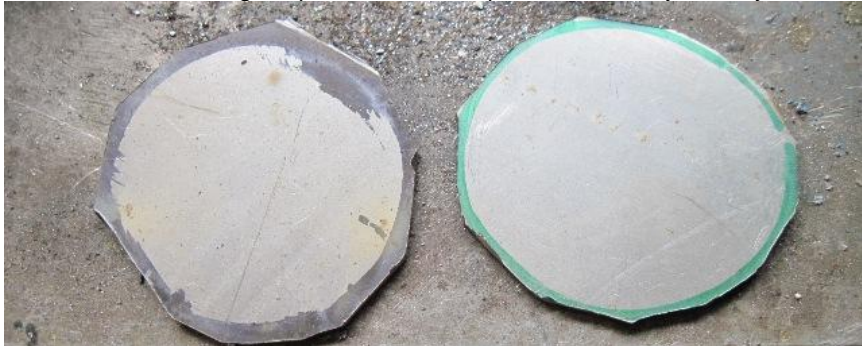
These are the top and bottom of the pot roughly cut out from 16G mild steel sheet.

Finished off the making the parts for the swirl pot for the fuel injection system.

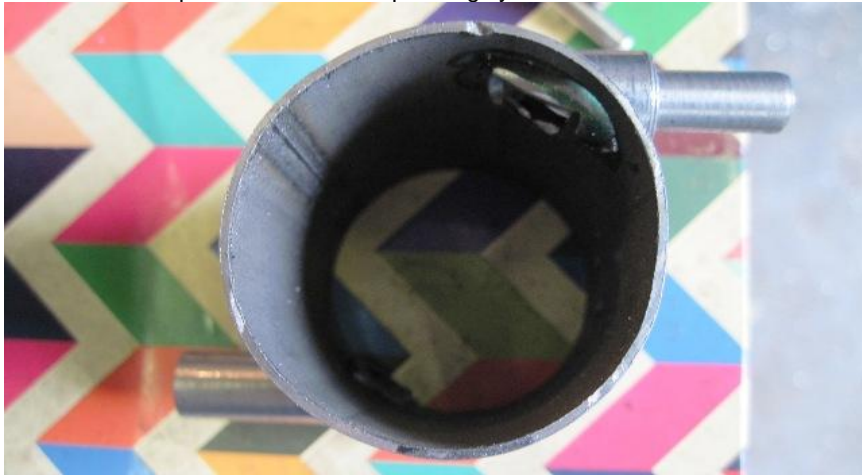
The swirl pot ready to weld up. Do I nickel bronze weld it or gas weld it? I took it down to the lower shed where my oxygen/acetylene welding equipment is. I put a section of exhaust pipe in the vice to try both types of welding to see which looked the neatest, as I had not carried out either types of welding for some time and needed some practice before I did the welding on the swirl pot. I opened the both gas bottles and found that one of the hoses had a leak at the torch end – Knickers! The hose had become porous, probably through lack of use. I had really wanted to try and get this bit finished today. I rang my usual welding equipment supplier and the answerphone was on, I left a message to ring me back, all to no avail. Jane had an appointment to collect Darcy at 5:10 after the operation to her rear suspension. I rang a welding supplier in North Walsham where the vets is and found they had a set of hoses in stock. I said to Jane that I would go with her and collect the hoses before we collected the dog. Hoses collected we arrived at the vets and the vet said she had been a very brave girl – Darcy that is – not Jane.

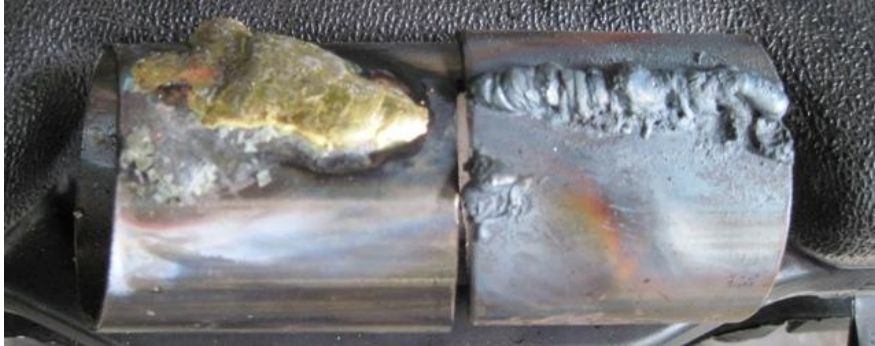
I tried running a bead of weld along a scrap bit of the 2" diameter exhaust pipe that I am using for the swirl pot, and also a bead of nickel bronze weld. After all the time that has passed since I have done these sorts of welding I was extremely disappointed at my results. I am very embarrassed about showing you a photo. But I did say I would give you the lows and highs of this project in the reports.

How **not** to gas weld or nickel bronze weld!

I must have forgotten something about both these types of welding! I spent the afternoon watching videos of gas welding on You-Tube. They say that once you have ridden a bike you can always get on a bike and ride it – believe me – welding doesn't seem to be the same!

The thing I had forgotten with nickel bronze welding is that the acetylene should be turned on a little and the torch lit and the flame turned up until the black smoke disappears and the end of the flame is feather like. Then turn the oxygen on and the oxygen turned up until you have a neutral flame. That is the inner cone at the torch end should be rounded. For gas welding the inner cone should be just pointed, an oxidizing flame. With the bronze welding, you need to heat the metal up to cherry red before you start adding the nickel bronze filler rod to the flame. If you get it hotter than that the weld will be no good and if you get it not hot enough all you get is balls of nickel bronze on the metal you are trying to weld and these do not attach themselves properly to the metal and can be knocked off quite easily.

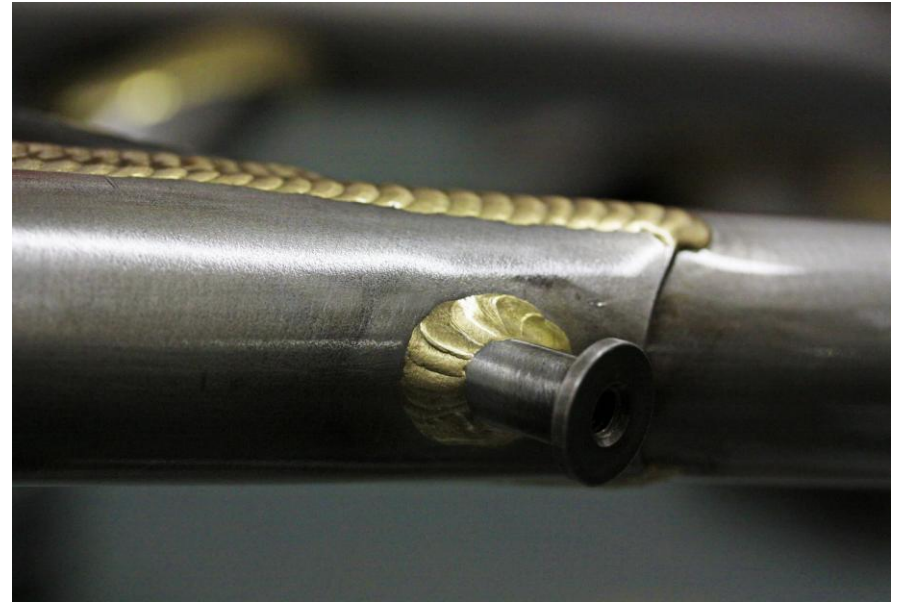
This is how it should look!

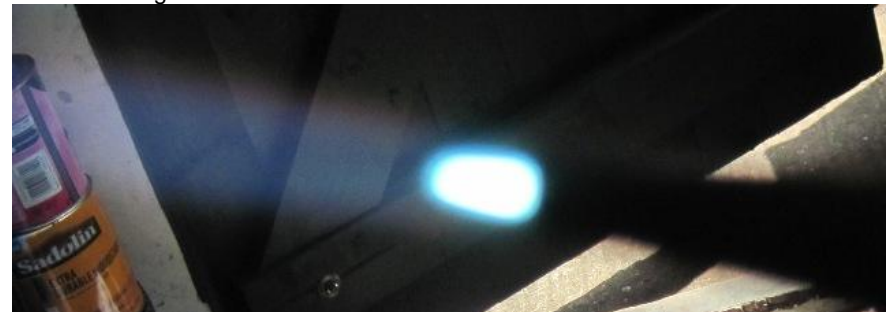
I have been having some practise with the bronze welding. Here is how the flame on the welding torch should look.

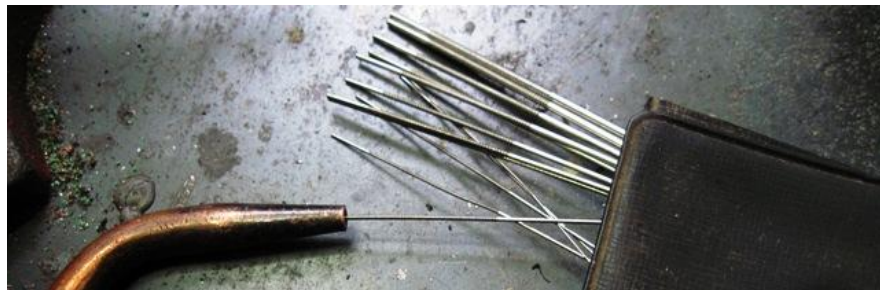
Cleaning the torch nozzle.

Firstly I cleaned out the nozzle of the torch and I tried nickel bronze welding two bits of tube together using different nickel bronze rods that I had.

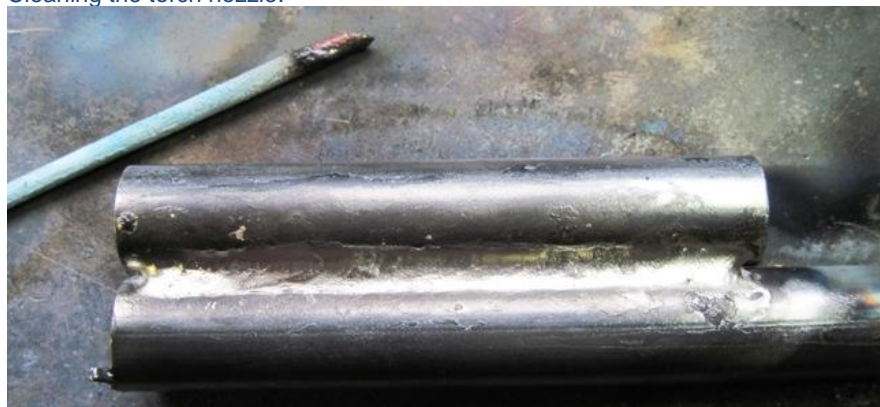
Weld with the blue fluxed rod.

Firstly I used a rod that was already coated with a blue flux. Secondly some rod that had been coated with some pink flux and lastly some un-fluxed rod that you had to heat up and dip into the SIF bronze flux. I was surprised at the difference in weld that the different fluxes made to the weld. Surprisingly the first rod with the blue flux coating worked the best as you can see from the photos below. Although I forgot to take a photo of the un-fluxed rod weld it was the same as the pink fluxed rod. Presumably the pink flux makes nickel bronze flow out more, like brazing. The problem is I can't remember where I got the blue coated rods!

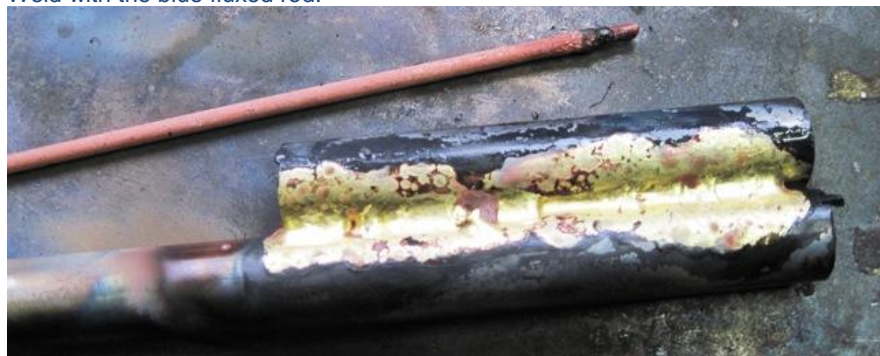
Weld with the pink fluxed rod.

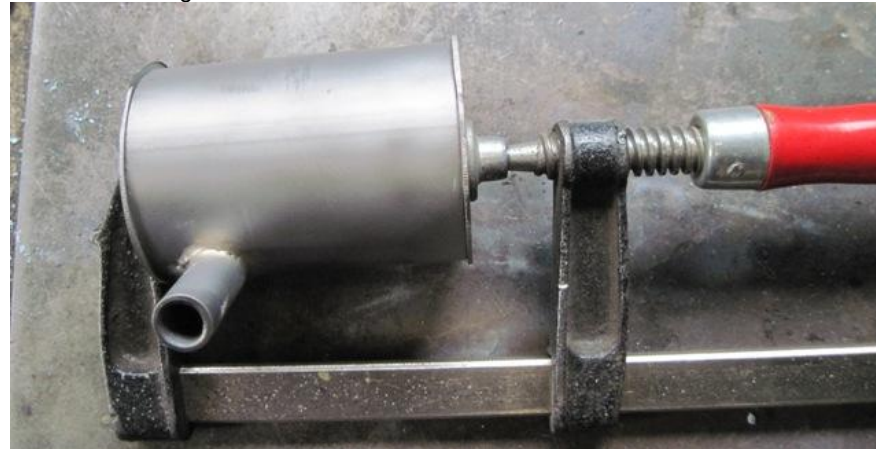
The swirl pot clamped up ready for 'gluing together'. Hopefully with no leaks.

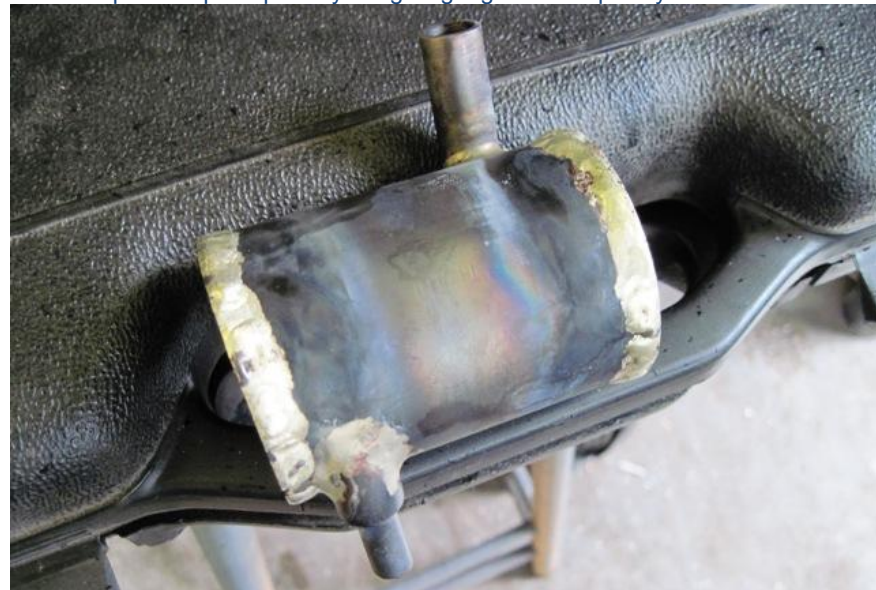
Top and bottoms stuck to the tube with the nickel bronze welding. 6 out 10, Mike could do better with more practise. Sounds like my school reports!

The pump should be delivering fuel at 34 to 48psi, which is Rover's specification, but the pump should be able to deliver fuel up to 60psi. I had better pressure test the 'swirl pot' to at least this pressure. The next photo is the 'swirl pot' after being put in the blast cabinet. It looks as if I definitely should pressure test it as it looks as if there maybe some pin holes in the welding. As long as I don't put petrol

through it first I can heat it up, let the nickel bronze flow to seal up the hole, or holes. If I do it after having petrol in it then it might go B-A-N-G!

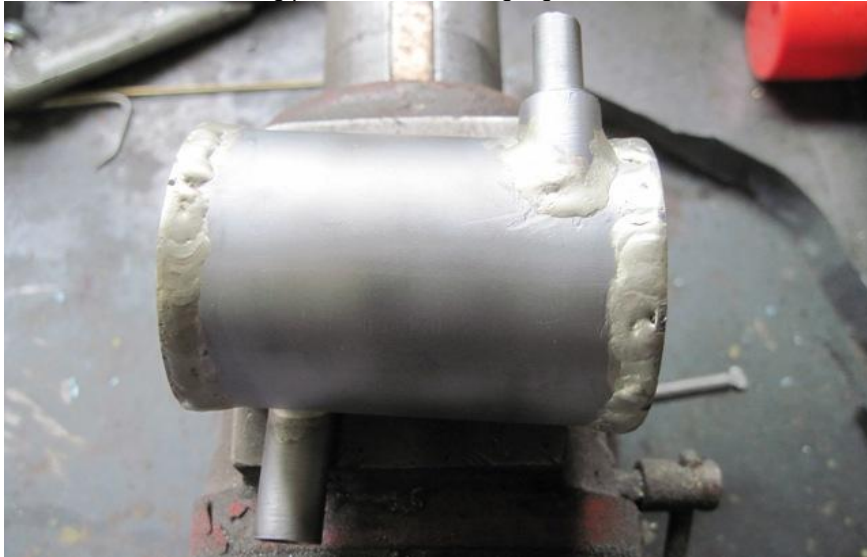
Swirl pot ready to try in position before making a mounting bracket.

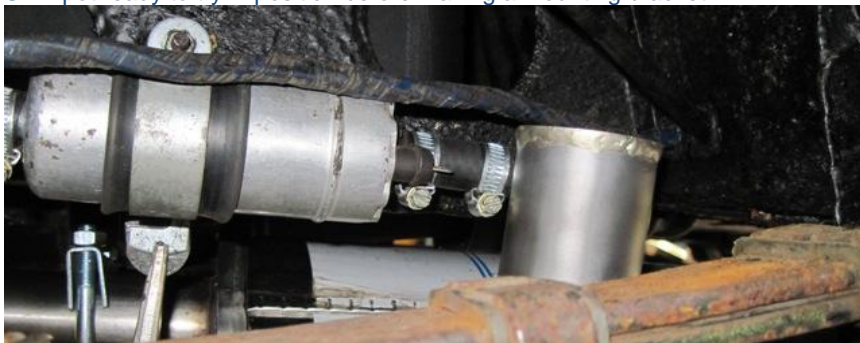
The pump and swirl pot in position and ready for making a bracket for the pot. It looks as if it will line up nicely with the fuel line to the engine.

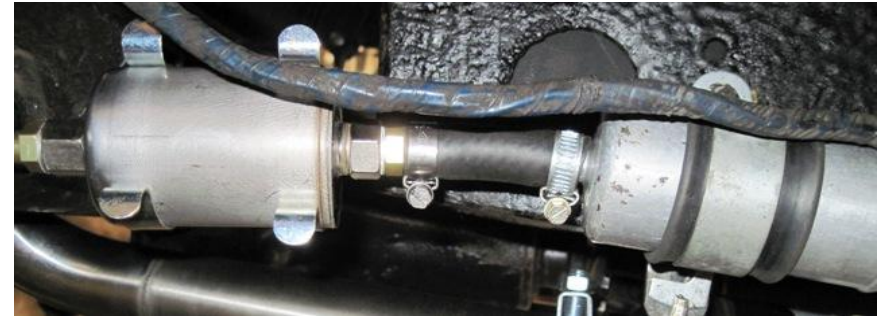
The photo in the next column shows the pre pump filter fitted to the fuel pump. I need to make another bracket for this filter. I shall mount it at about 45 degree to make the pipe work run to the fuel tank fairly straight so the pump does not have to suck the fuel up to a higher point than the fuel take off in the side of the fuel tank. I decided to pop up the pub for a beer in the evening to see how John was getting on as, yesterday lunchtime, he was talking about packing up the chemo as he felt so awful. Robert and I spent about an hour on Sunday trying to persuade him to keep on the chemotherapy course. Luckily, tonight, he felt a lot better and agreed that he should carry on with the chemo. They hope to stop the cancer growing with the chemo and then give him radiotherapy treatment.

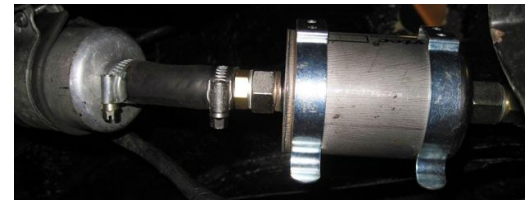
This photo is from the underneath of the car showing the angle it's at so that the petrol does not have to go up hill. **Note:** When replacing rubber petrol hose make sure it is suitable for ethanol fuel.
