### Check your plastic breather pipe is not missing

Derek Squires highlights a check worth making on your RV8 back axle.

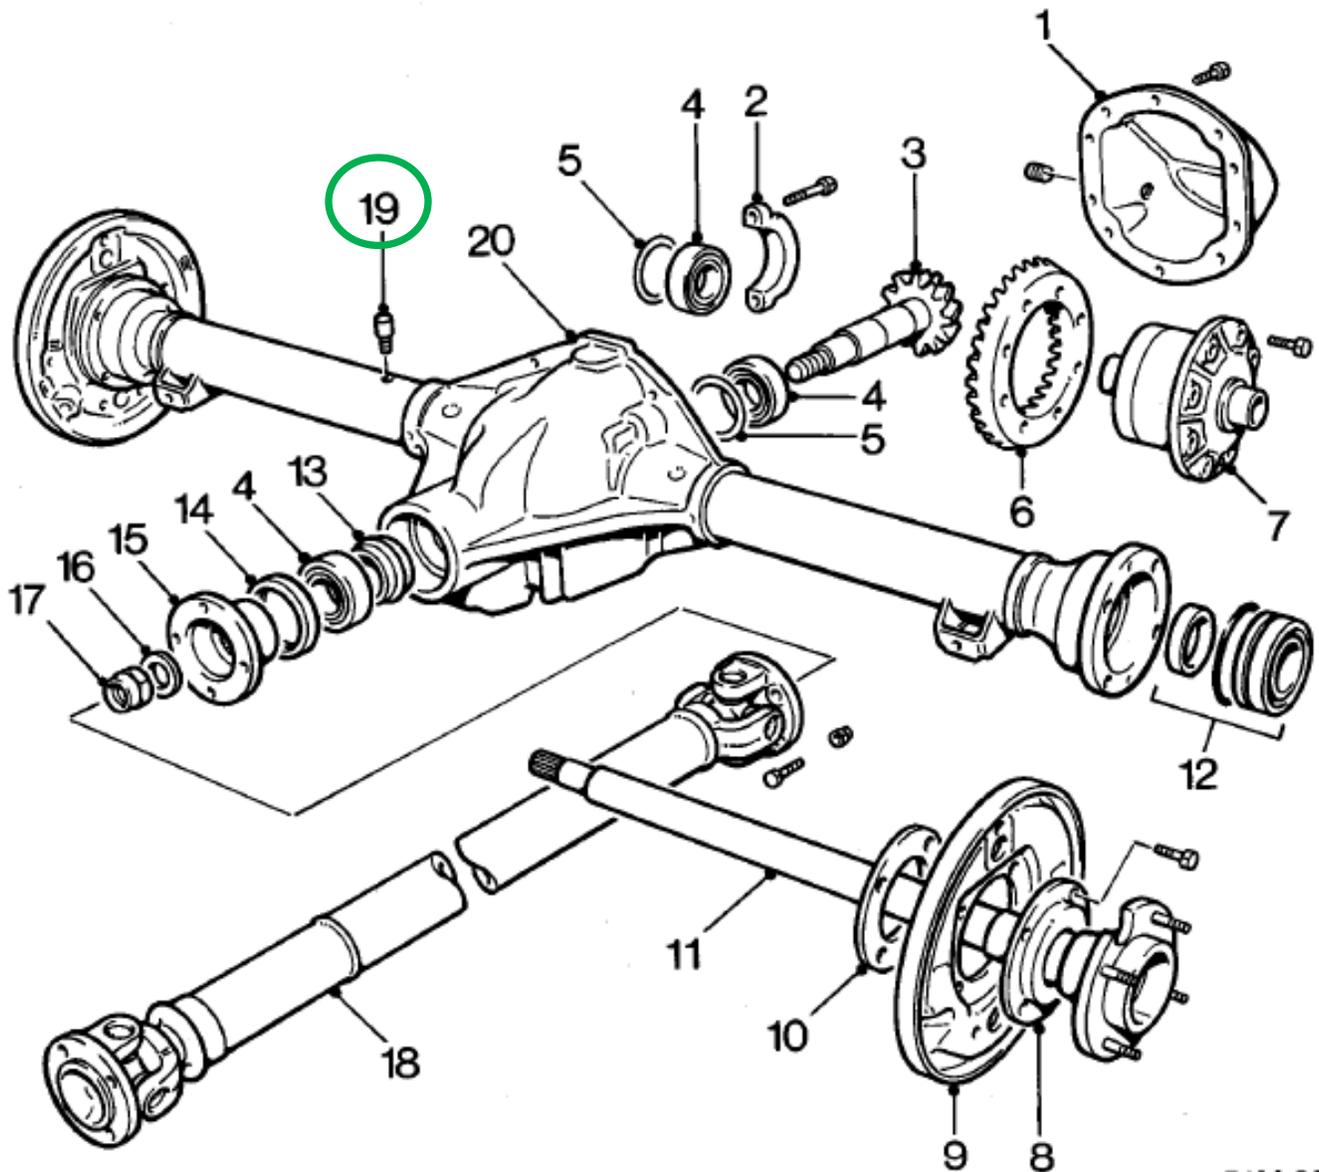
Diagram: RV8 Repair Manual AKM7144ENG

Went into my garage a couple of weeks ago and saw something lying on the floor under the back of the RV8. Turned out to be the plastic rear axle breather (19), which had sheared off at the top of the short threaded section that holds it into the axle, and so I now have an open hole of about 7mm diameter in the top of the axle to let in water and grit! Readily obtainable, but if it had fallen off on the road, I'd never have noticed that it was missing. My RV8-owner friend here in southern Spain has just crawled under his car, and his is

Might be worth a check that you still have one on your RV8! You can find it on top of the axle, right-hand side, just outboard of the differential.

| 1. Rear cover | 12. Bearing, 'O' ring and bearing collar |
| 2. Carrier bearing cap | 13. Collapsible spacer |
| 3. Pinion | 14. Oil seal |
| 4. Bearing | 15. Pinion drive flange |
| 5. Shims | 16. Washer |
| 6. Crown wheel | 17. Pinion nut |
| 7. Differential assembly | 18. Propeller shaft |
| 8. Oil shield | 19. Breather |
| 9. Brake back plate | 20. Rear axle casing |
| 10. Bearing retainer | |
| 11. Half shaft | |

The replacement parts are listed by Brown & Gammons as **ZXC5726** for the RV8 and **21H6060** for the GTV8.

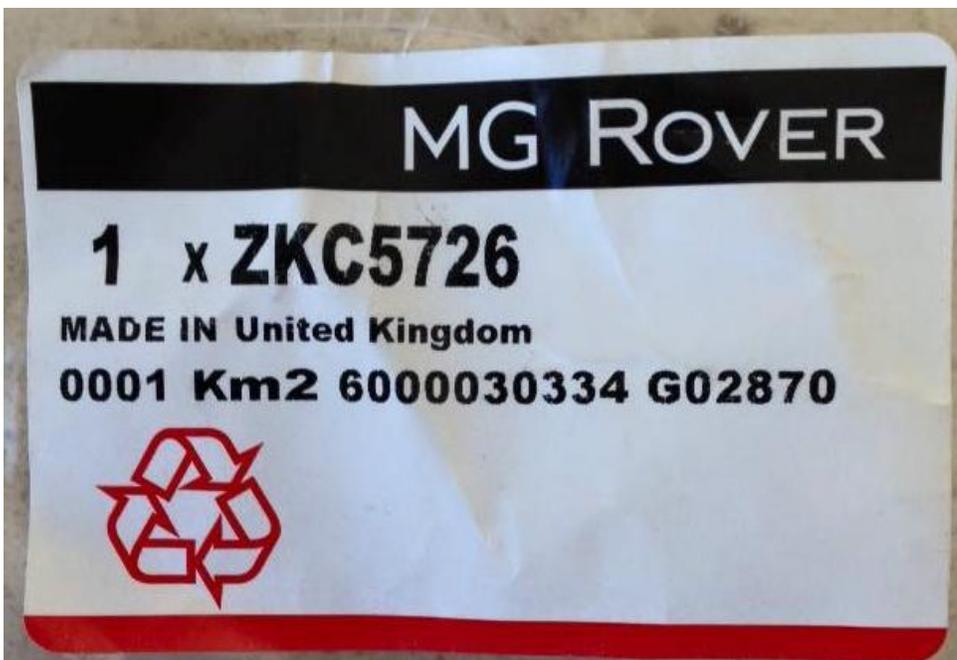
In the photo alongside, the threaded section of the MGB breather (at the bottom right in the photo) screws into the top of the axle. The discoloured portion on the righthand breather is the broken thread that was still in my axle. A black rubber cap sits on the top of the breather."

Derek Squires later posted a note saying "further to my previous post concerning the RV8 rear axle breathers, I've just fitted a correct replacement (**ZKC5726**) from Brown & Gammons. This is about 6mm shorter/lower than the (MGB) breather that was on my car, as it doesn't have the unthreaded narrow section, and it has a small ball-bearing inside the cap to act as a non-return, which the old one didn't have - although it may just have been missing. So I can confirm that the RV8 breather is slightly different to the **21H6060** for the MGB which is illustrated on the B & G website.
