Replacing the HIF6 floats

Victor Smith found on starting up his MGBGTV8 that petrol was running from the overflow hose which is routed to discharge below the car. It was traced to the float in the nearside HIF6 carburettor that had leaked so it was partially full of fuel. Here he describes replacing the floats with a new pair from Burlen. (May 16)

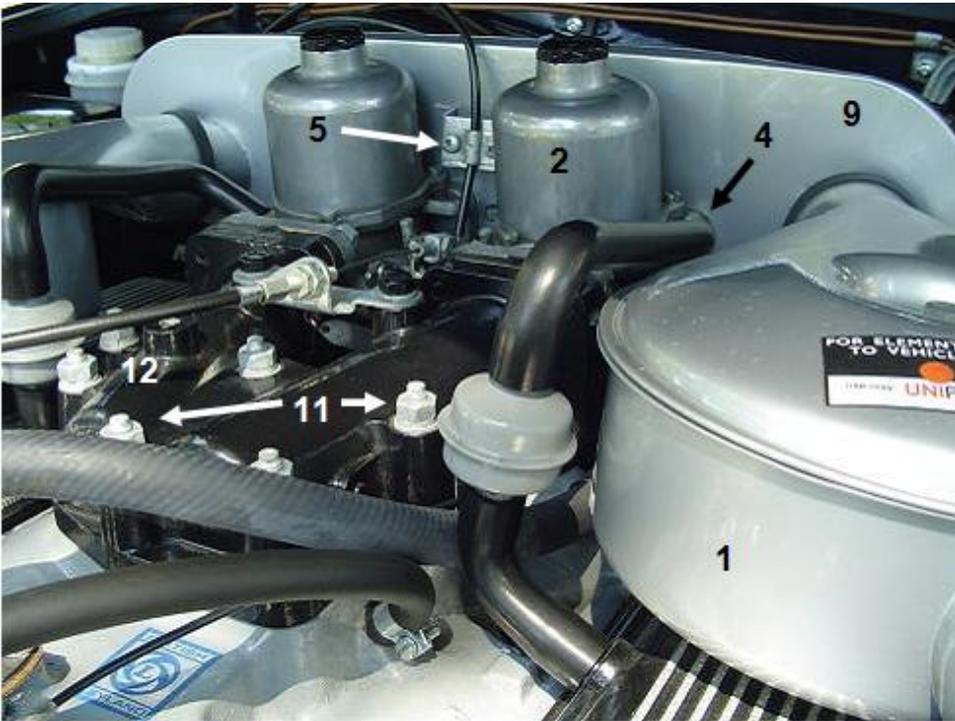
Replacing the HIF6 floats was relatively straightforward

Remove the air cleaners (1), remove the overflow fuel hose from the side of each carburettor (2), remove the fuel supply hose from the nearside carburettor (3) which comes from the fuel supply filter nearby, remove the hose from both flame traps (4) on both sides of the engine which push on to connectors on each carburettor, remove the two bolts on the choke cable clamp on the front of the airbox (5) and the clip (6) on the offside of the airbox holding the choke cable, remove the two bolts (with grommets and spacers) at the back of the airbox (7), remove the two short bolts through the lower carburettor body (8) to the airbox (they have

both a head you can get a spanner on and a groove for a screwdriver), then lift the airbox (9) away from the carburettors. As you lift the airbox the engine breather filter (10) will disconnect from the rubber hose below but remain in the clip.

Next remove the six nuts on the threads (11) clamping the adapter assembly (known at the Factory as the "pair of trousers" from its appearance) above the inlet manifold and then lift the adapter (12) clear of the studs.

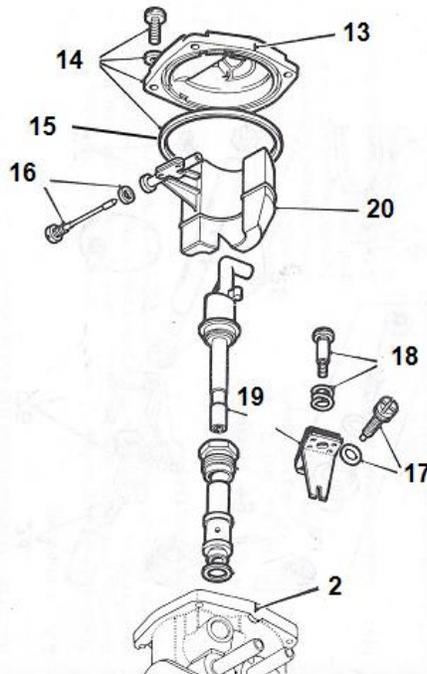
As the two carburettors are attached to the adapter assembly, you can turn the adapter over so the underside of each HIF6 is ready for the removal of the bottom coverplate (13). Mark the coverplate and body of the carburettor to ensure the correct reassembly. Unscrew the four retaining screws (14) on each cover plate and remove the cover plate with the rubber sealing ring (15). You will now see the float which is held in position by a float pivot spindle (16).

Remove the jet adjusting screw complete with the "O" ring (17) and then the jet adjusting lever retaining screw with spring (18). Withdraw the jet (19). Remove the float pivot spindle (16) and fibre washer and then lift out the float (20). Replace the float with the new float supplied by Burlen.

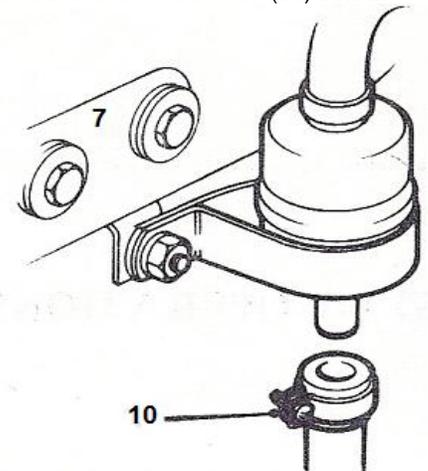
Reassembly is essentially the process above reversed with a few points to note. First you will see there is no gasket between the lower inlet manifold and the adapter assembly above, but there will be traces of sealant with a bluish colour. Nic Houslip suggests using a thin layer of [Hylomar](#), a blue coloured sealant that never goes hard, between the surfaces on reassembly. He adds "that when you buy it make sure you get the original one, not the silicone replacement - and get a tube, avoid the aerosol as it's inconvenient". The MGBGTV8 Workshop Manual Supplement [AKD8468](#) shows the induction manifold on Sheet 2 30.15.02 and on page 06-1 the torque setting on the induction manifold bolts as **28 lbf ft (1.80kgf m)**.

The second point is it is a tight squeeze reaching in between the back of the airbox and the heater box to reconnect the breather filter to the hose (10) below.
