### Fitting replacement ducting to hot air shrouds

As a sequel to an earlier V8NOTE534, Angus Munro has provided some photos of the replacement ducting which indicates the care needed when cutting the ducting. Here he explains how he did the job. (Jan 18)

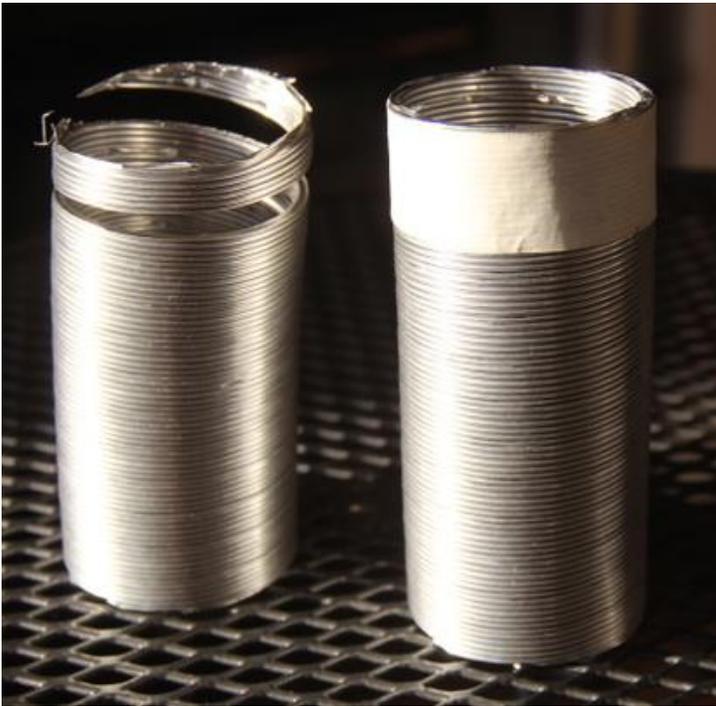
The photo alongside shows **on the left how not to cut the ducting** and **on the right how to cut the ducting** by following the line of masking tape.

**Cutting the ducting needs care.** Angus Munro explains that his first cut of the ducting to the length he needed for a replacement which would fit neatly above the hot air shroud, he followed the valley of the spiral. But he found that he was four 'threads' out. He then found the trick is to wrap a length of masking tape around the ducting such that both ends meet, and then make the cut by following the edge of the tape. Surprisingly it makes a fairly neat end finish.

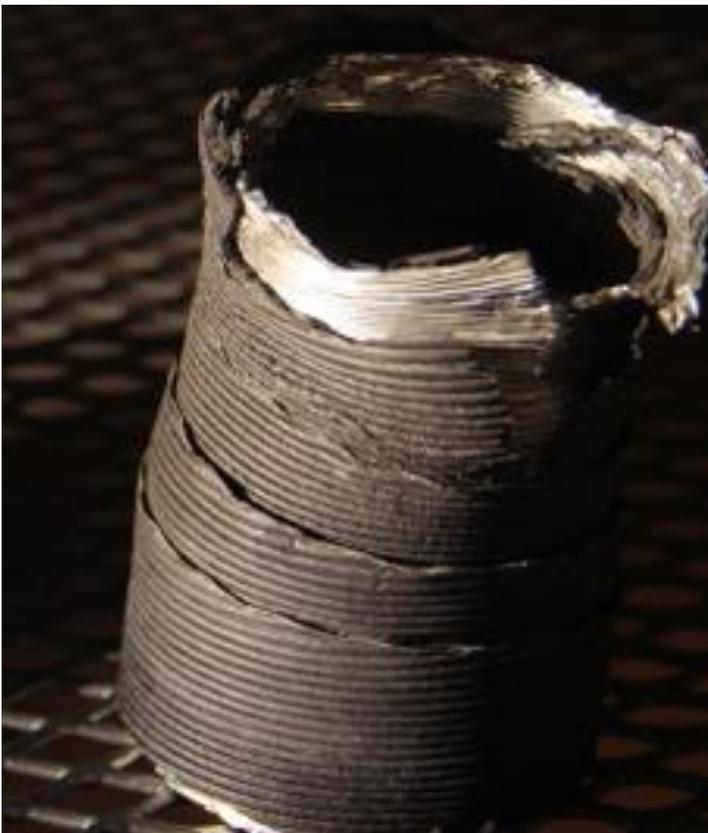
Duct that was with the car when purchased in 2017.

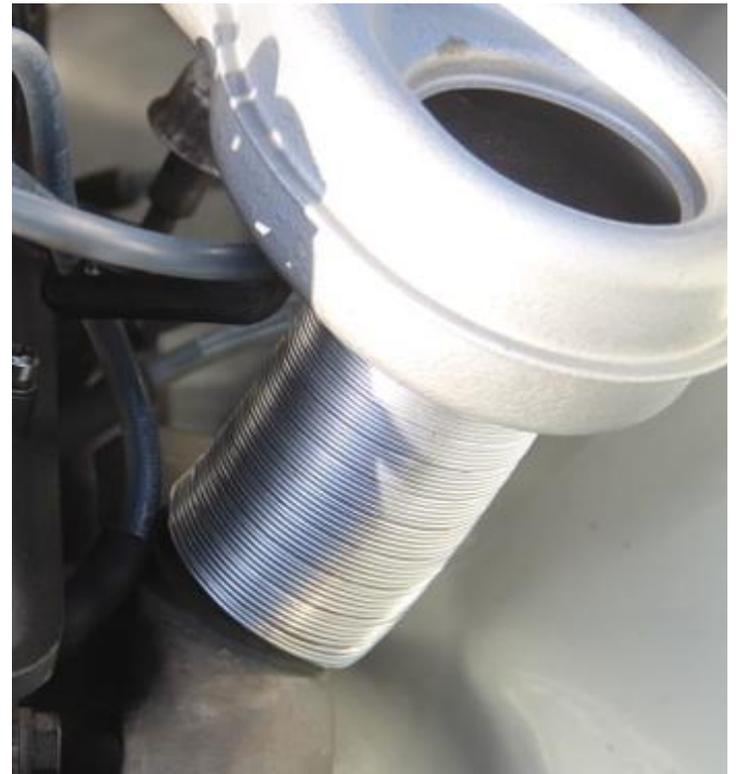
The replacement duct looks very neat above the shroud.
