#### Refurbishing the bulkhead shelf

Clive Wagerfield acquired a Pre-Production Development MGBGTV8 from Norma Ward in 2008 and has set about refurbishing the car. Here he provides a pictorial record of his work on the bulkhead shelf. (Dec 08)

## Refurbishment of the bulkhead shelf on an MGBGTV8 – V8 Workshop Note 394

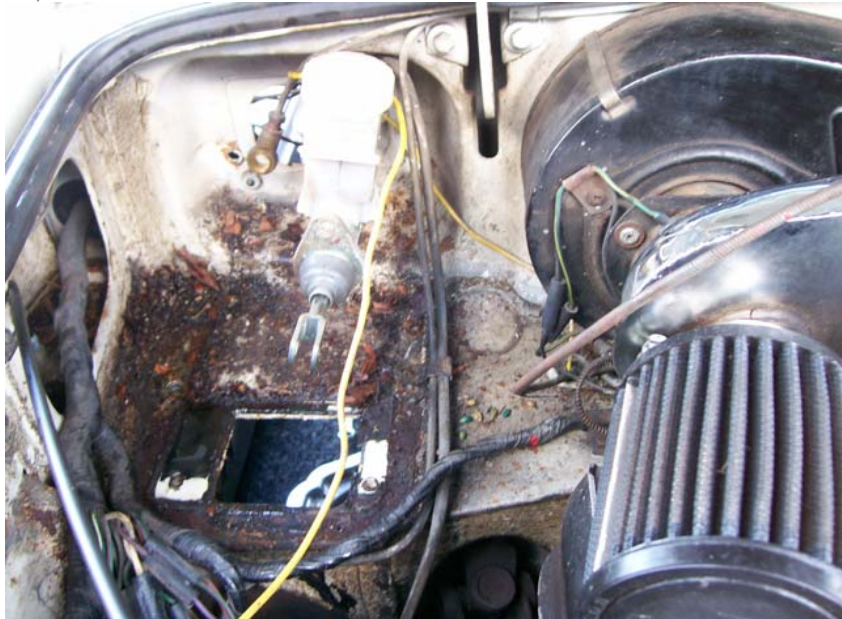
*Offside portion of the bulkhead shelf where corrosion in the pedal box area is seen on so many cars. (Photo: Clive Wagerfield)*

The images show the progressive stages of the refurbishment of the bulkhead 'shelf'. As MGB owners are aware, fluid from the master cylinders can leak over the years causing typical damage as can be seen above. This can also occur on the opposite side where the servo is located although to a much lesser extent.

To do the job properly, I decided to completely strip and refinish the whole area. This will also give me the opportunity to refurbish the pedal box assembly with new master cylinders, replace the original Smiths heater box with upgraded matrix, refurbish the servo and finally the windscreen washer brackets.

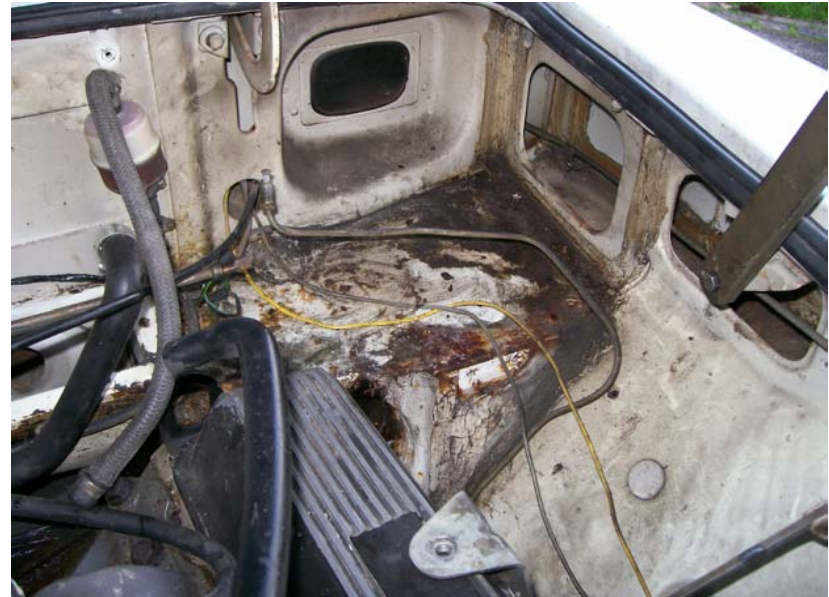
*Nearside portion of the bulkhead shelf where corrosion under the servo unit is seen. Below, the area cleaned up and undercoated. (Photo: Clive Wagerfield)*

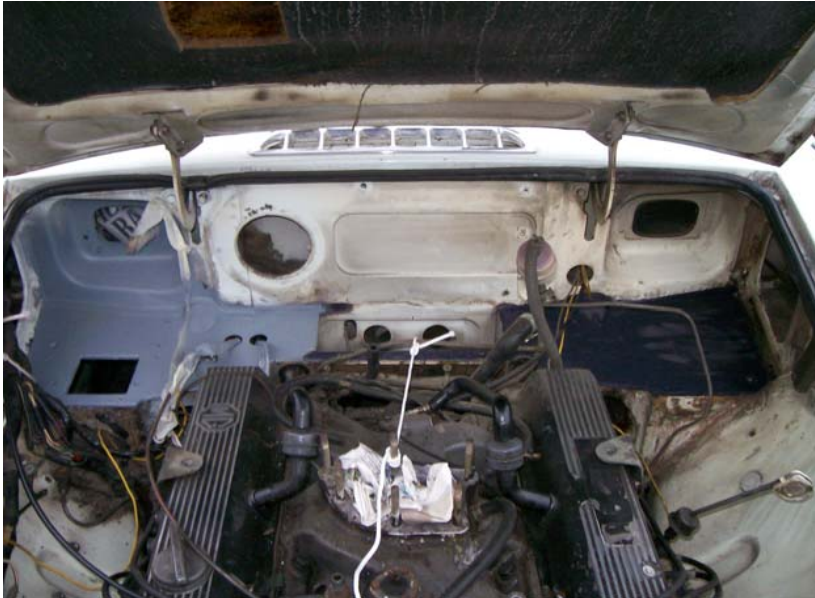
Heater matrix removed and offside portion of the bulkhead shelf cleaned up and undercoated. (Photo: Clive Wagerfield)

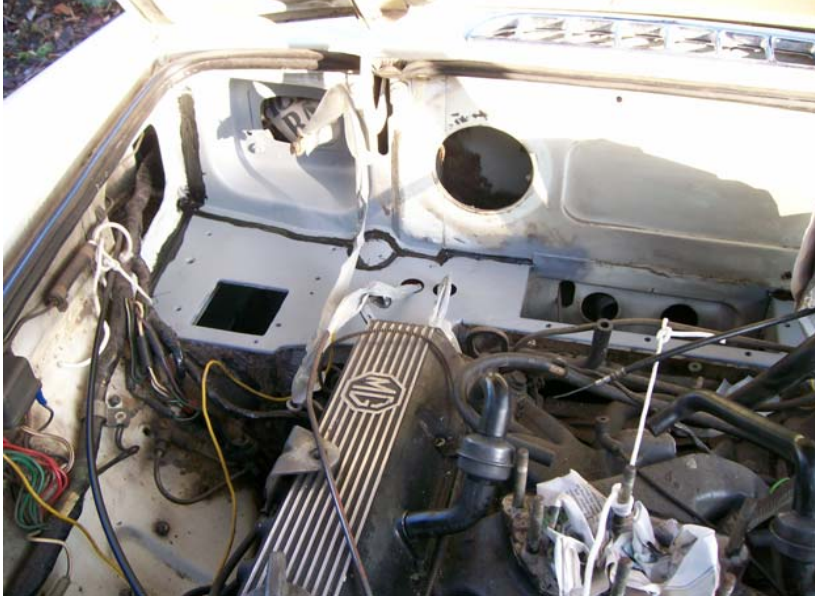
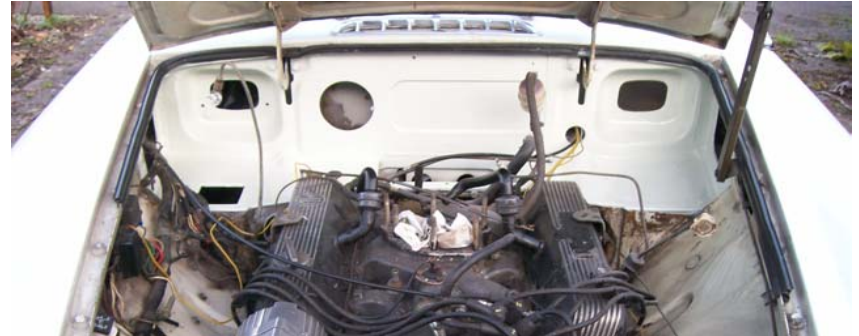
Completed refurbishment of the bulkhead shelf ready for reassembly of the brake and clutch master cylinders, heater matrix, brake servo and screen washer bottle. (Photo: Clive Wagerfield)
