Collapsible steering column

Mike Macartney has been rebuilding a rubber bumper V8 Roadster conversion and supplying a popular series of rebuild reports which have been released on the V8 website. In one of his reports he described the maintenance undertaken on the collapsible steering column. Here we expand on Mike's report with an illustrated note on the steering column and how the maintenance can be carried out. (Nov 16)

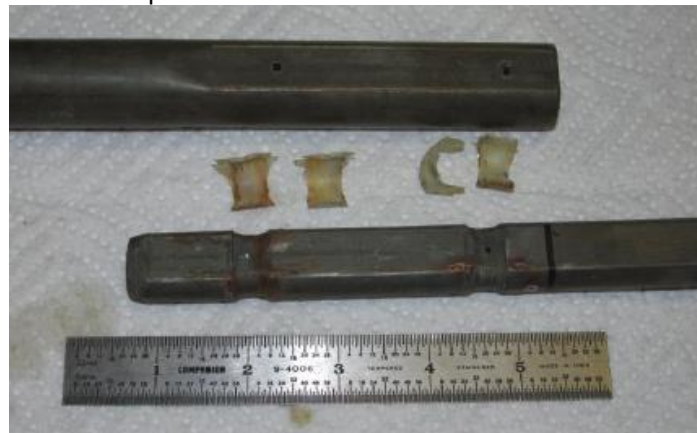
The two parts of the inner collapsible steering that slide inside each other in the event of an accident with the broken bits of plastic that hold the column at the correct length. These I replaced with small screws to hold the two parts together.

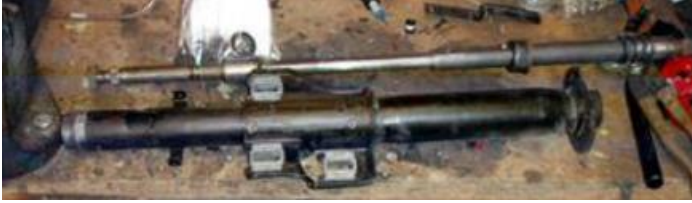
I was going to replace the bearings in the collapsible steering column. There is a ball race at top of the column and loose balls in a track at the bottom held in with a clip. A large spring and circlip hold the whole lot in place. There is also a circlip at the bottom of the top bearing to stop it moving. When I tried to purchase the bearings I found that you could only buy the late date rubber bumper MGB steering column complete, if there was any stock available! Undeterred, I decided to rebuild the steering column.

When I cleaned up and oiled the bearings they turned out to be useable with very little sign of wear. The main problem with the column was that the inside shaft was sliding up the outer shaft easily, which it shouldn't. It is meant to stay in place and only slide up when the crumple zone part of the outer steering column casing buckles up, in the case of a front end crash.

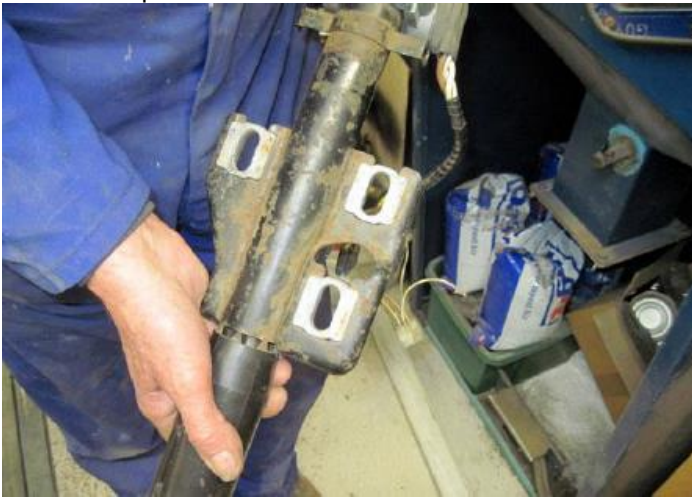
This photo shows the crumple zone part of the steering column where my right hand is holding the column. The three aluminium 'bits' are the top bolts mountings for attaching the steering column to the bodyshell by the dashboard.

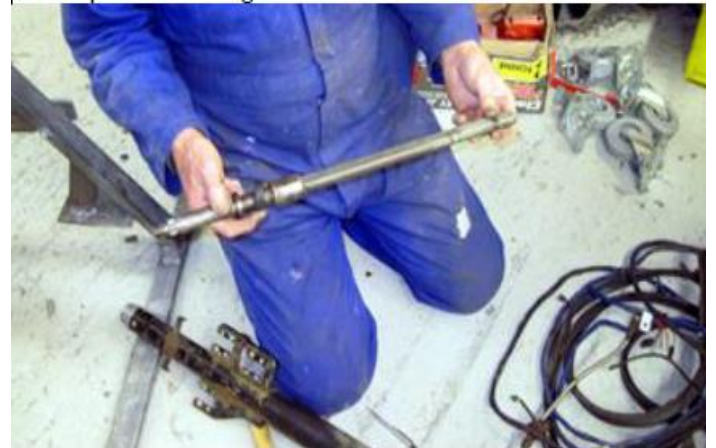
The part I am holding is the inner steering column that I need to repair.

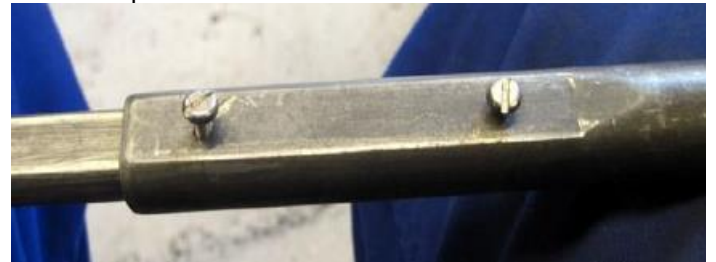
Unfortunately, I forgot to take photos before I repaired this part. Normally, there are some pins where I have installed the 4mm screws. They fit into some plastic inserts in the bit underneath the screws you can see in the photo. What I have done is tap the holes where the pins fitted and replaced them with screws. The column should then still collapse in an accident. The screws just press on the inner shaft and have stopped the inner shaft sliding about.

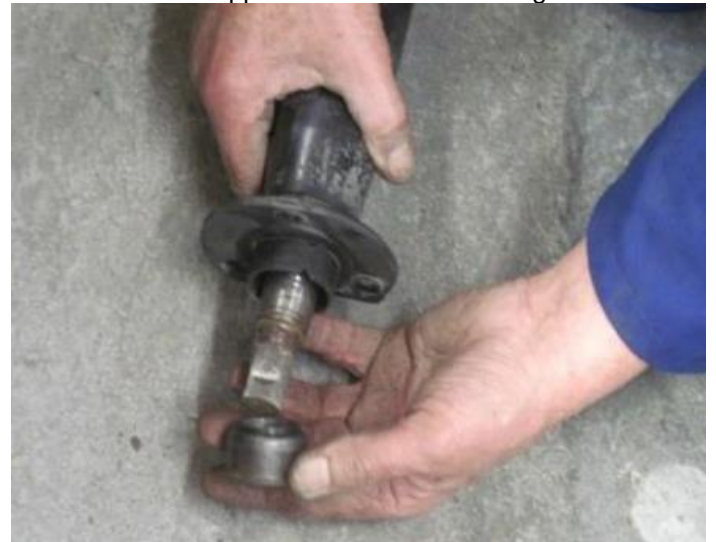
Below is the spring that holds the centre steering column in place. The circlip at the bottom looks as if I need to replace it. As it is not available from MG suppliers I will

have to find a suitable circlip in my box of circlips of various sizes. Each side of the spring is a washer, or spacer.

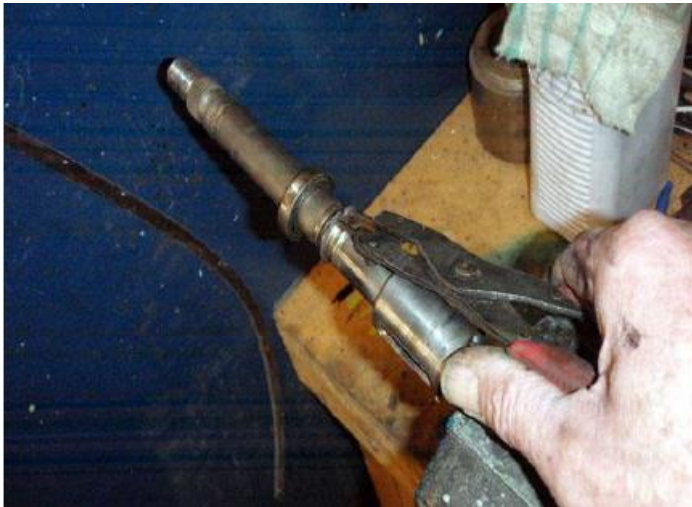
The top bearing is held in place with another circlip. There seems to be two grooves each side of the bearing. In the bits I took off, ages ago, there appears to be two circlips, but there is no way this second circlip will fit in the groove as the bearing covers it?

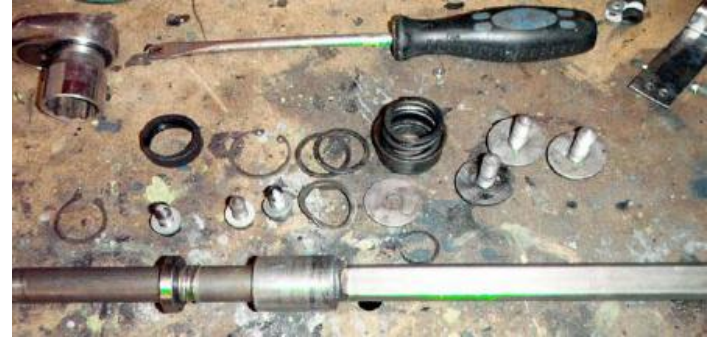
These are the parts that need to find a home back on the steering column.

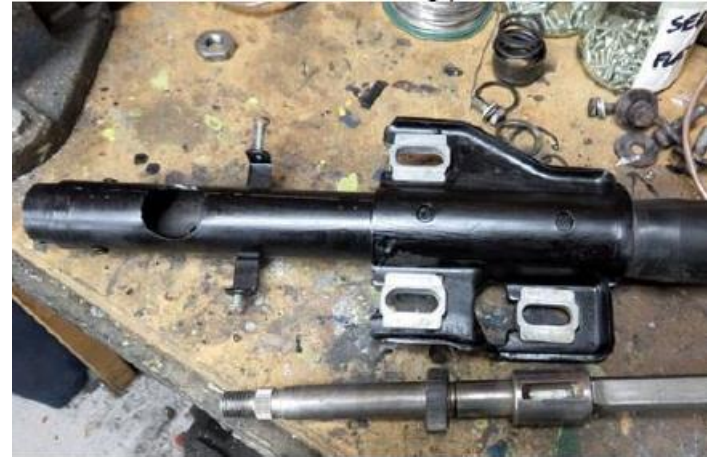
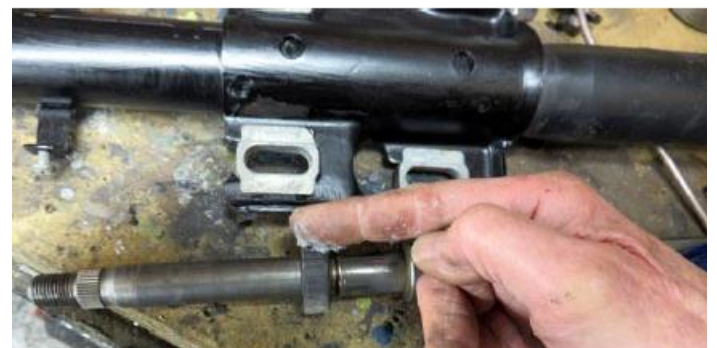
Now the paint is dry on the outside of the steering column I can get to work trying to put it back together. Advice for others – It is much easier if you take bits apart and repair them there and then, rather taking them apart and leaving them for some period of time before you reassemble. In this photo above, you can see where the cut out is in the outer steering column and the slot in the inner shaft where the actual locking parts sits.

I wiped the bearing cover with Vaseline to help the bearing and its cover (spacer) to slide into its correct place inside the outer column.

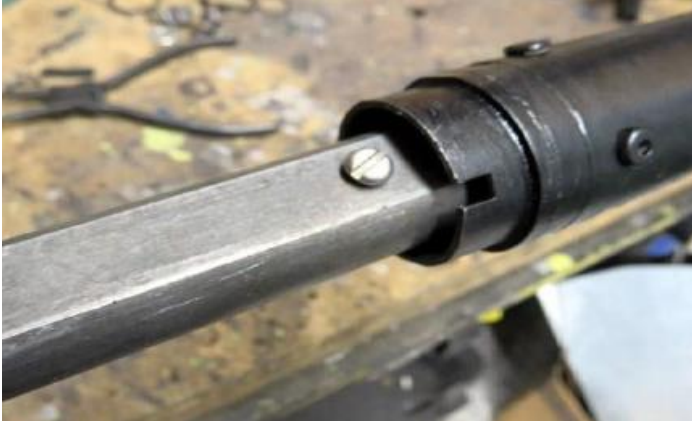
The inner shaft would not slide down the outer steering column. The M4 screws I had used had too large heads on them.

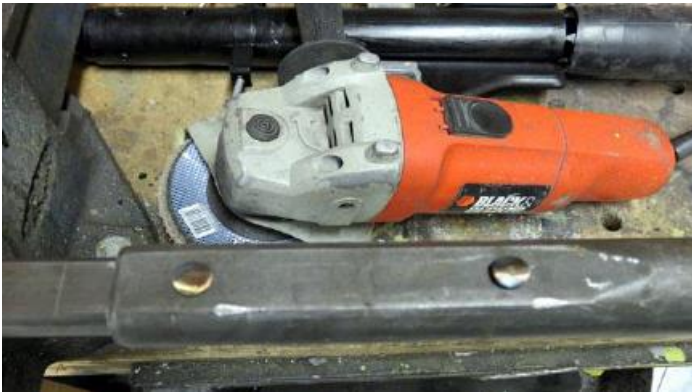
Out came the grinder to grind off most of the head. This does not really matter as I was only using them to hold the inner shaft to the outer shaft. The problem will come if I didn't fix them in the correct place!

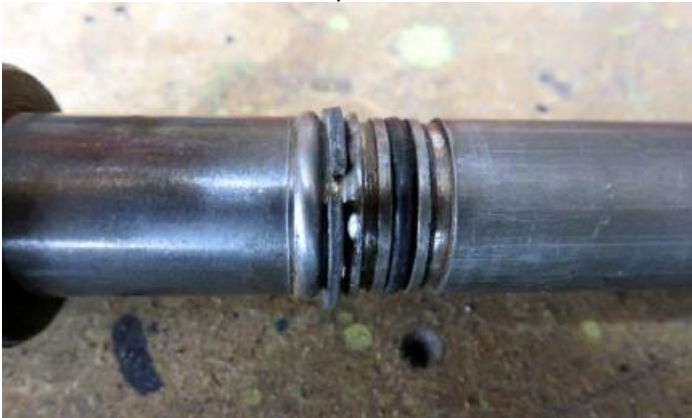
At last, I found out that you do need two circlips to hold the top bearing in place. The standard bearing that BL used was also not the correct size for the steering column shaft. You can see in this photo the 'O'-ring that they added to the shaft to stop the inner race of the ball race rotating on the shaft. Another BL bodge!

The bearing and spacer were pushed into the outer steering column at the top where the steering wheel goes

and the circlip pushed down to sit in the second circlip groove.

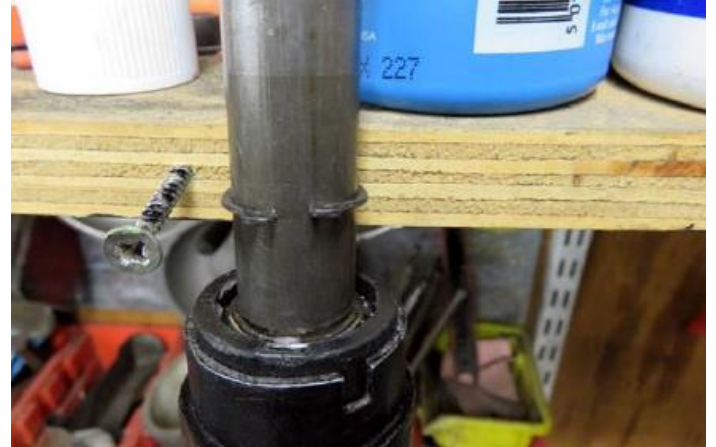
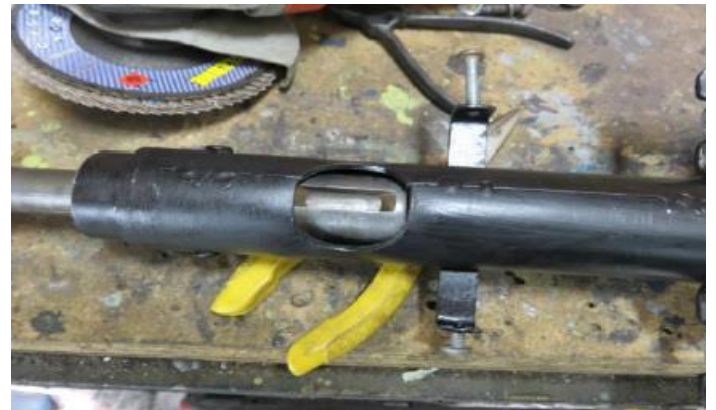
The bearing, spring and circlip at the bottom of the steering column will hold the inner steering column shaft in its correct position.

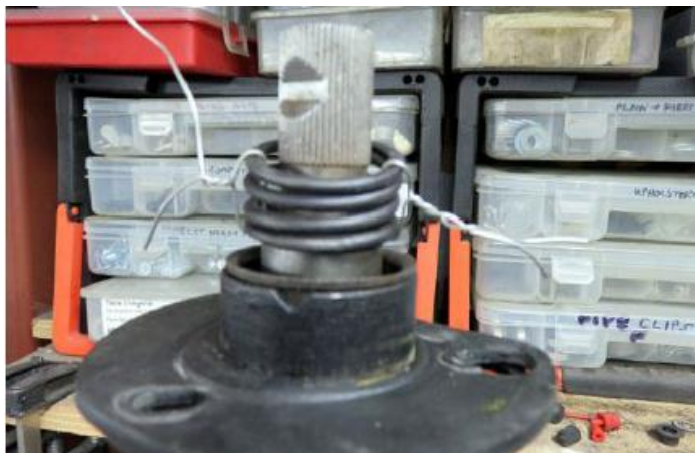
How the hell am I going to push on this large spring and get the circlip to fit, all at the same time? Time for a cuppa and some thoughts. I think I will need some help with this. This is a trick I have used in the past, wiring the spring in the fully compressed position. I put the spring in the vice to compress the spring and tied it up with wire. The problem was that the wire would not let the spring drop down over the inner shaft.

I got Jane to come and help me with the circlip. I held the spring back with a couple of screwdrivers whilst she tried to fit the clip in place. After about ten attempts I gave up that approach to the problem. The spring that BL used, back in the late 1970s, looks to me far stronger than it needed to be. Looking on the internet the other week I found a site in America saying that the problem with these steering columns is that the ball bearings at the bottom break up. This I think is probably due to the high pre load that the spring is imparting on the balls.

I went and had a look to see if I could find a weaker spring of the same diameter that I could use. No Joy, I had nothing like it. To decrease the load on the spring I decided to cut 1/8" off the bottom of the steering column with a Dremel cutting disc. I also put the spring on the finisher to make the end of the spring flatter so I could hold it in place better with the screwdrivers.

The amount I had cut off the outer column was just enough for Robert to hold the spring in place, and for me to fit the circlip. Success at last.

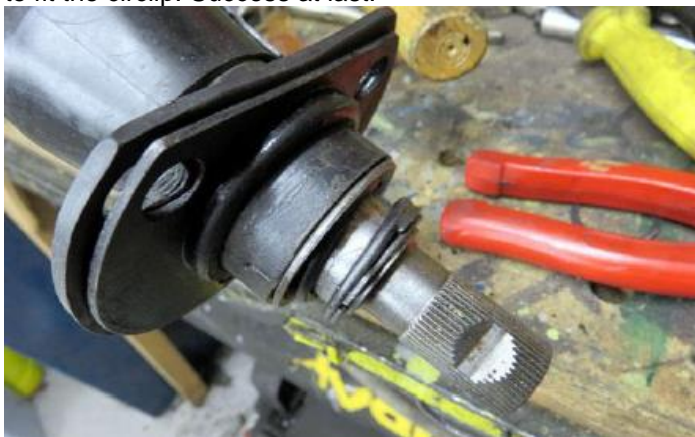
Yes, I did fit the rubber and plate the wrong way round in my excitement of getting the column together at last. This was easily rectified without having to take the column apart again.

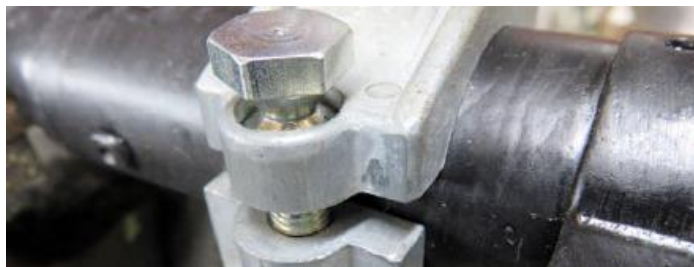
The next job was to bolt the steering lock back onto the other steering column. This photo shows clearly the 'shear bolt' holding the lock onto the steering column.

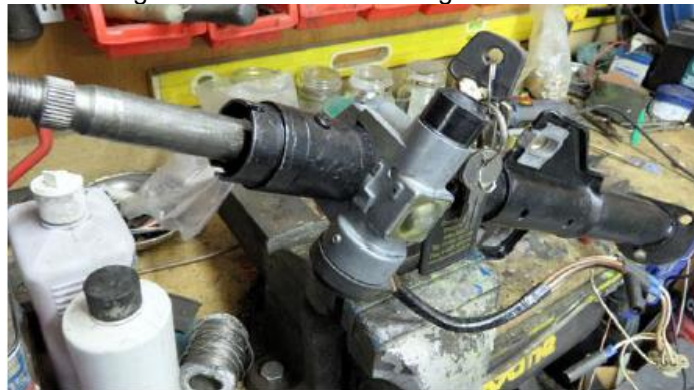
I have not tightened the steering lock fixing bolts to the shear point, just in case I need to take it apart again or the steering lock needs replacing in future.

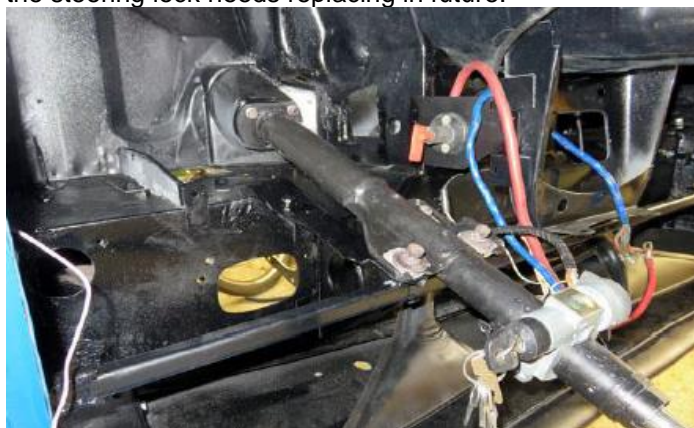
It was easier fitting the steering column to the body with the shell upside down on the spit".
